UV-Fluorescence Workshop ISFH 2018-10-12

UV-Fluorescence: Experiences from the Field

Eckhard Fleiss - Fleiss Engineering, Springe-Eldagsen
Matthias Diehl - photovoltaikbuero Ternus & Diehl, Rüsselsheim

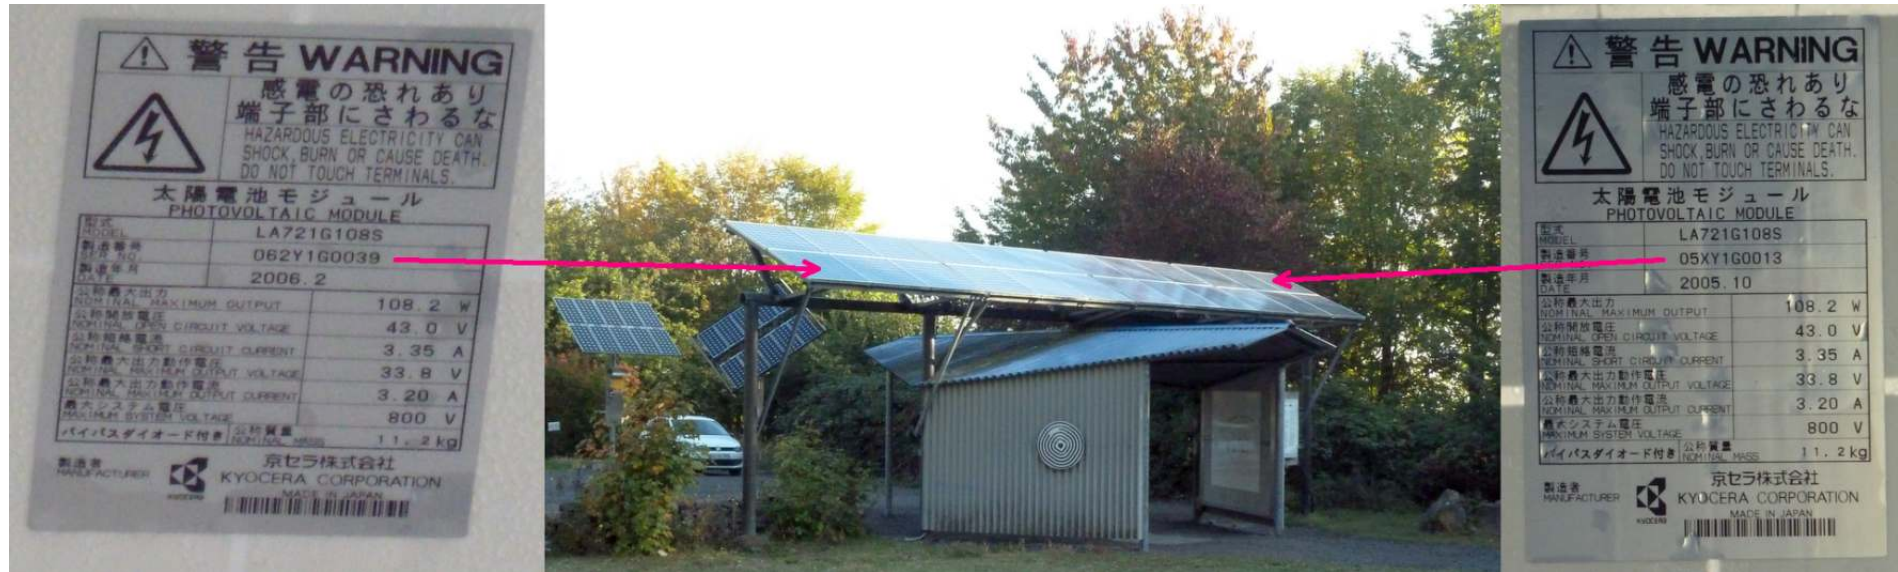
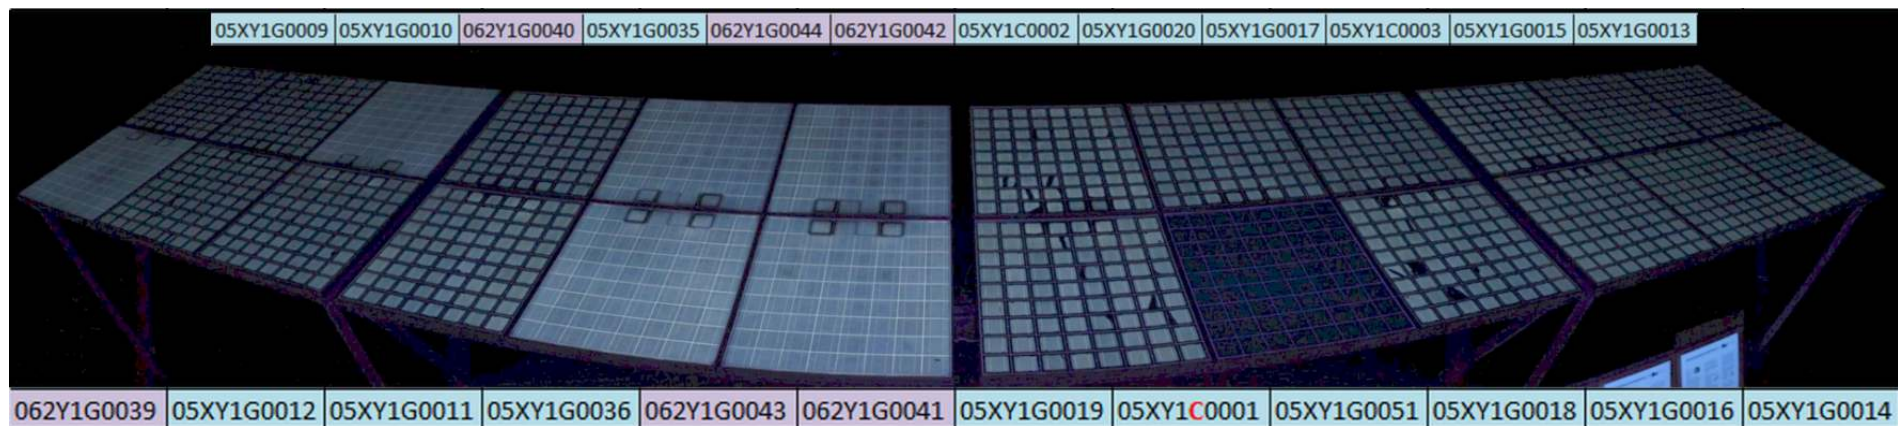
Overall appearance gives hints to manufacturing culture

we can sometimes distinguish SN ranges, i.e. Mfg date, factory / line, BOM?

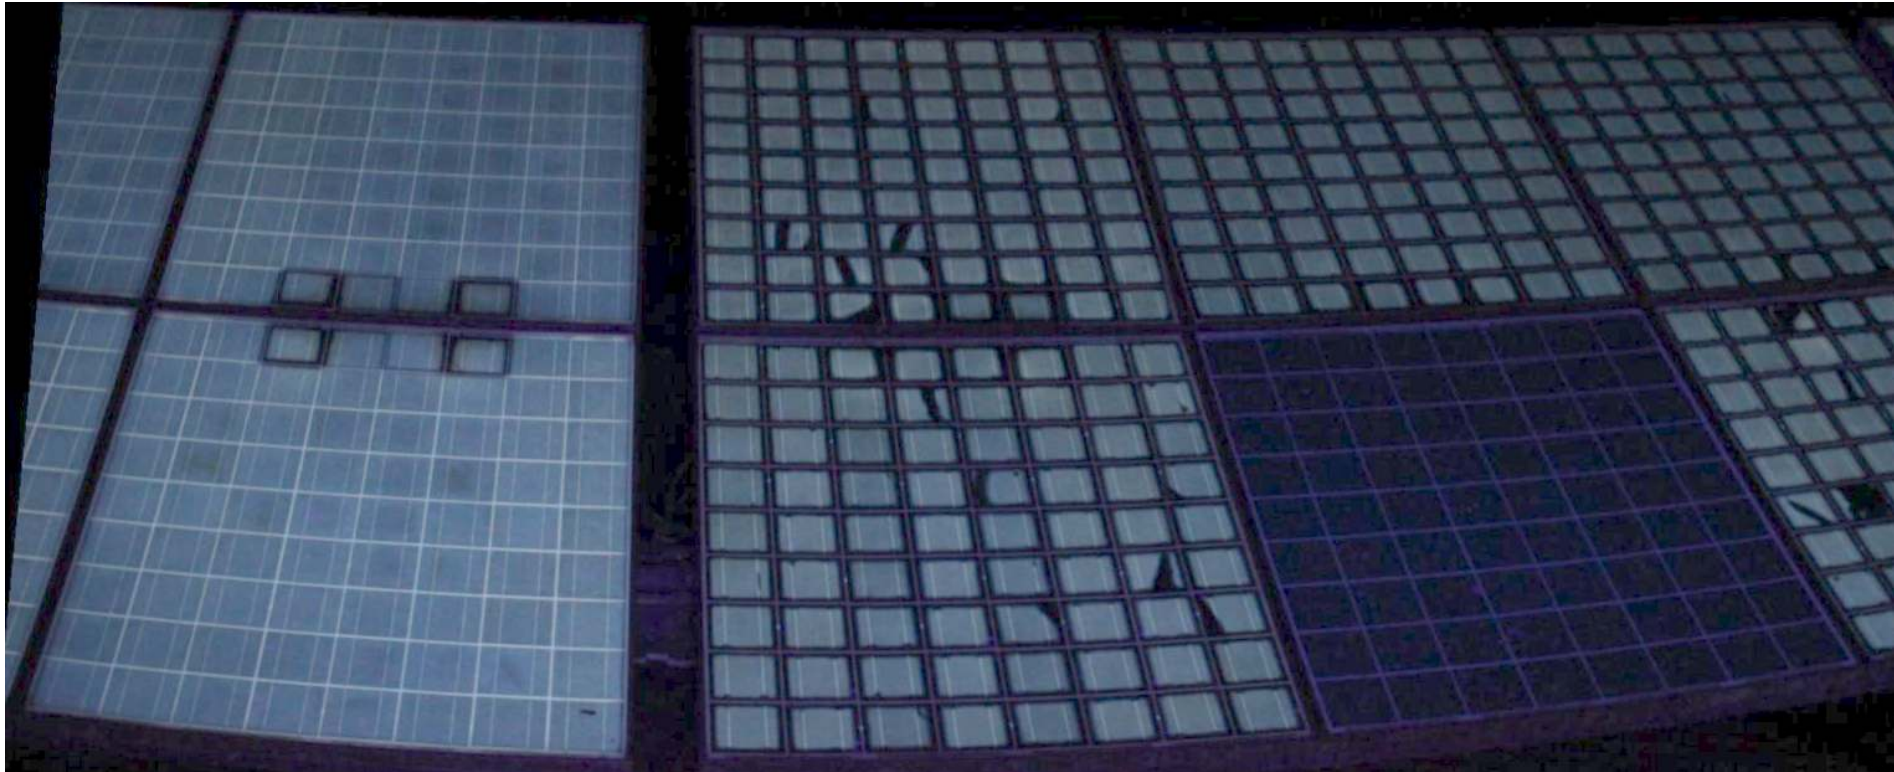
Zooming in gives hints to

position of JB - why?
intrusion-path for O_2 or
chemistry of sealing?

old cell cracks,
if BS sufficiently
permeable

nothing at all,
if BS totally open or
non-fluorescent EVA

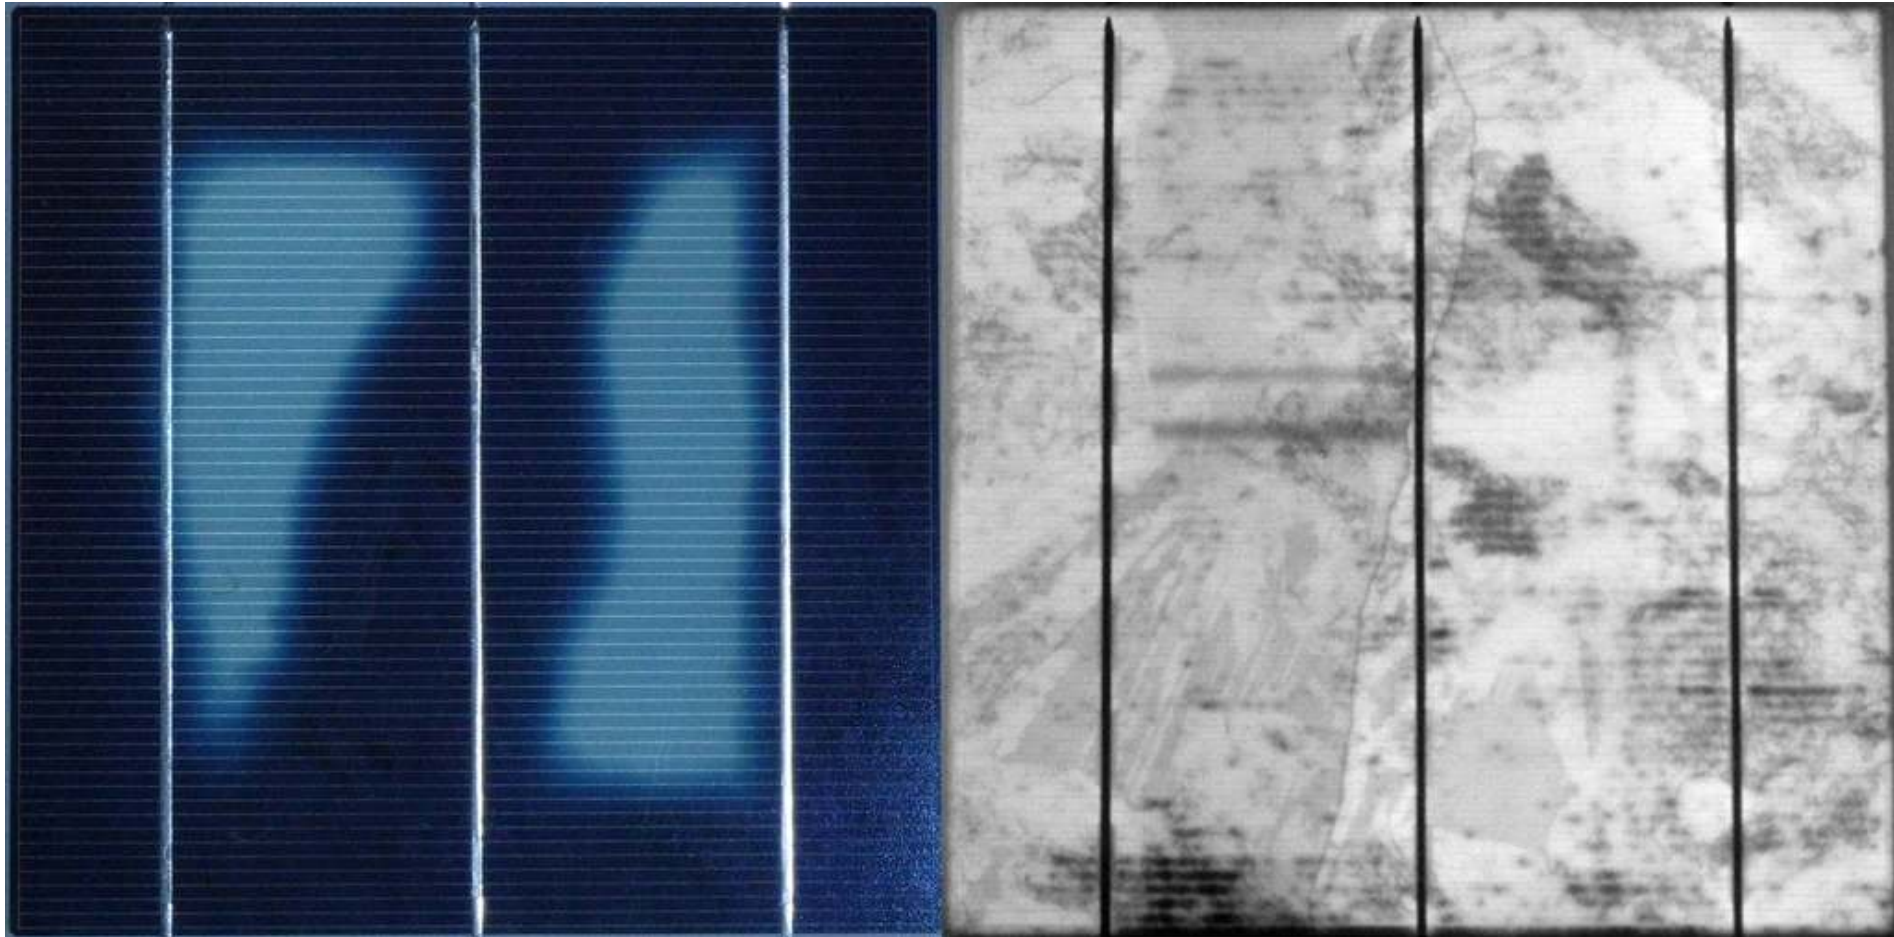
old cell cracks, distinguishable from newer ones in combination with with EL

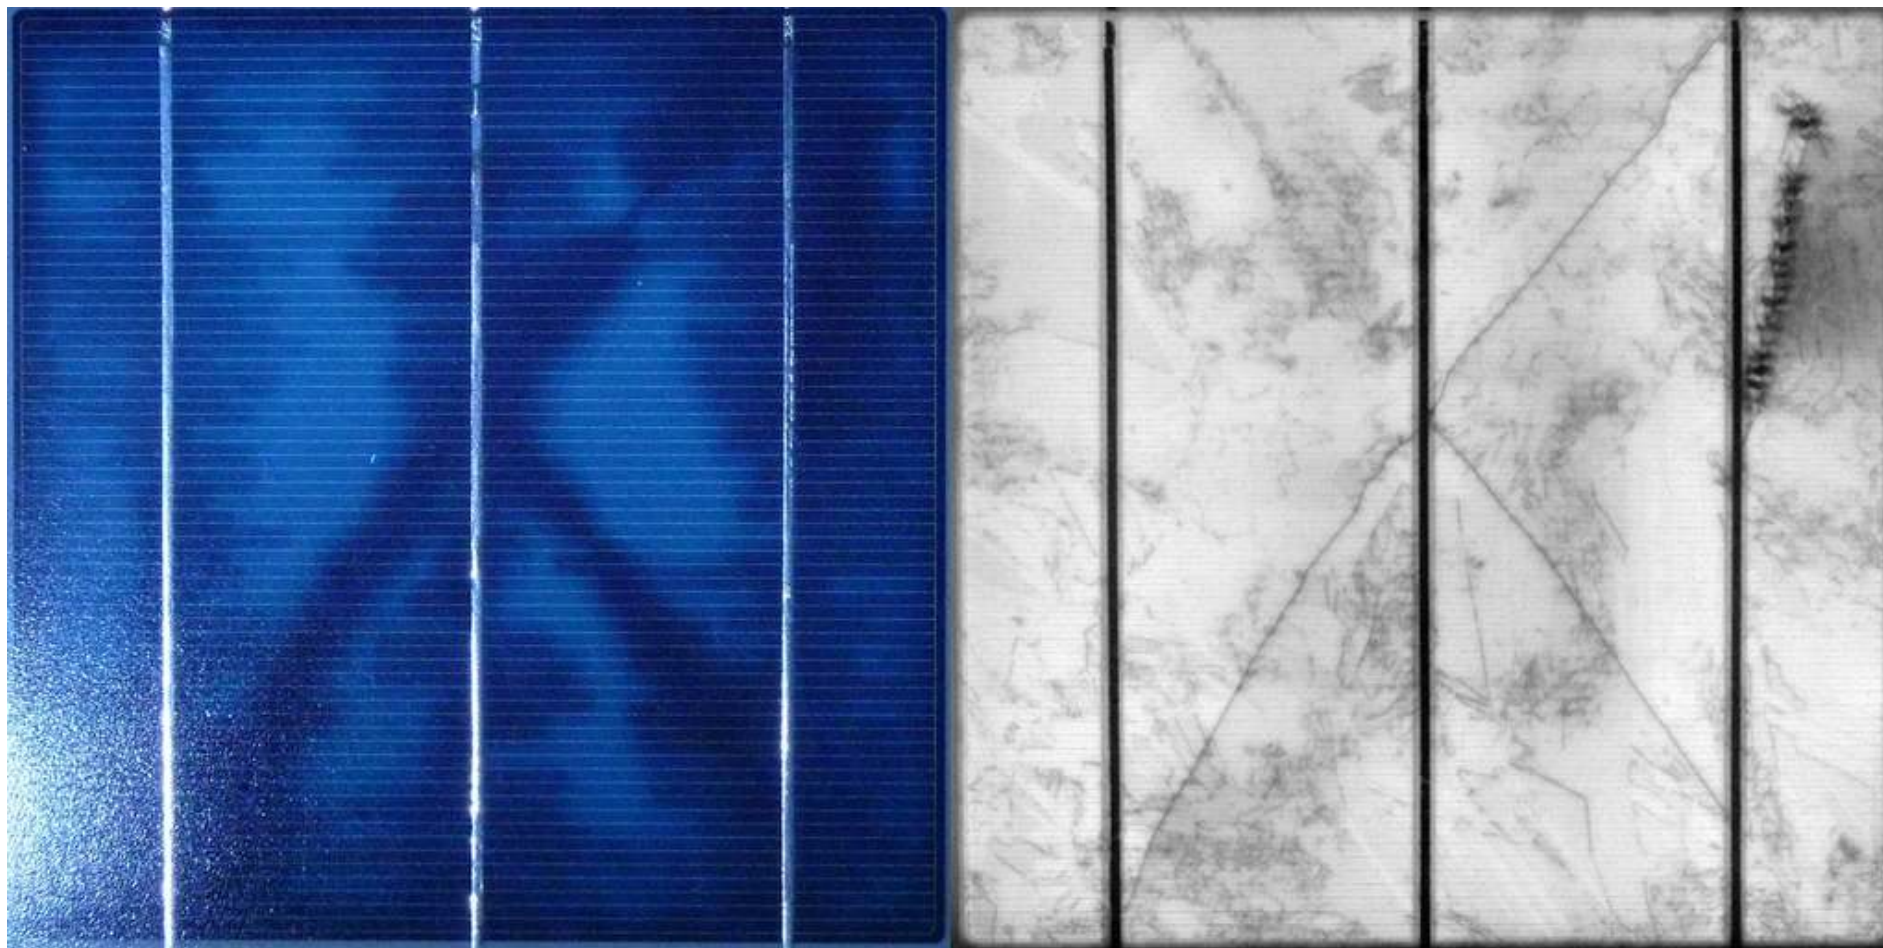
old cell cracks, distinguishable from newer ones in combination with with EL
quality of lamination process (O_2 diffusion along grind fingers)?

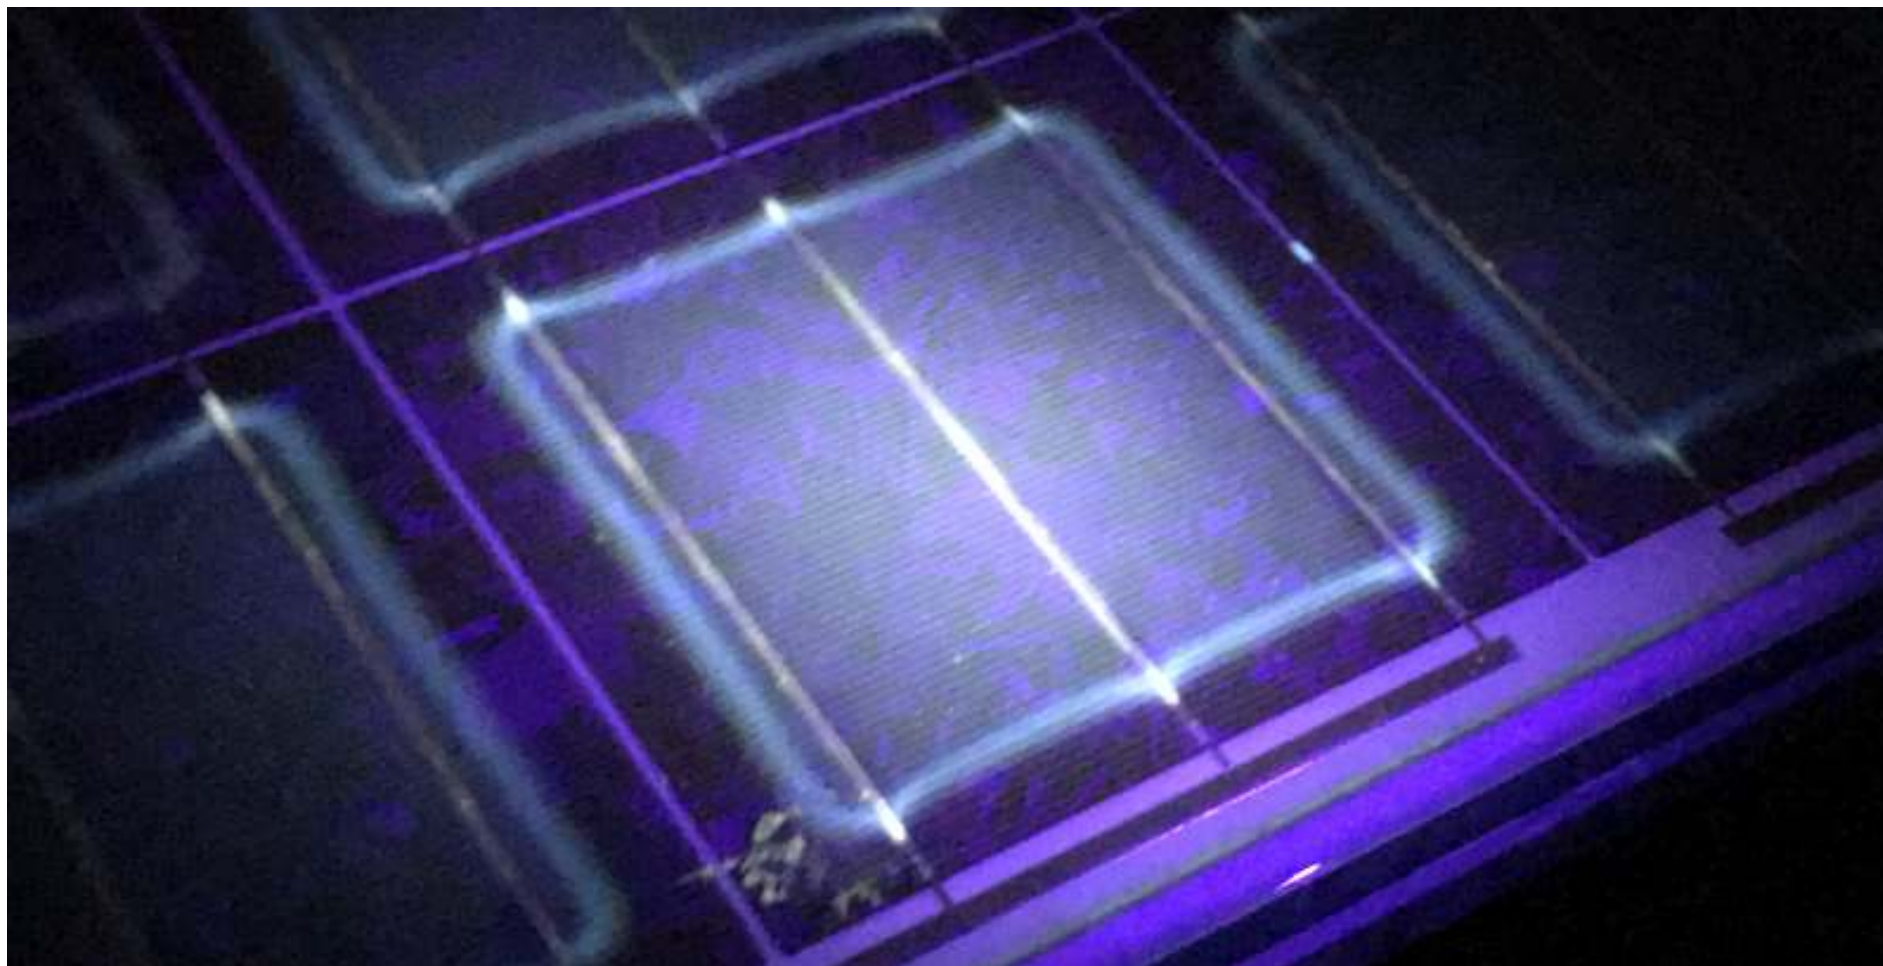
...surprising things - enhanced fluorescence by agglomerating fluorophores?

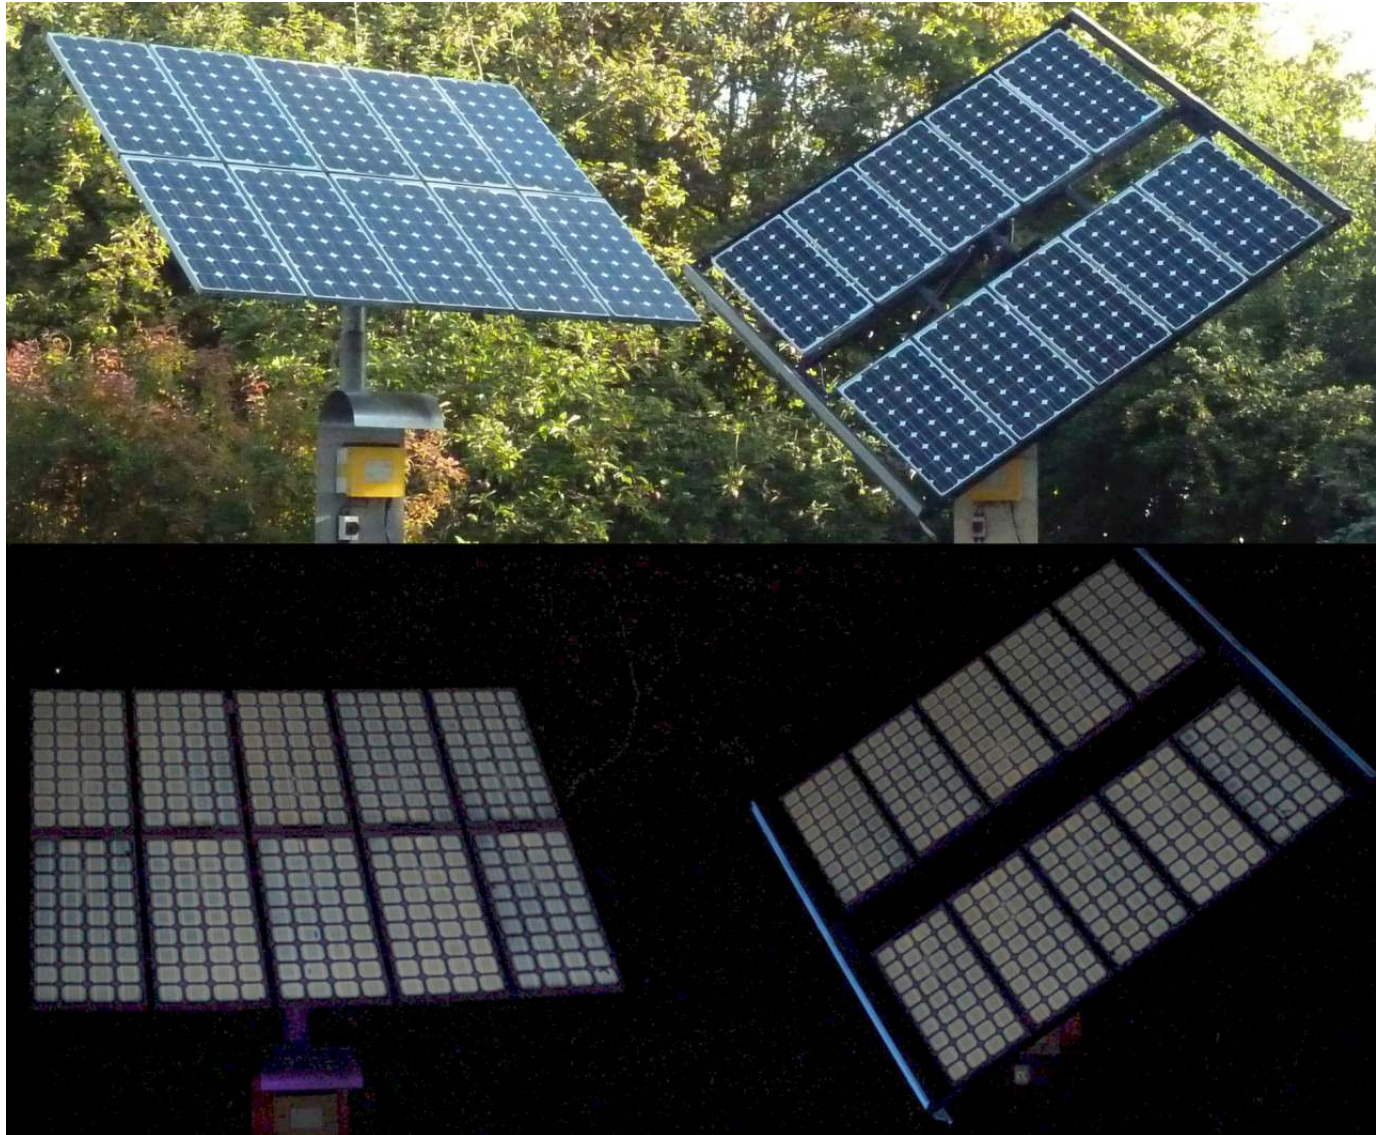
cz-Si BP585
from 1998
near Hanover

homogeneous
appearance,
almost no cracks

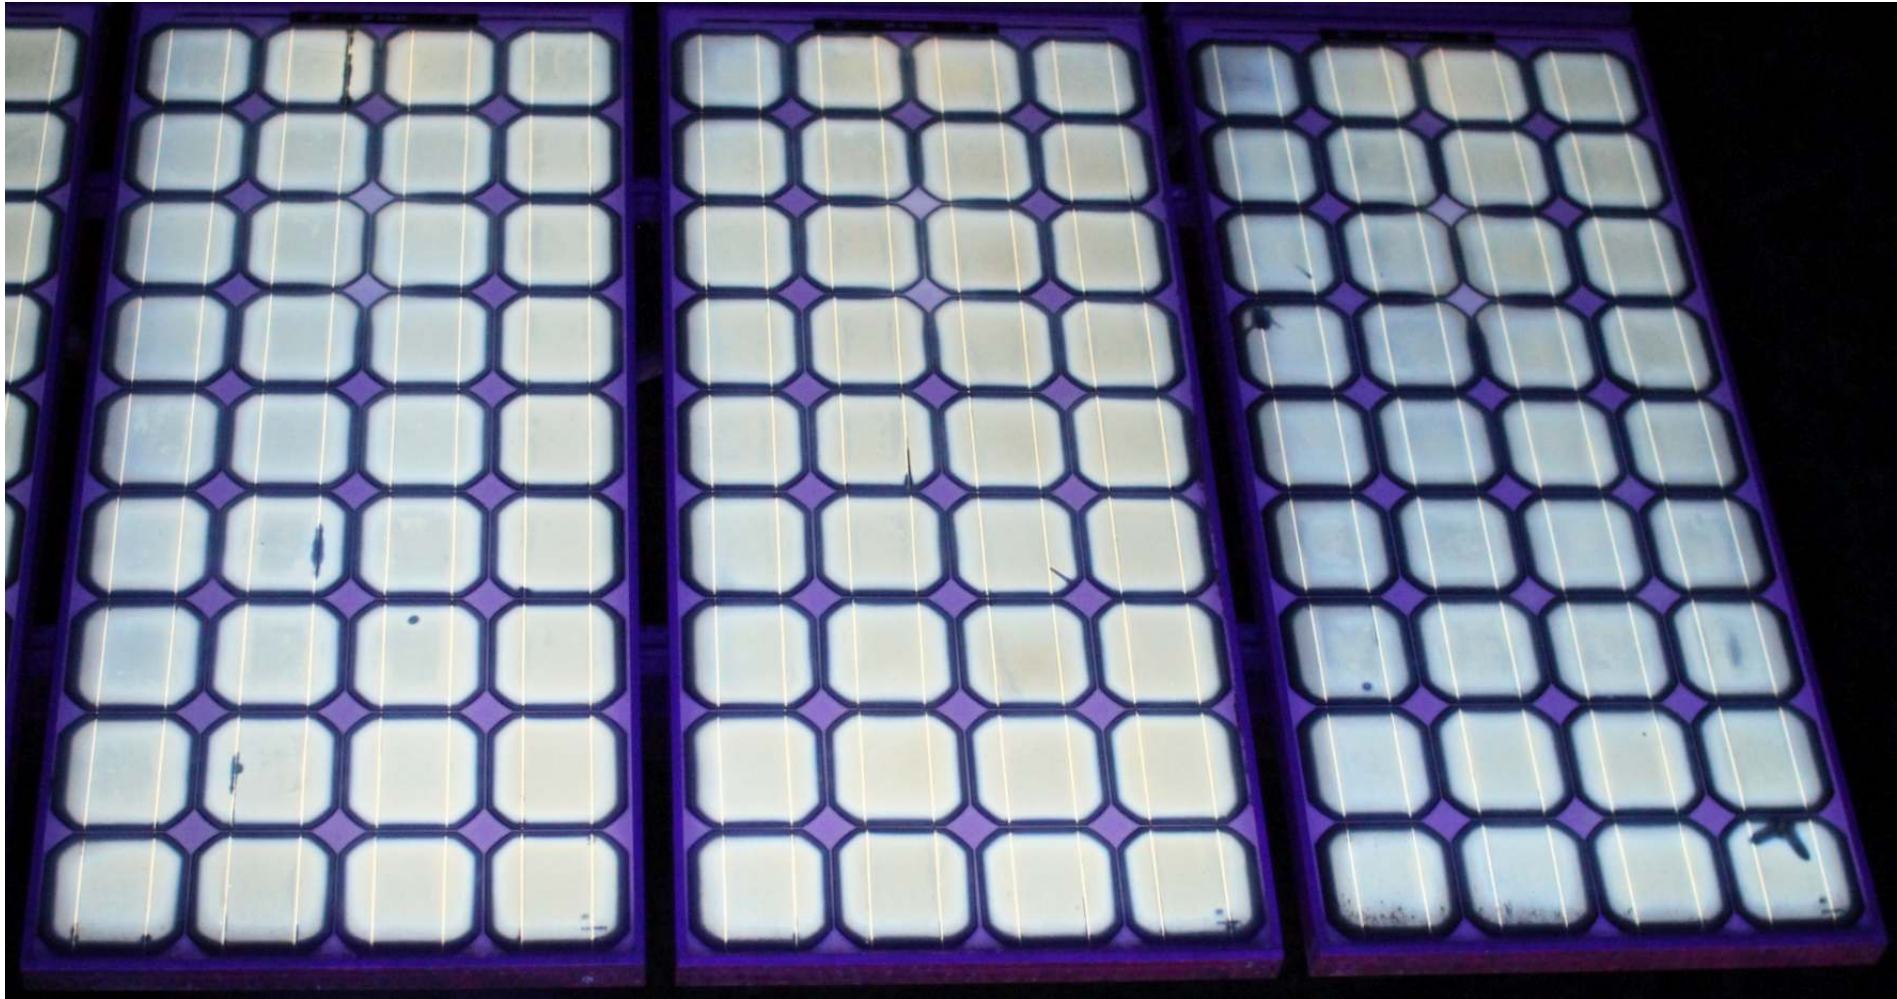
quenched fluorescence along tabbing -> chemical influence of flux?

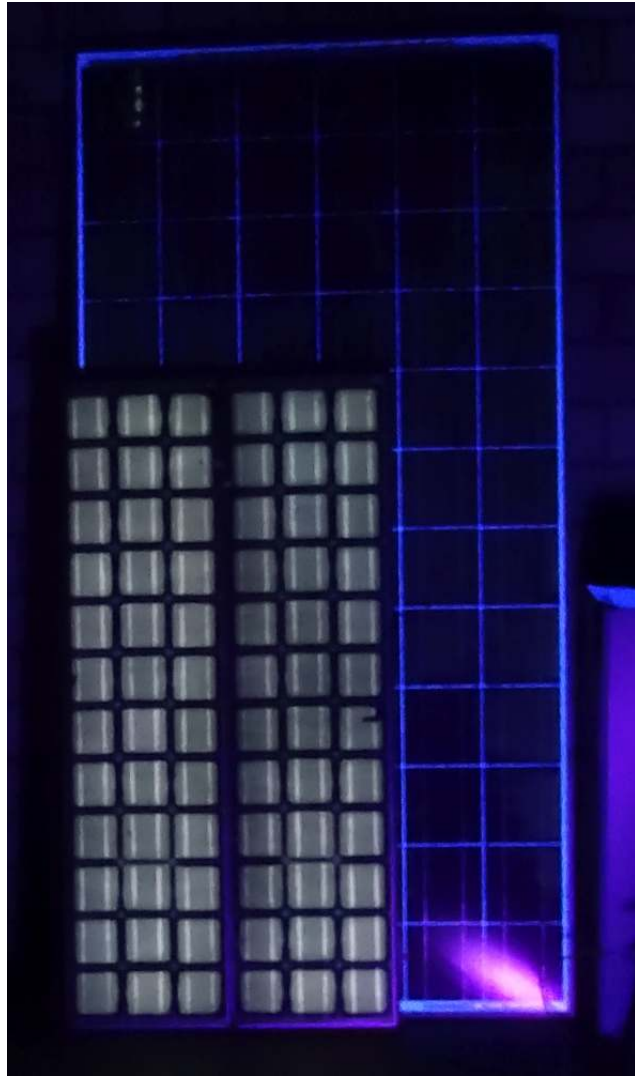
old Siemens M53 vs. young
poly-Si w/o fluorescence

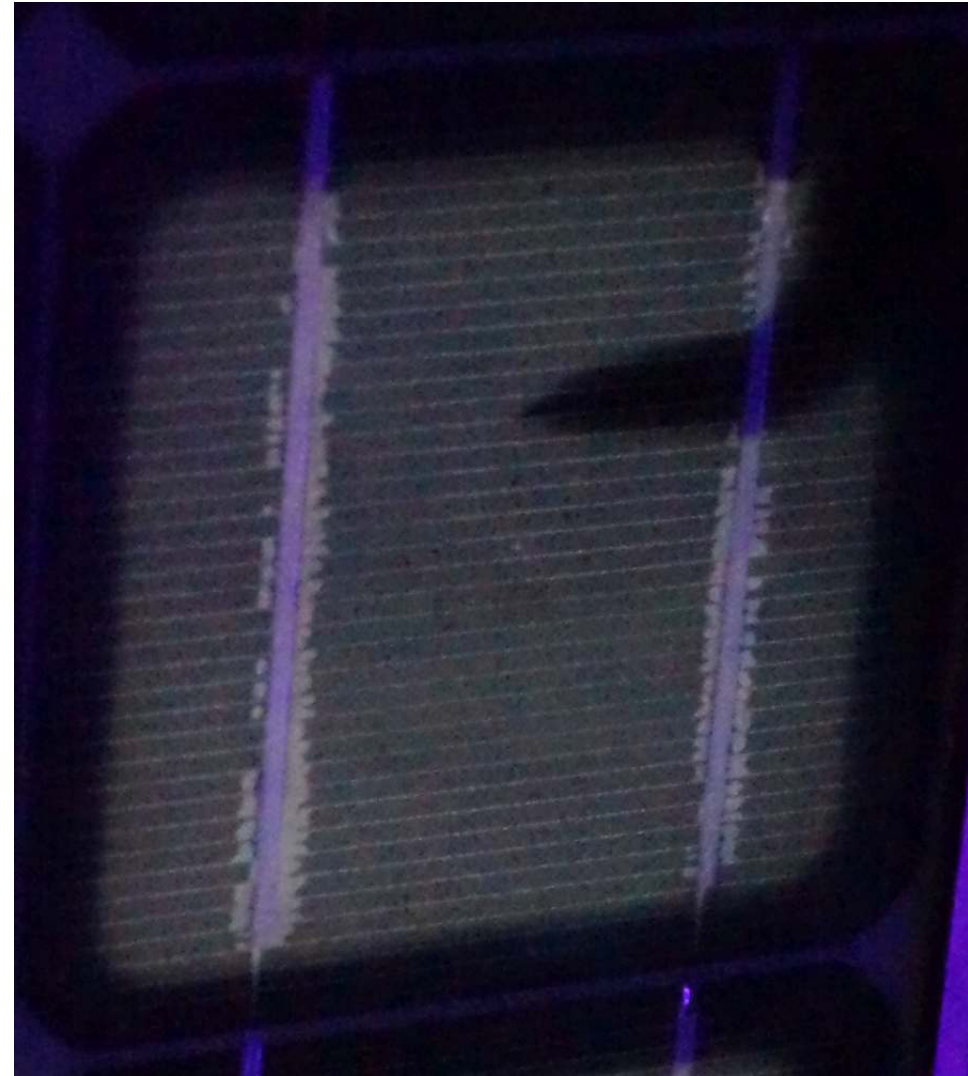
optical effects along tabbings

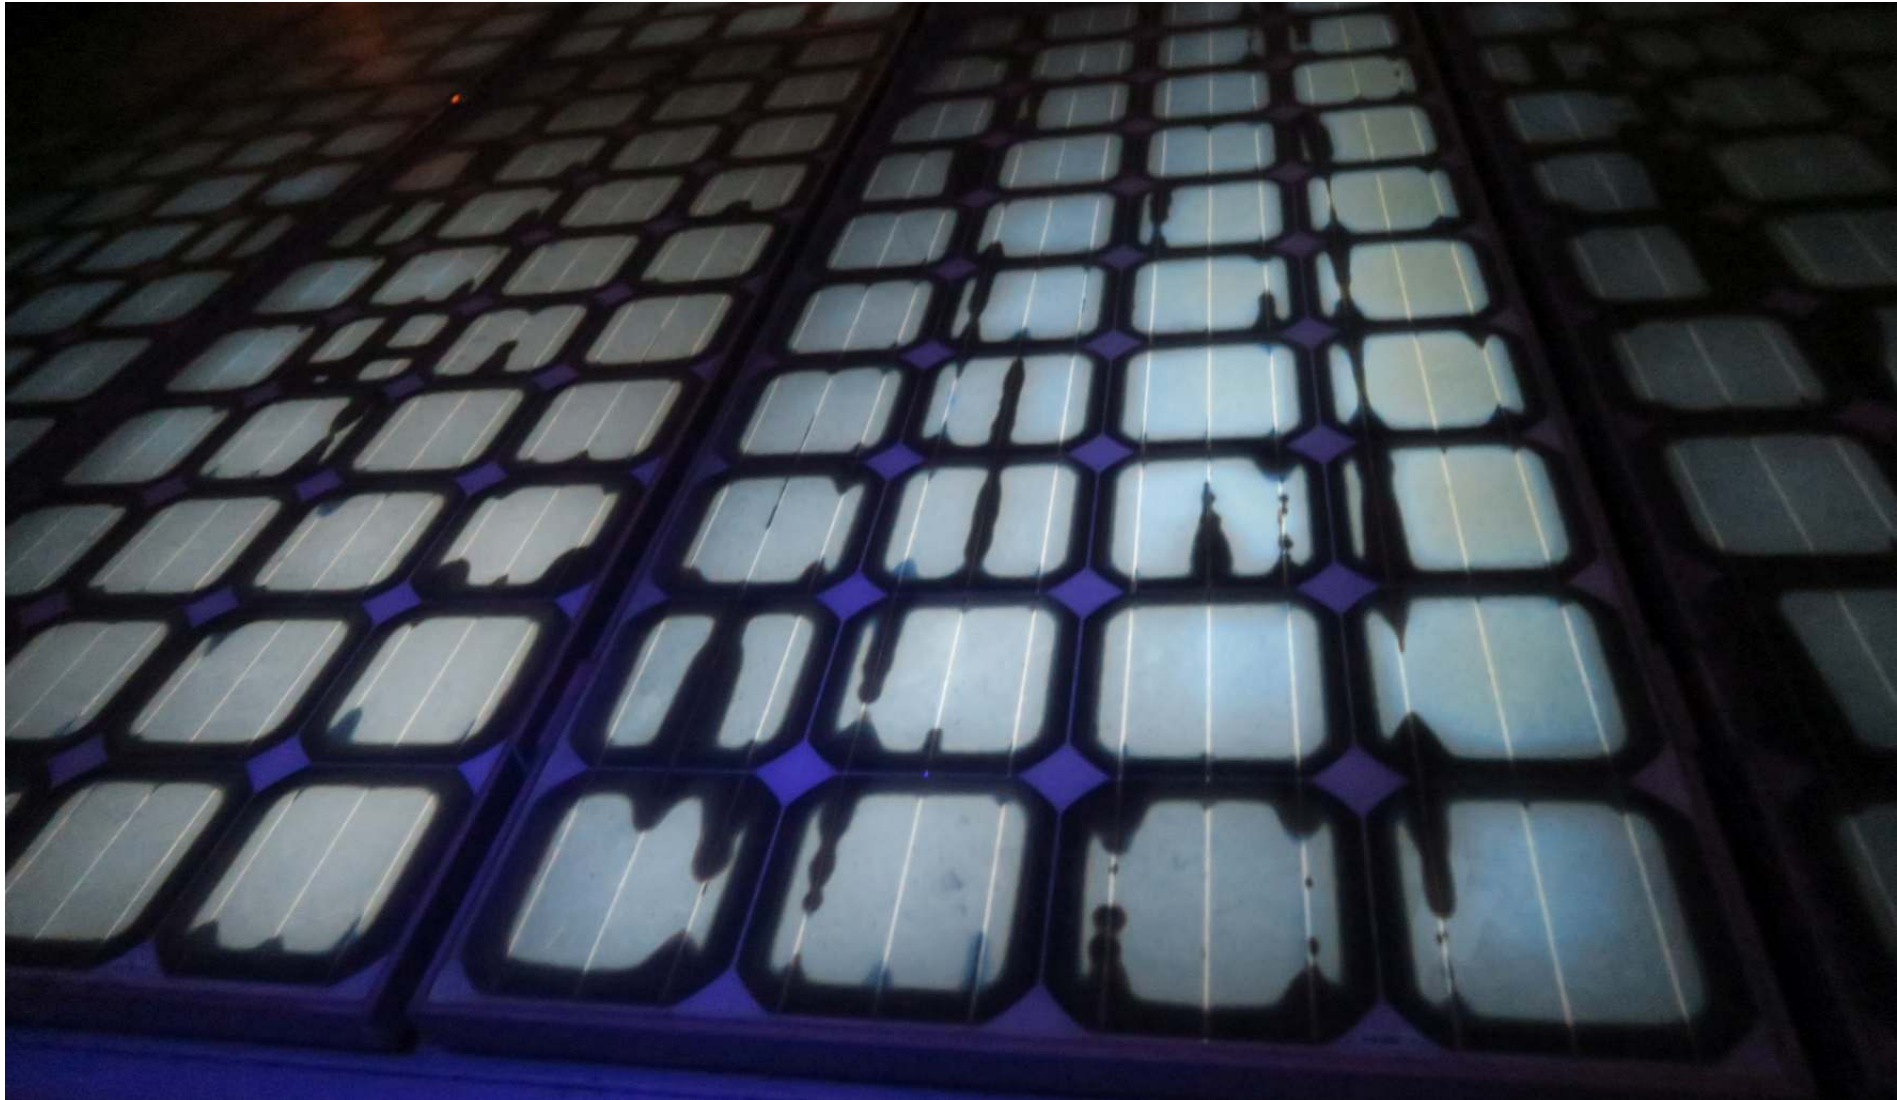
old Helios cz-Si modules with quenched fluorescence along tabbings

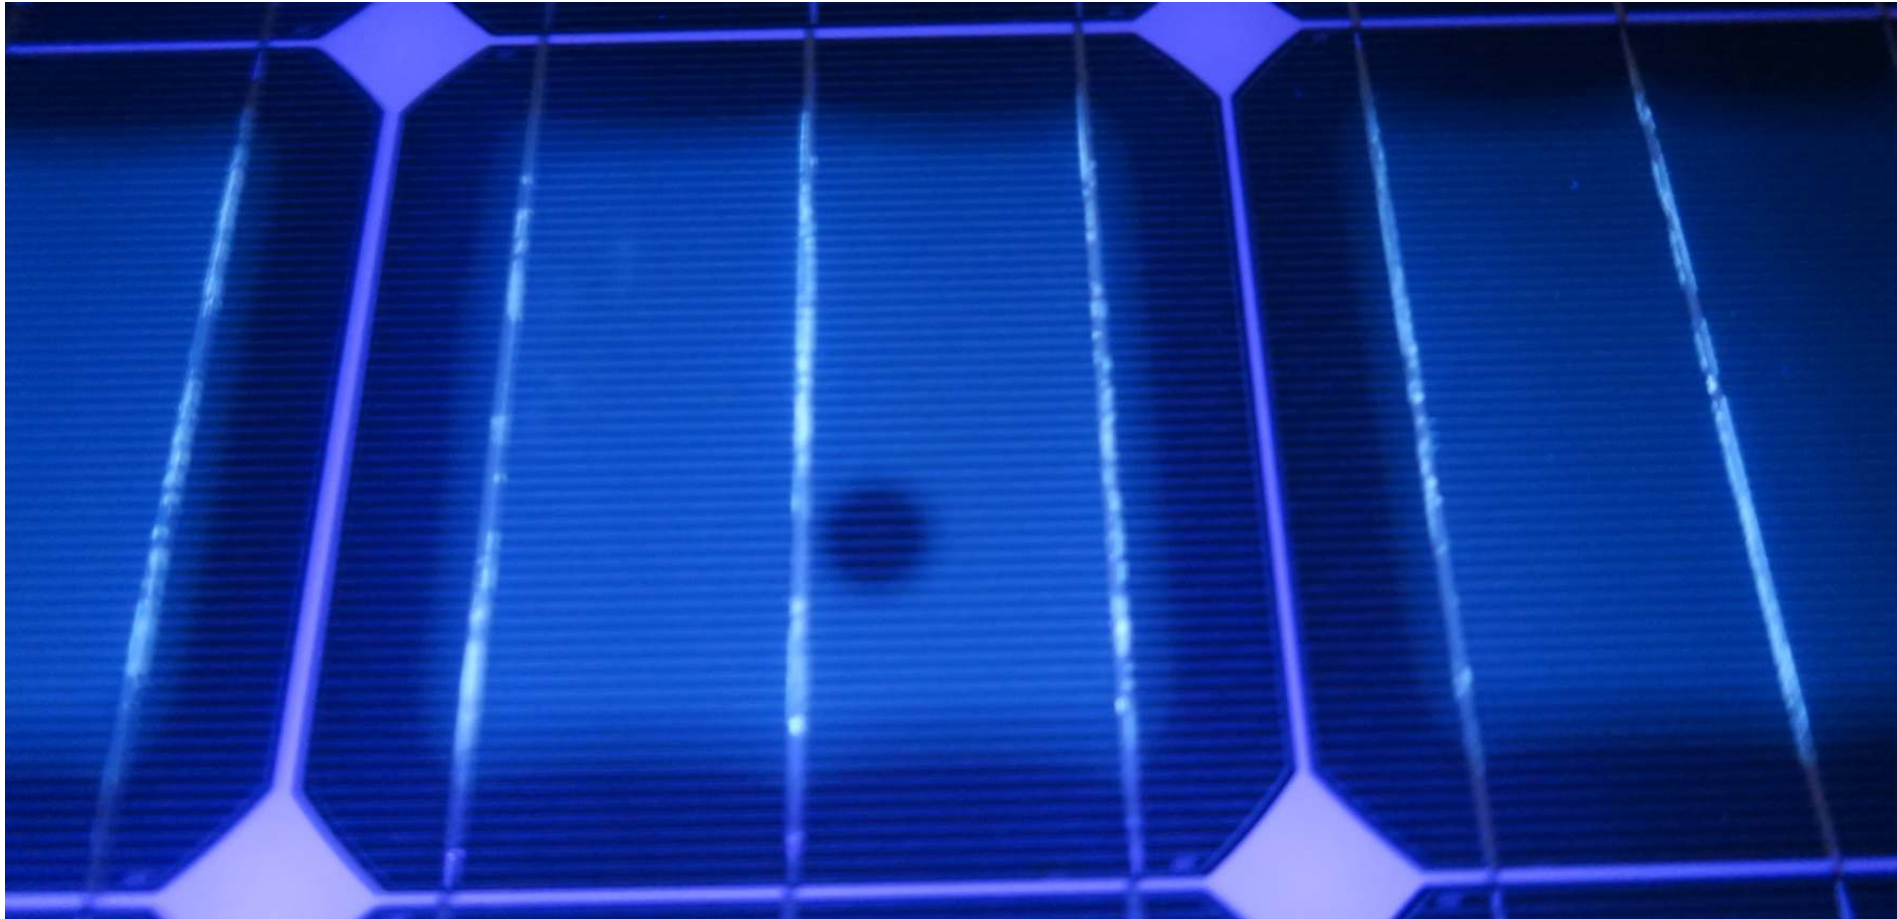
Suntech-Power 250W_p cz-Si module with spot-like quenched fluorescence

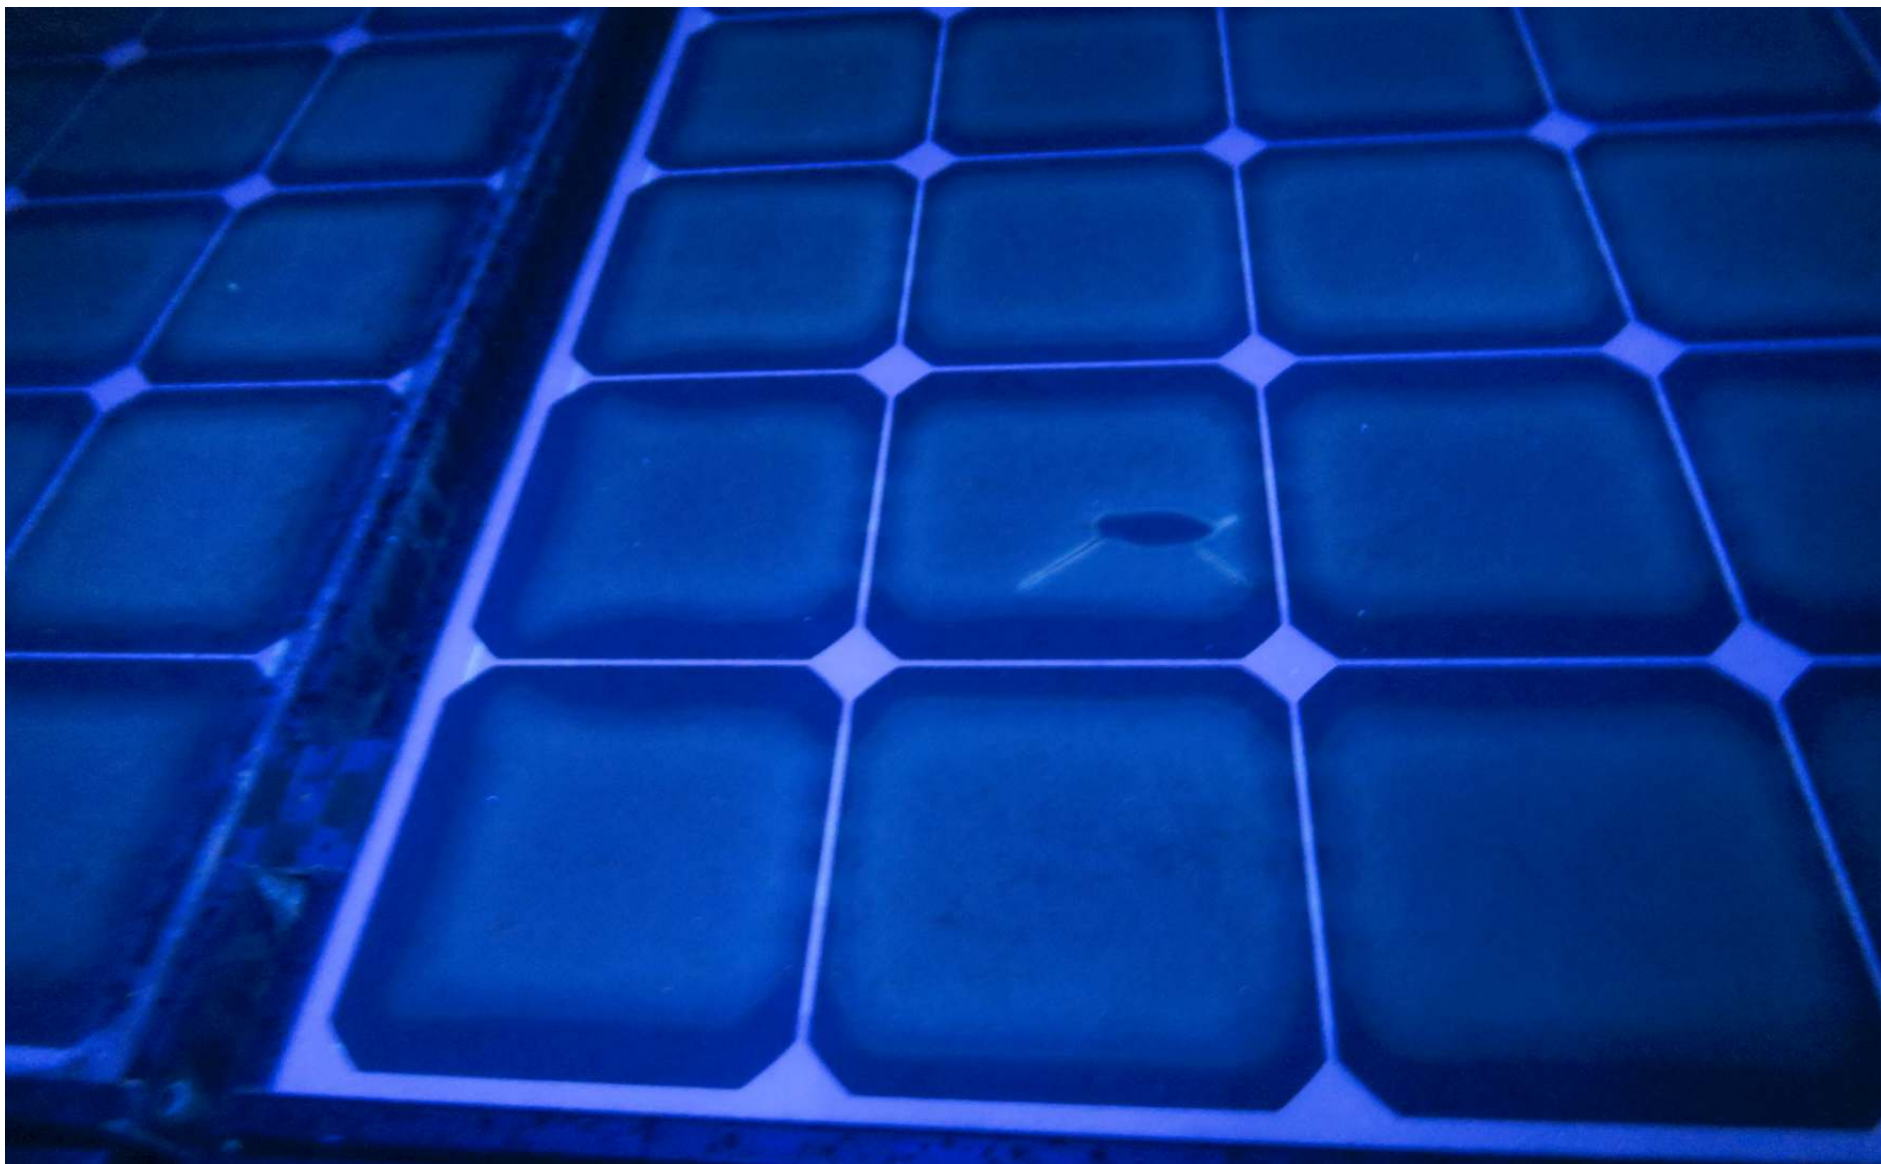
Sunpower BC module with spot-like quenched fluorescence and local crack?
