Advanced EL inspection with predictive estimation of module power loss

Ralph Schmidt (Dipl.-Ing)
pi4_robotics GmbH Berlin

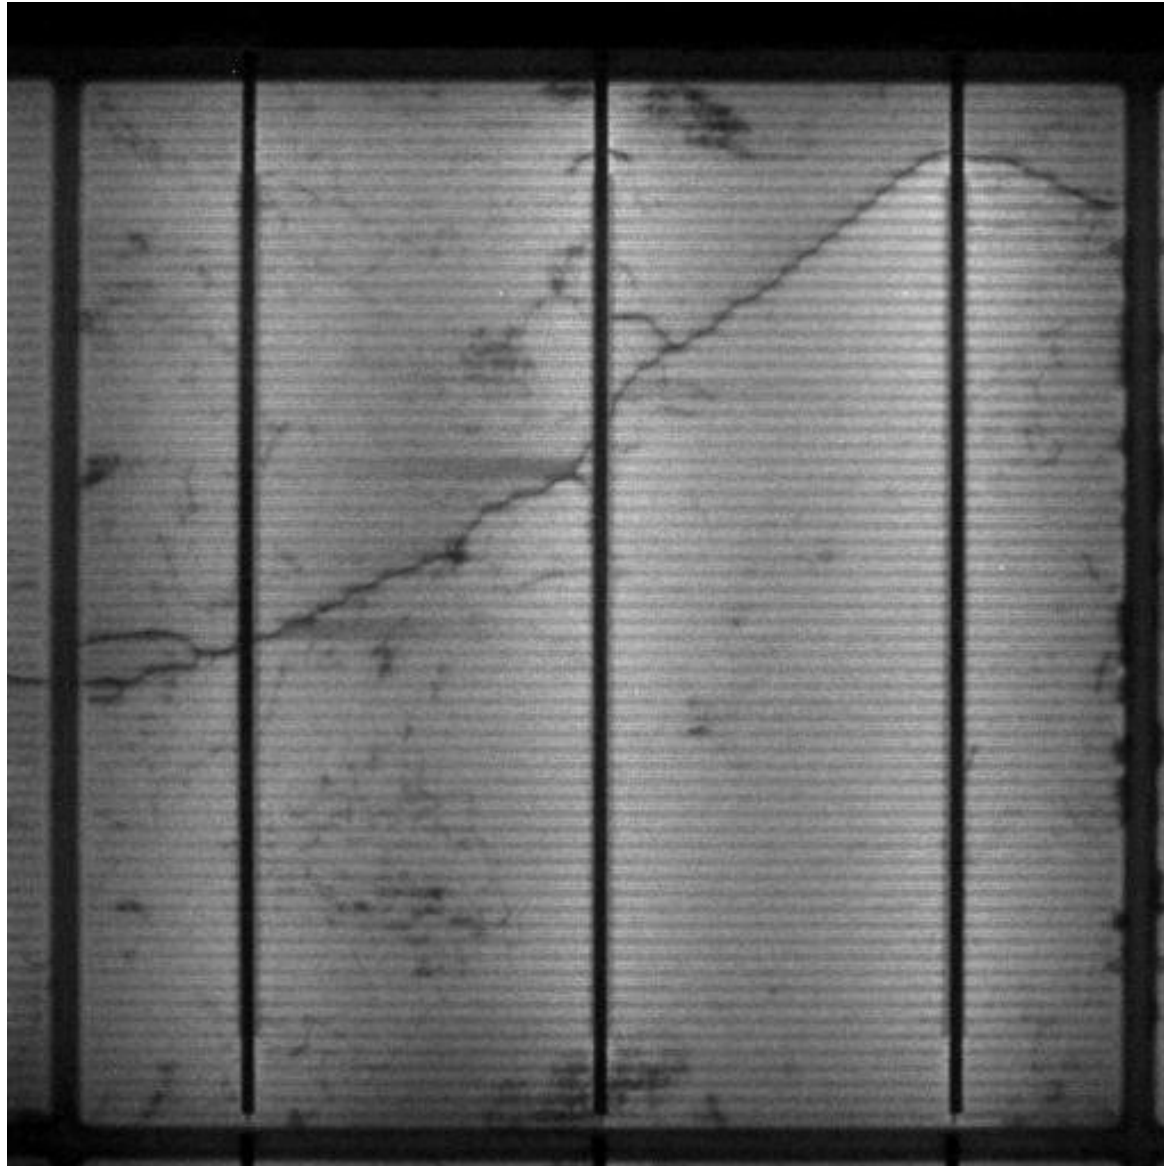
Power Loss Estimation

Original cell
image

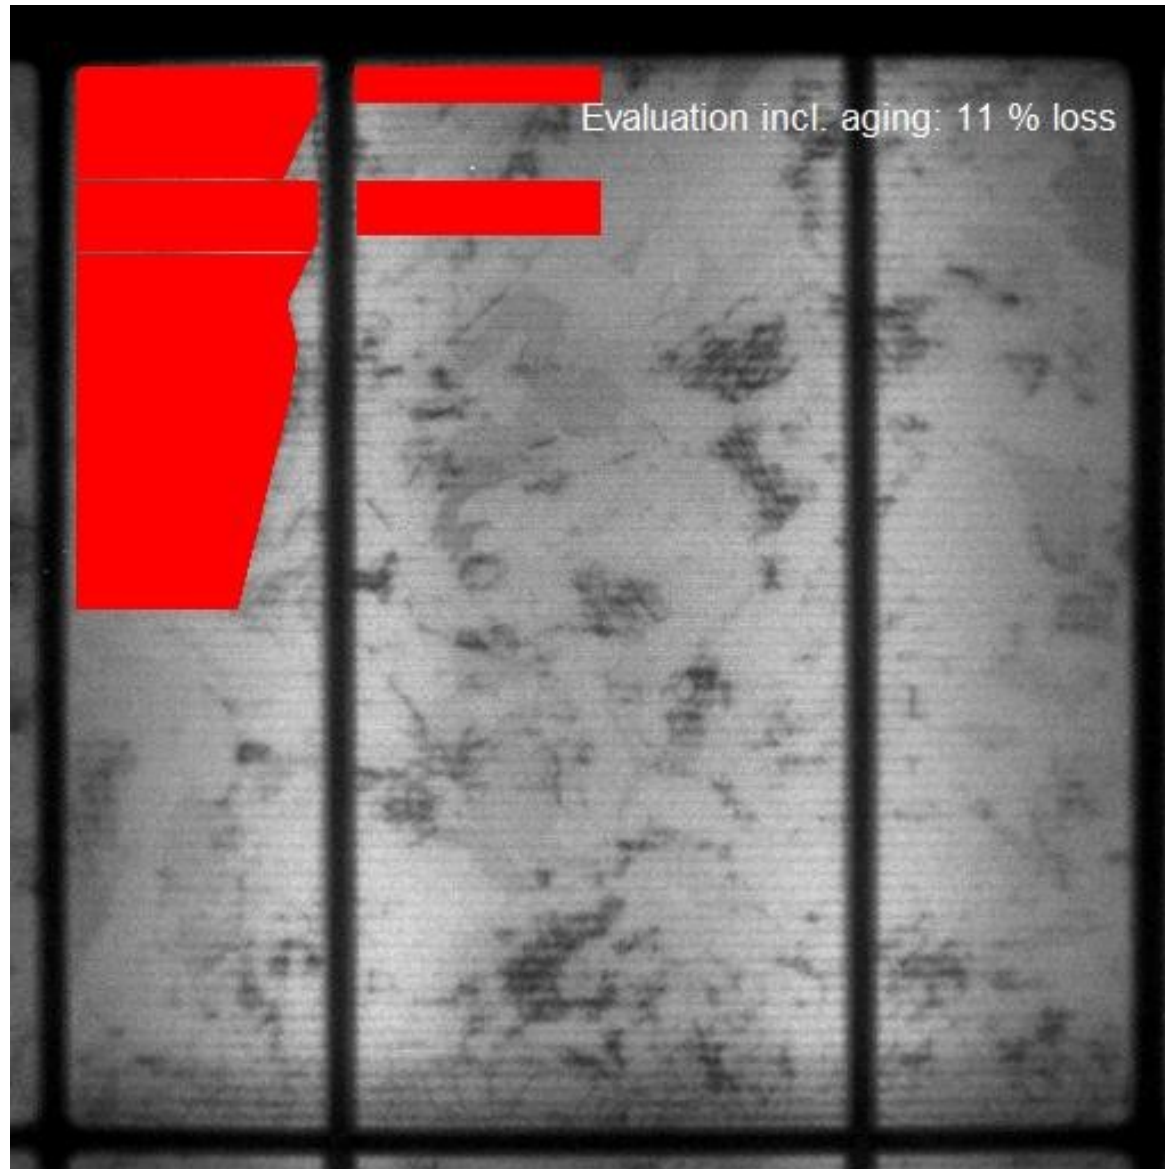
Power Loss Estimation

PL3:
All defects
after aging
