Exceptional UV features in the Field

Review of Failures of
Photovoltaic Modules

Report IEA-PVPS T13-01:2014

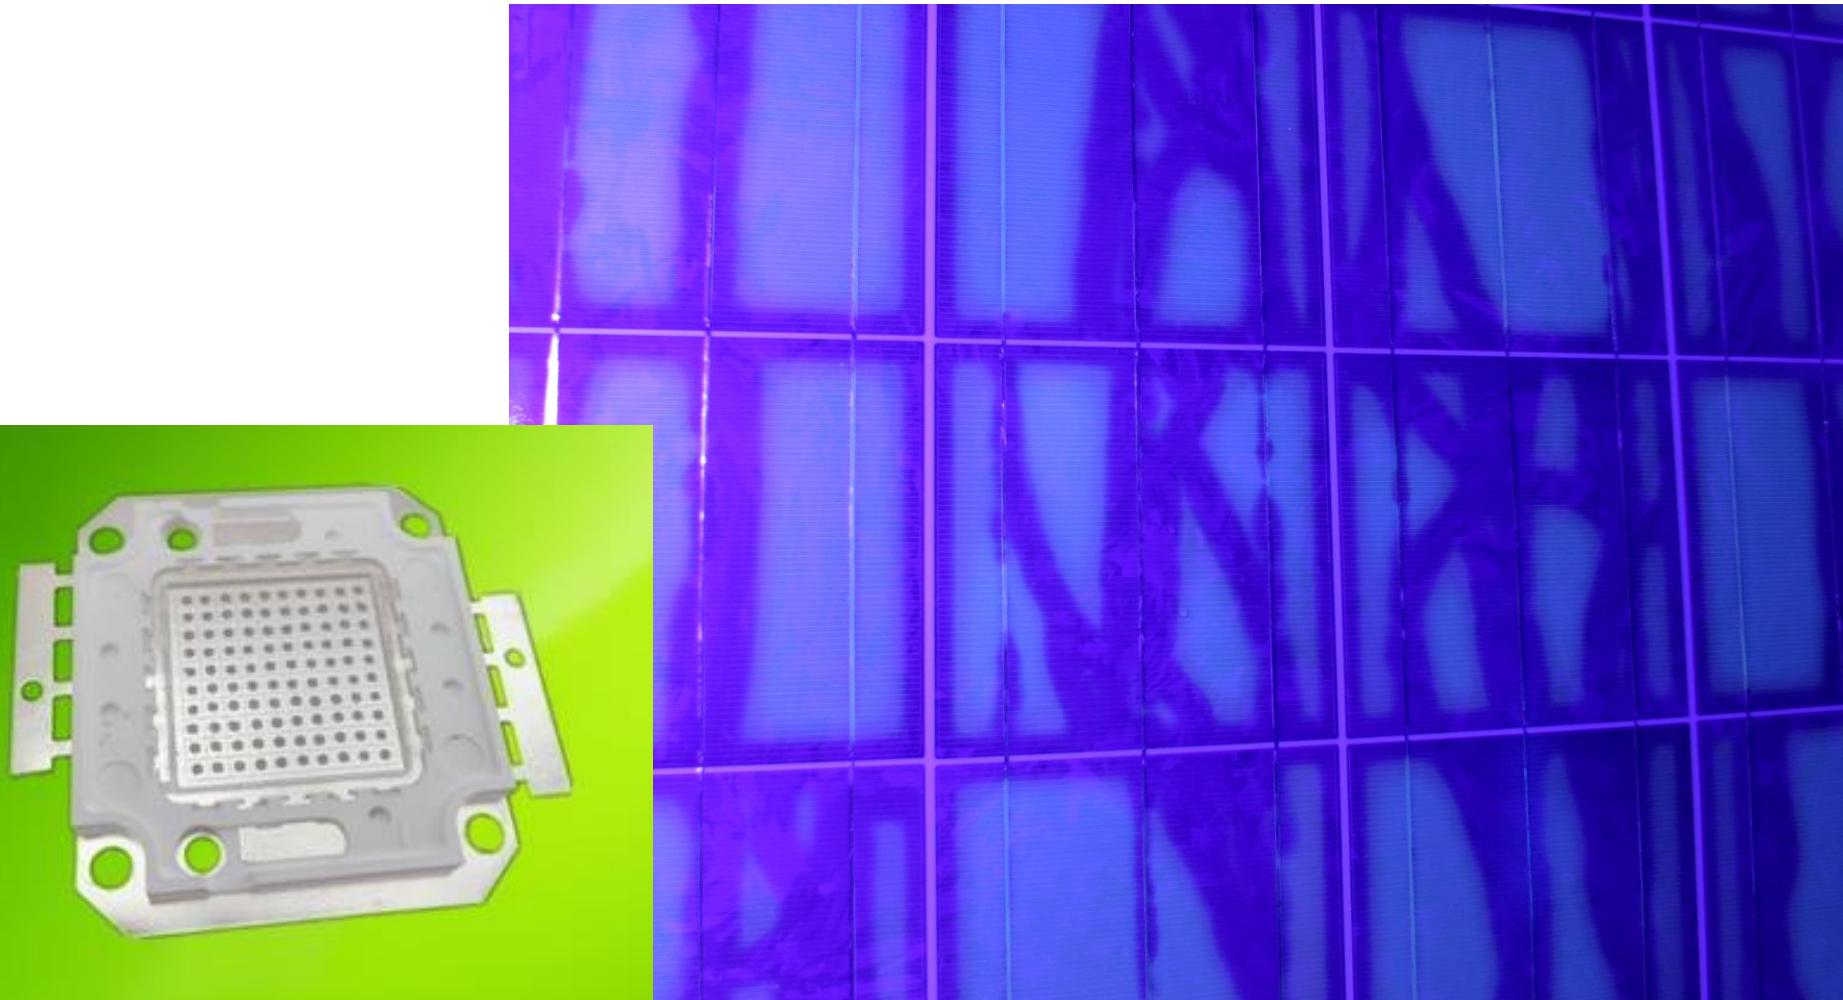
First trials: Contrast Problems

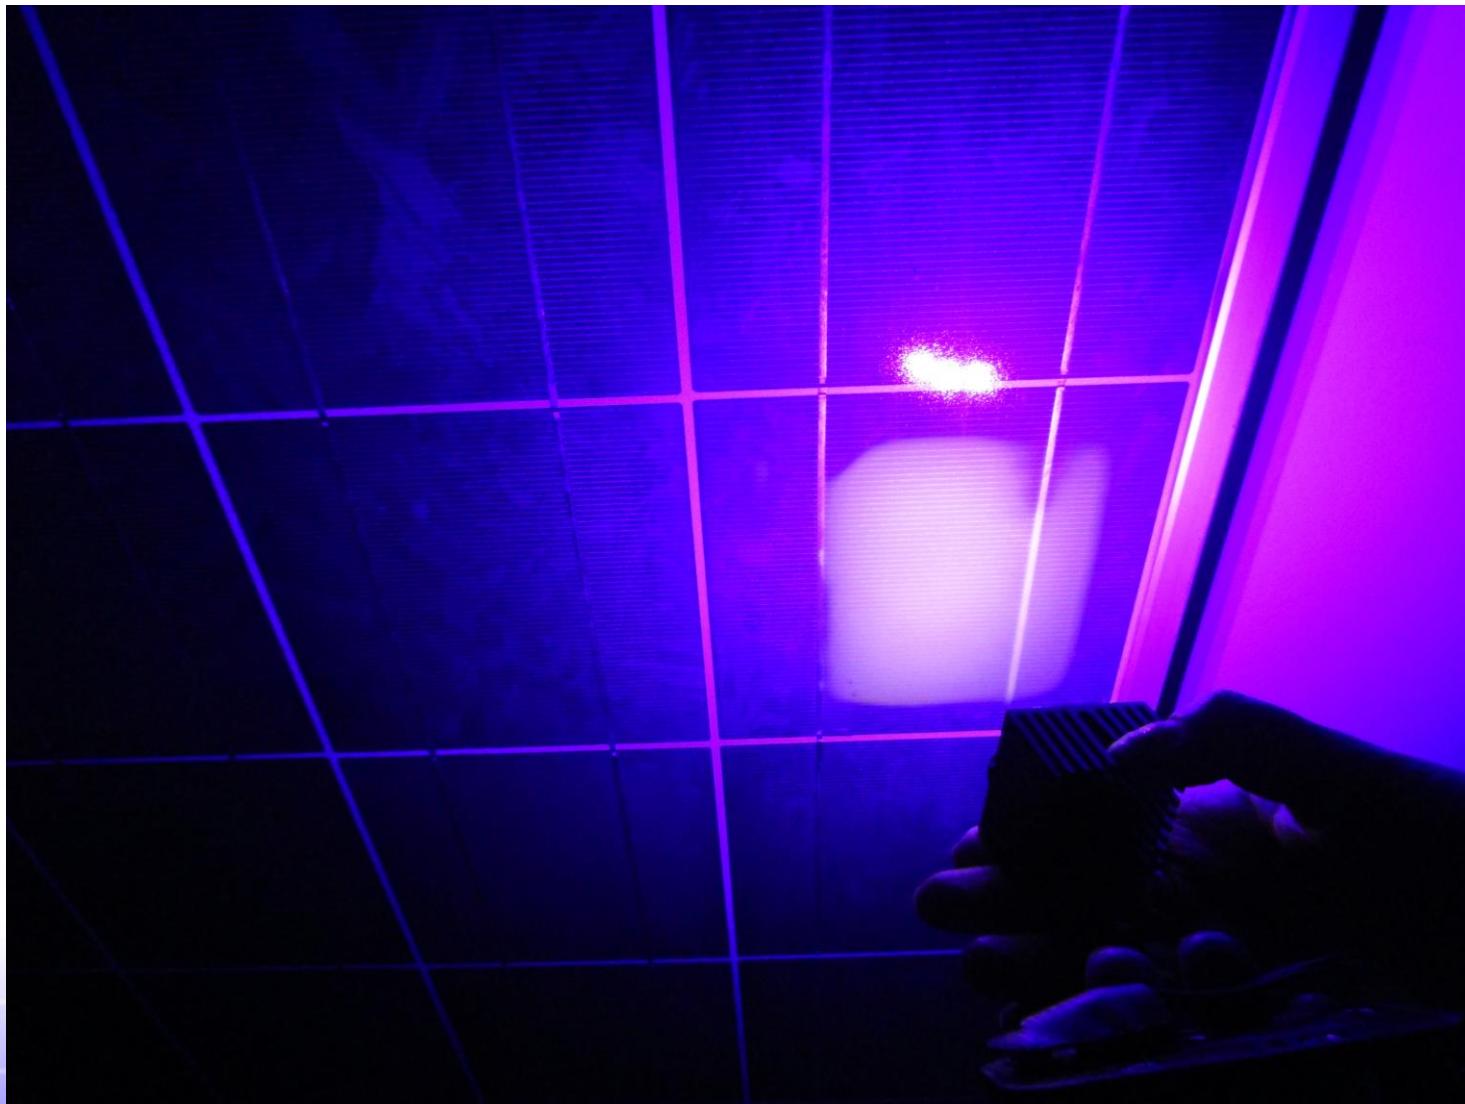
2nd Problem: homogeneity

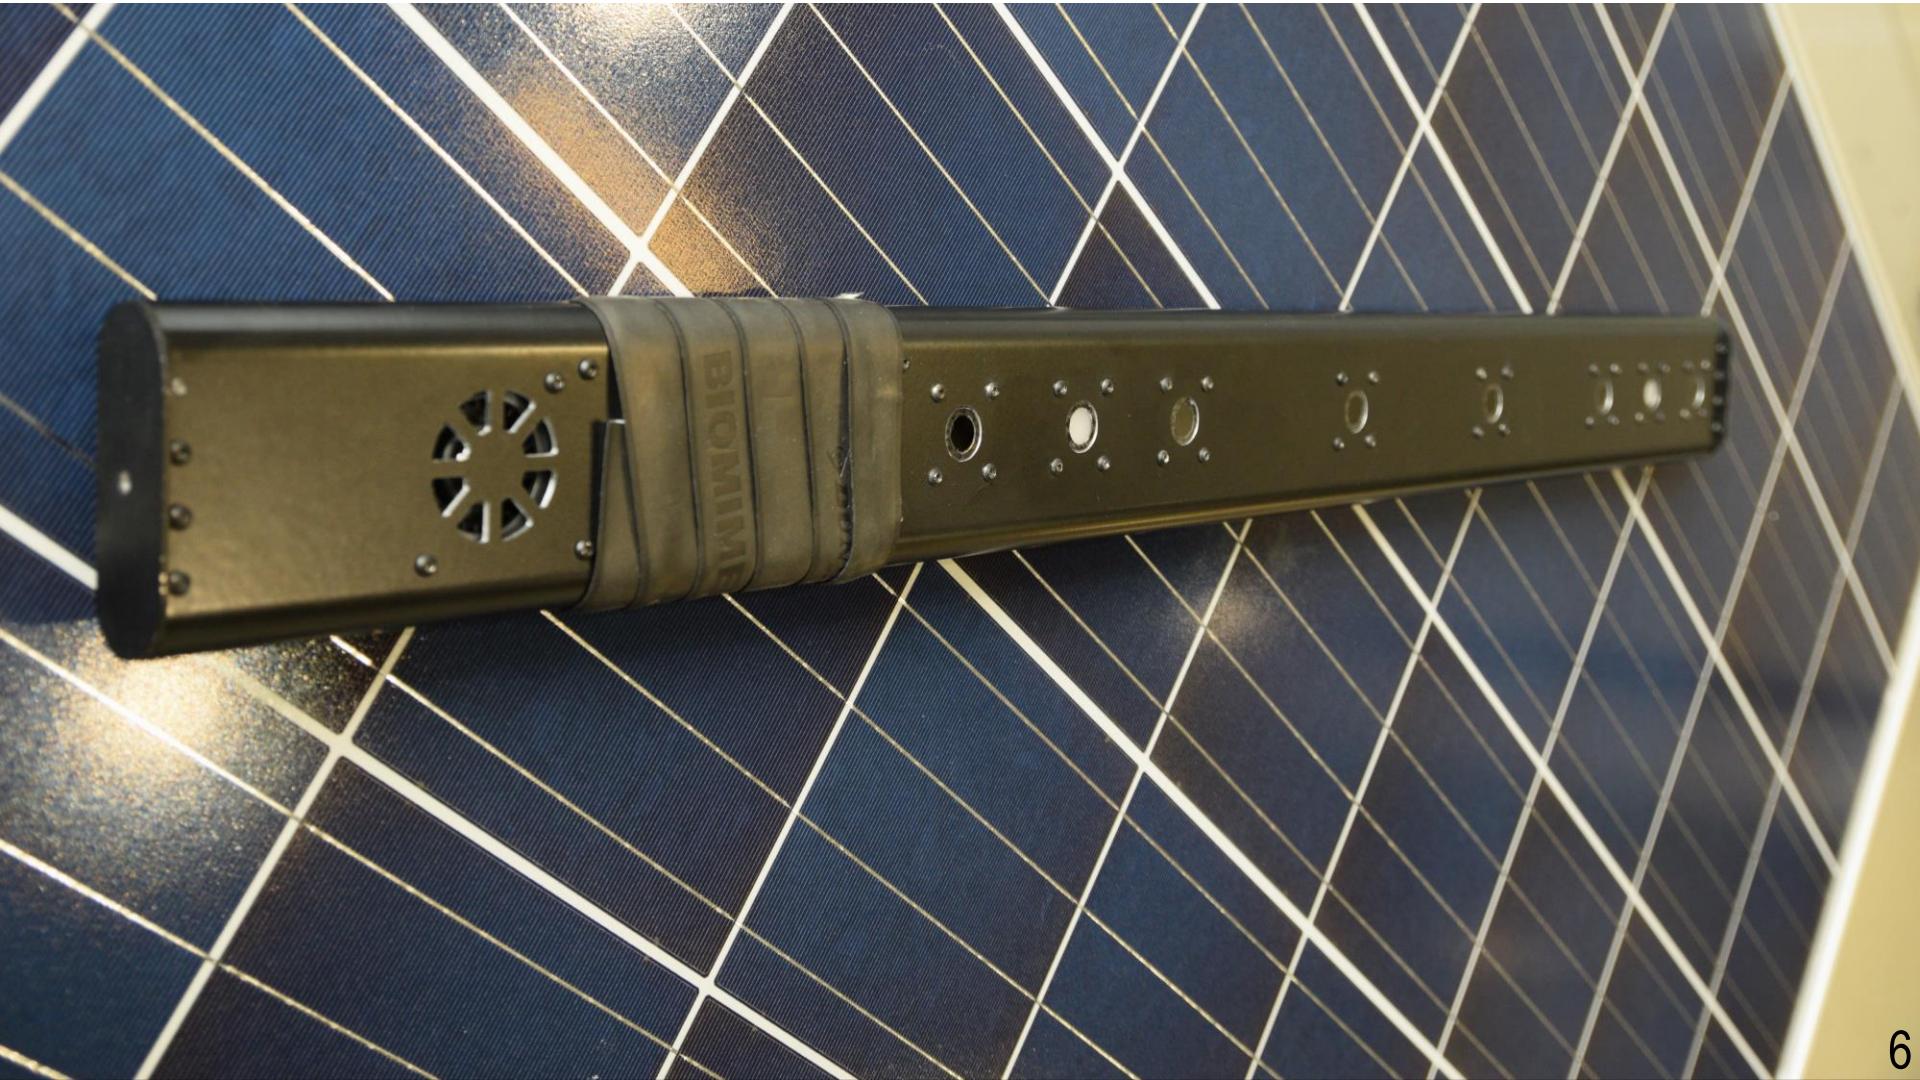
Improved design

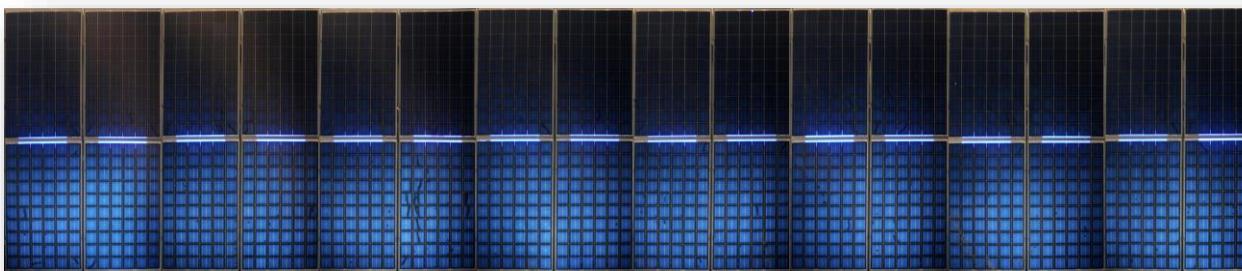
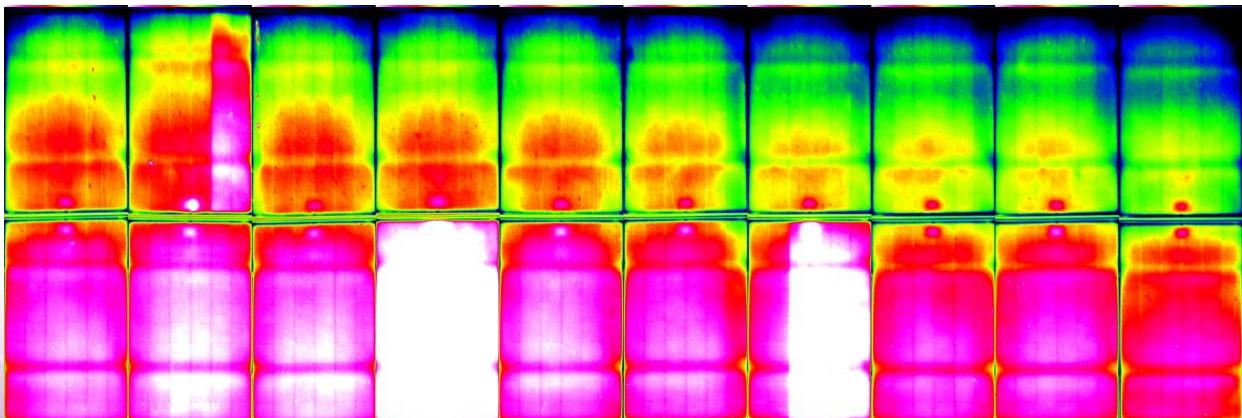
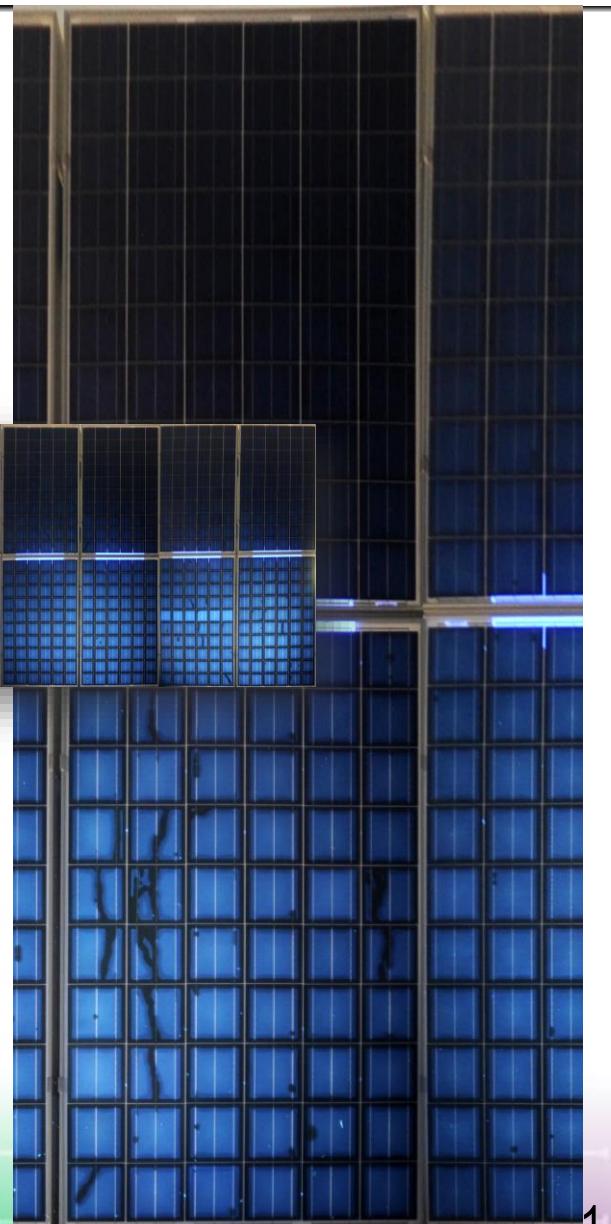
Next level: whole table

- Image resolution: 15000x2500 pixel
- Comparison with same data from thermography

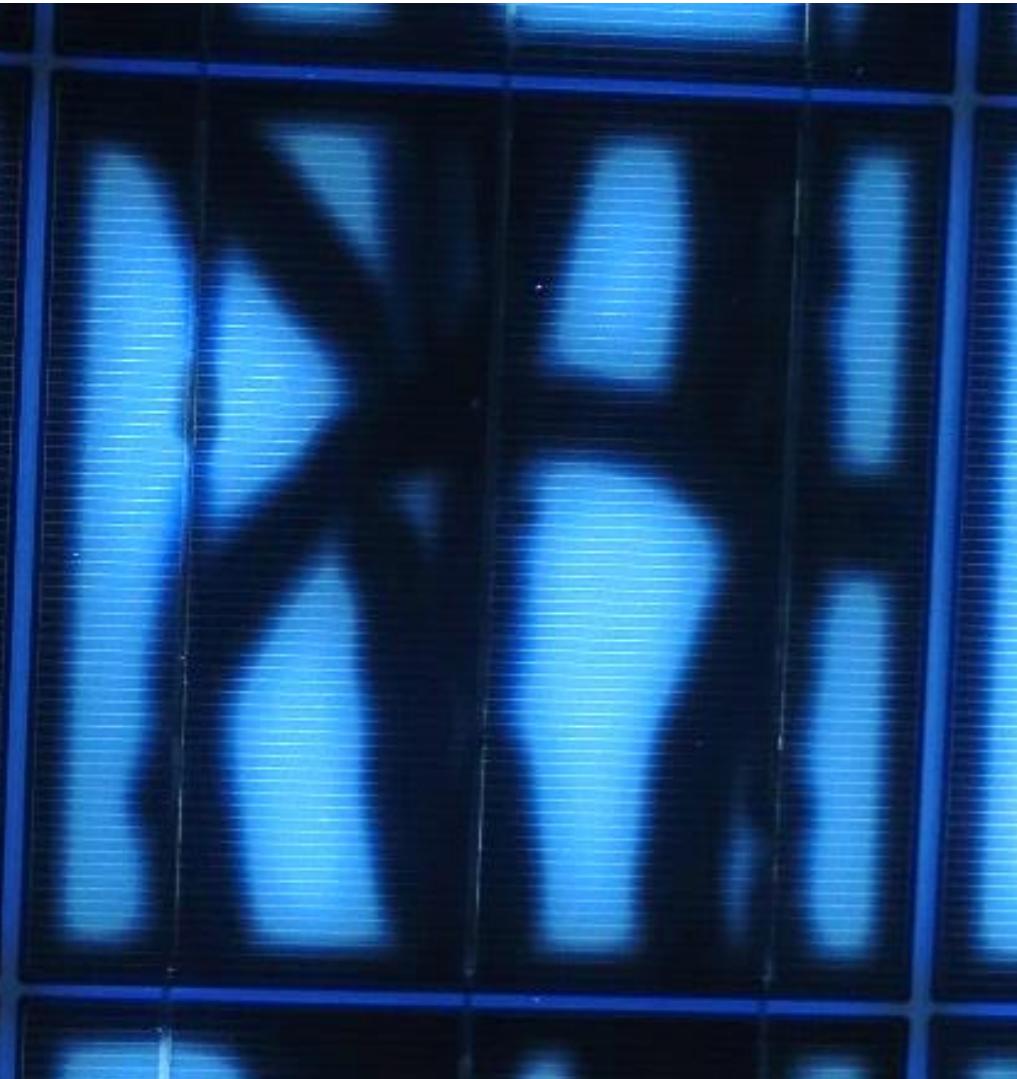
Perfect cell

- Center is bright
- Border with constant distance from cell sides
- Width of the dark borders depend on the outdoor exposure and the backsheet material's diffusion

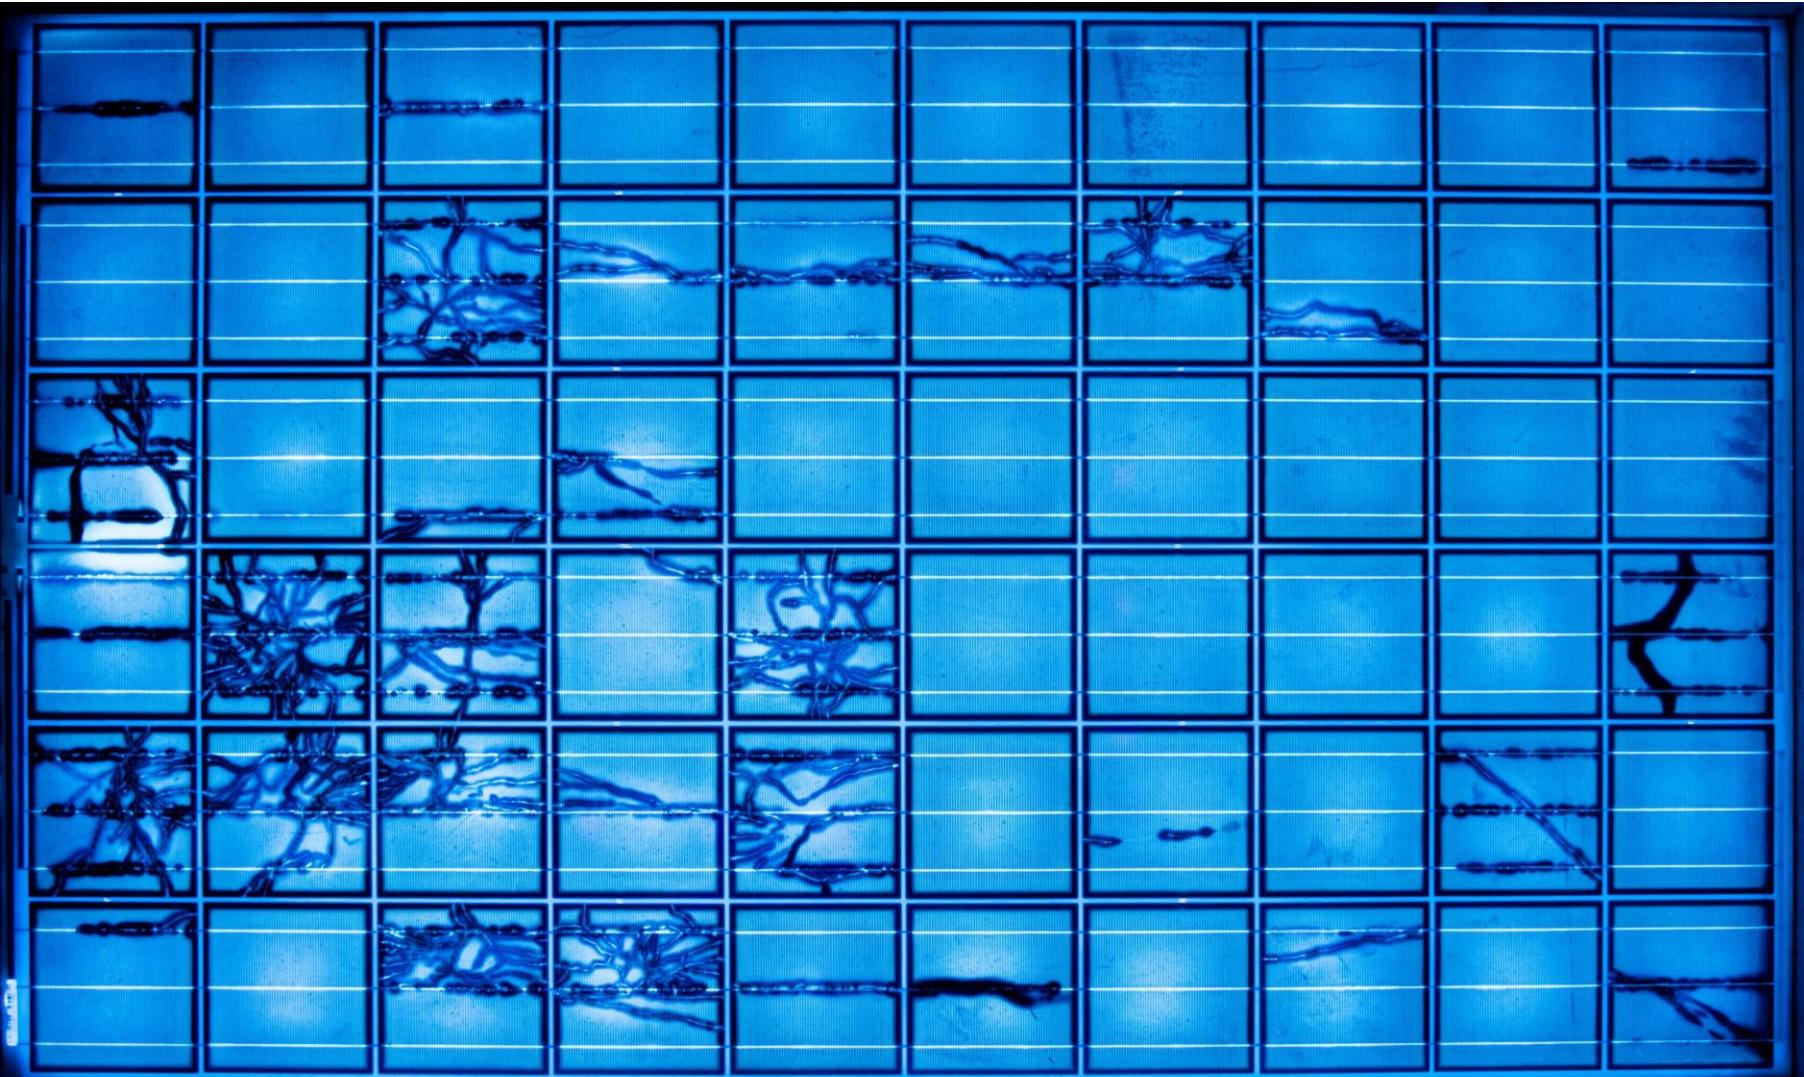
Cracked Cell

- Cell gaps and sides are brighter
- Hardly visible with naked eye (only on long exposure)

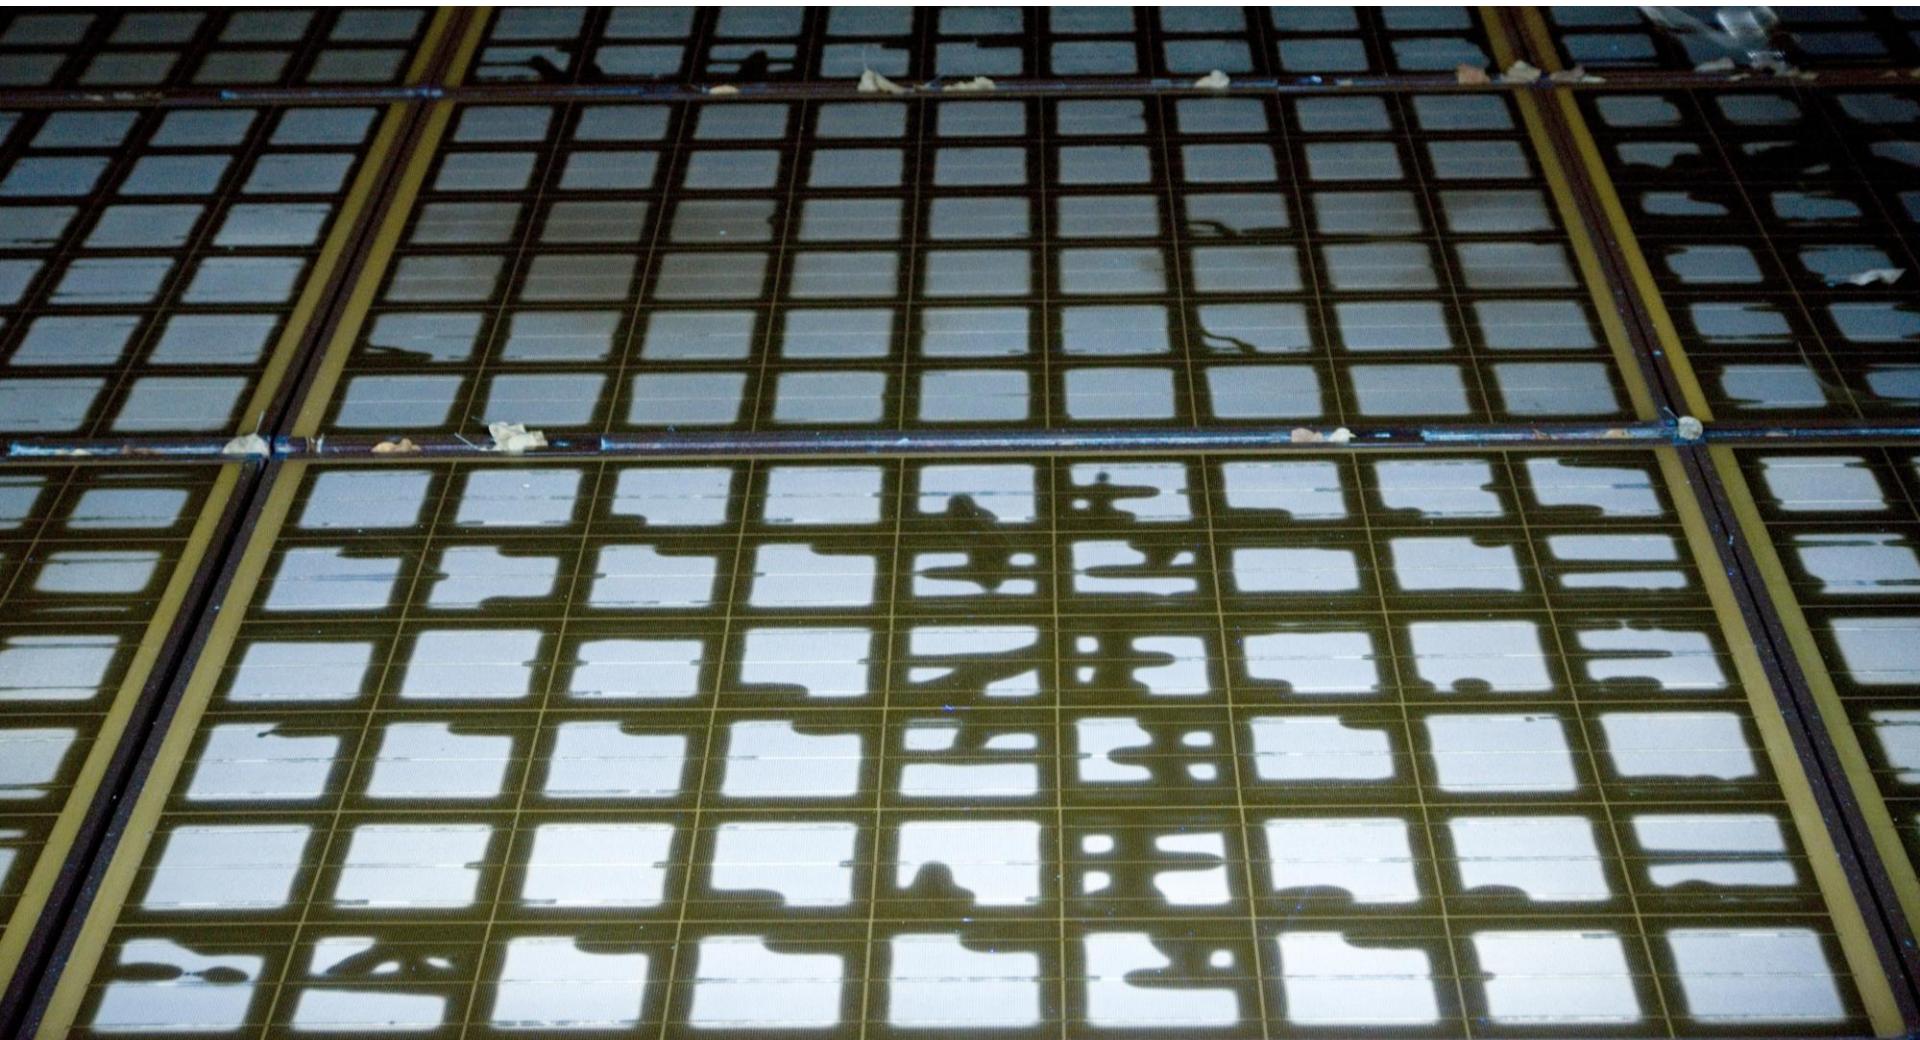
Hail corn impacts

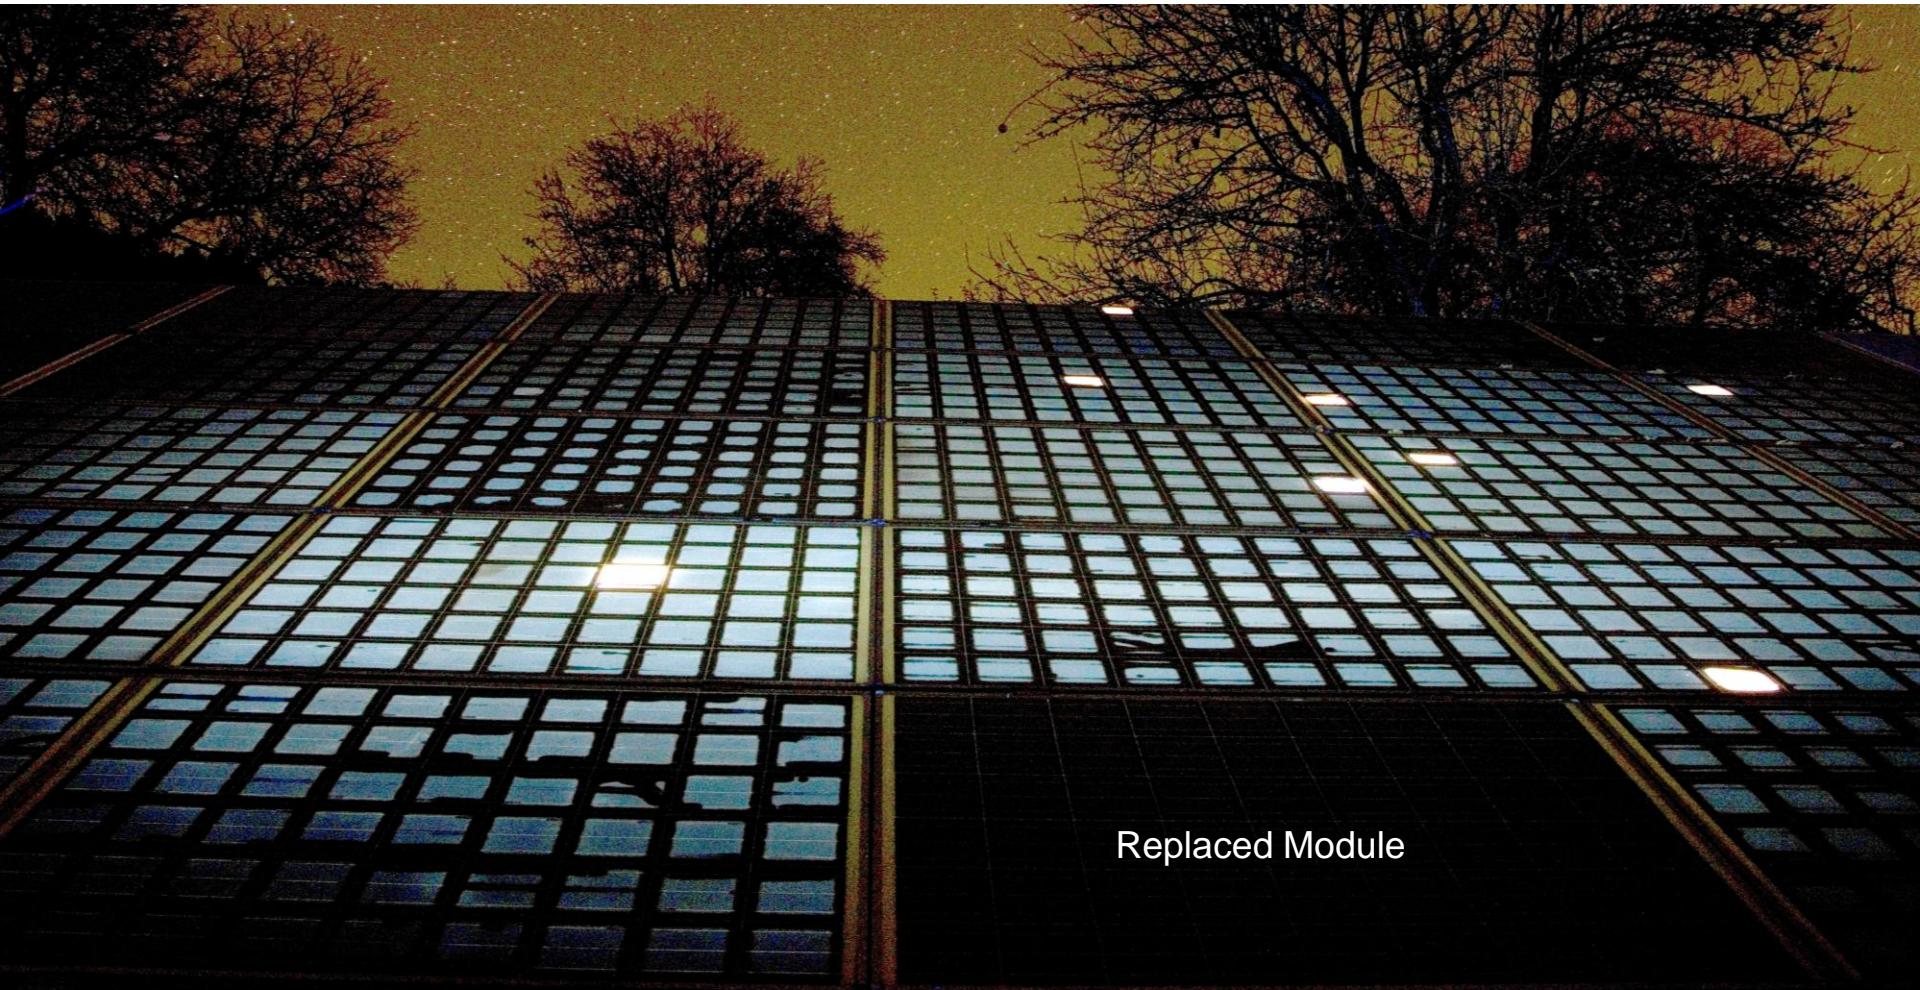
Extreme Hot Spot Cell

- Much brighter than average cell
- Red/orange additional to blue UVF
- Browning is often visible even without UV

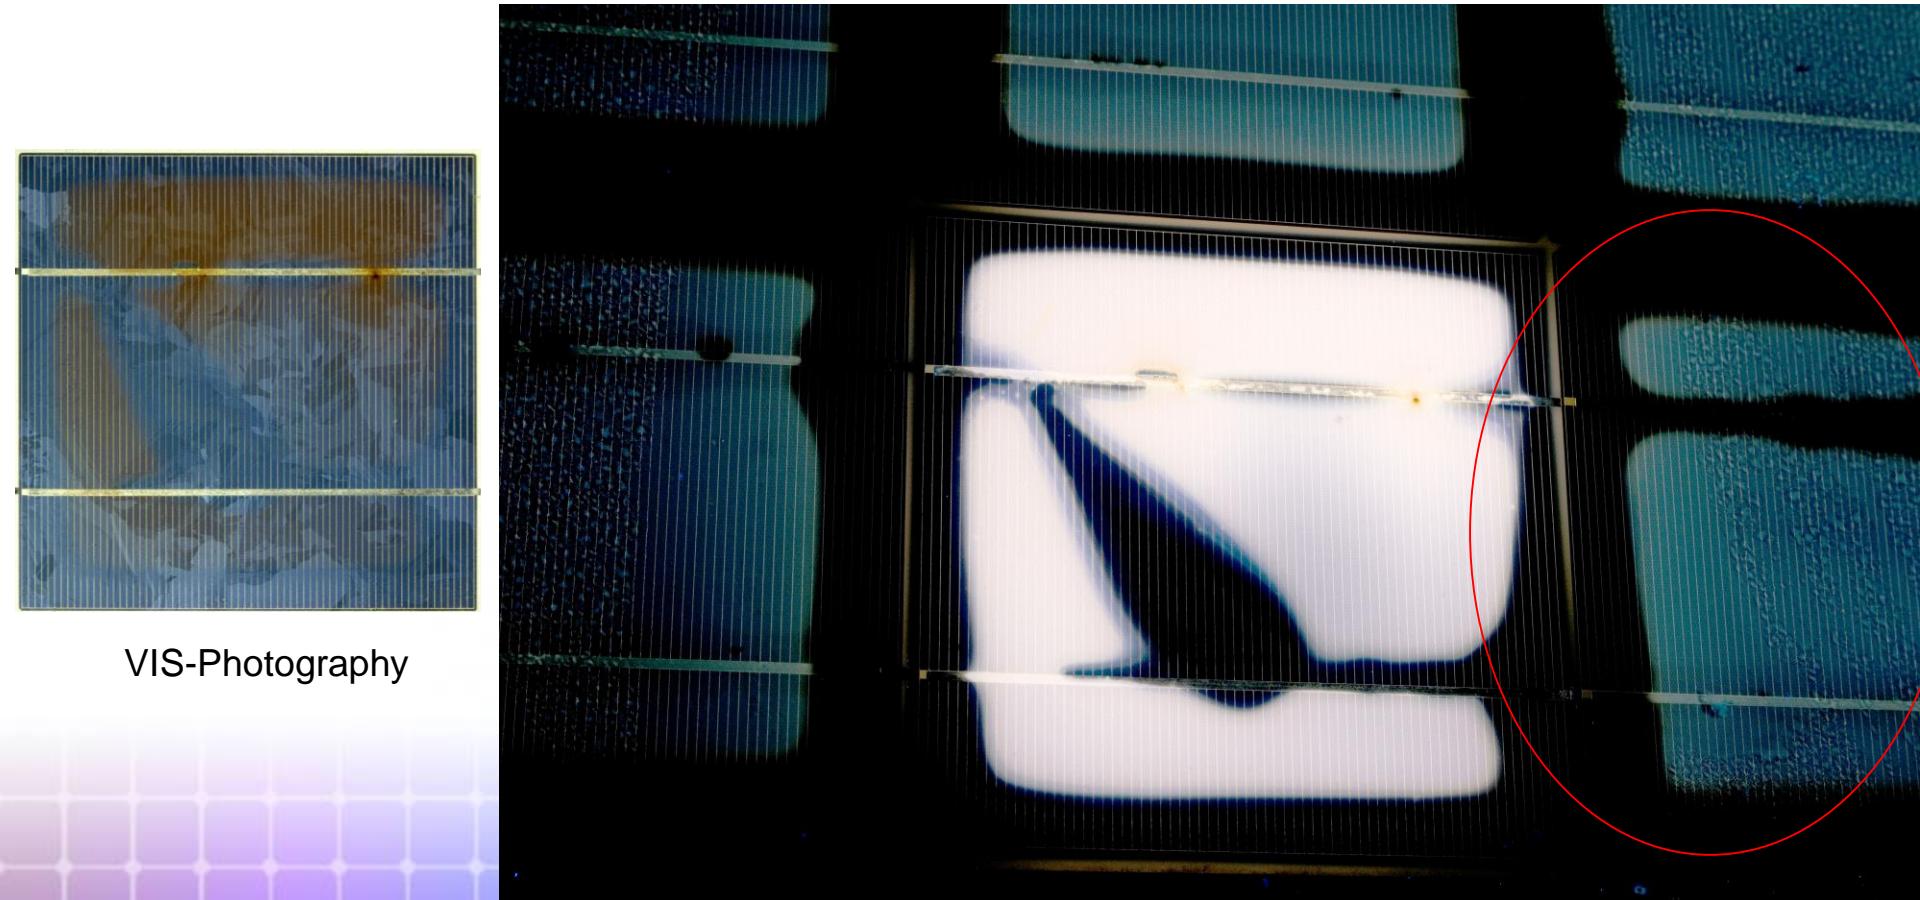
Hot cells + new module

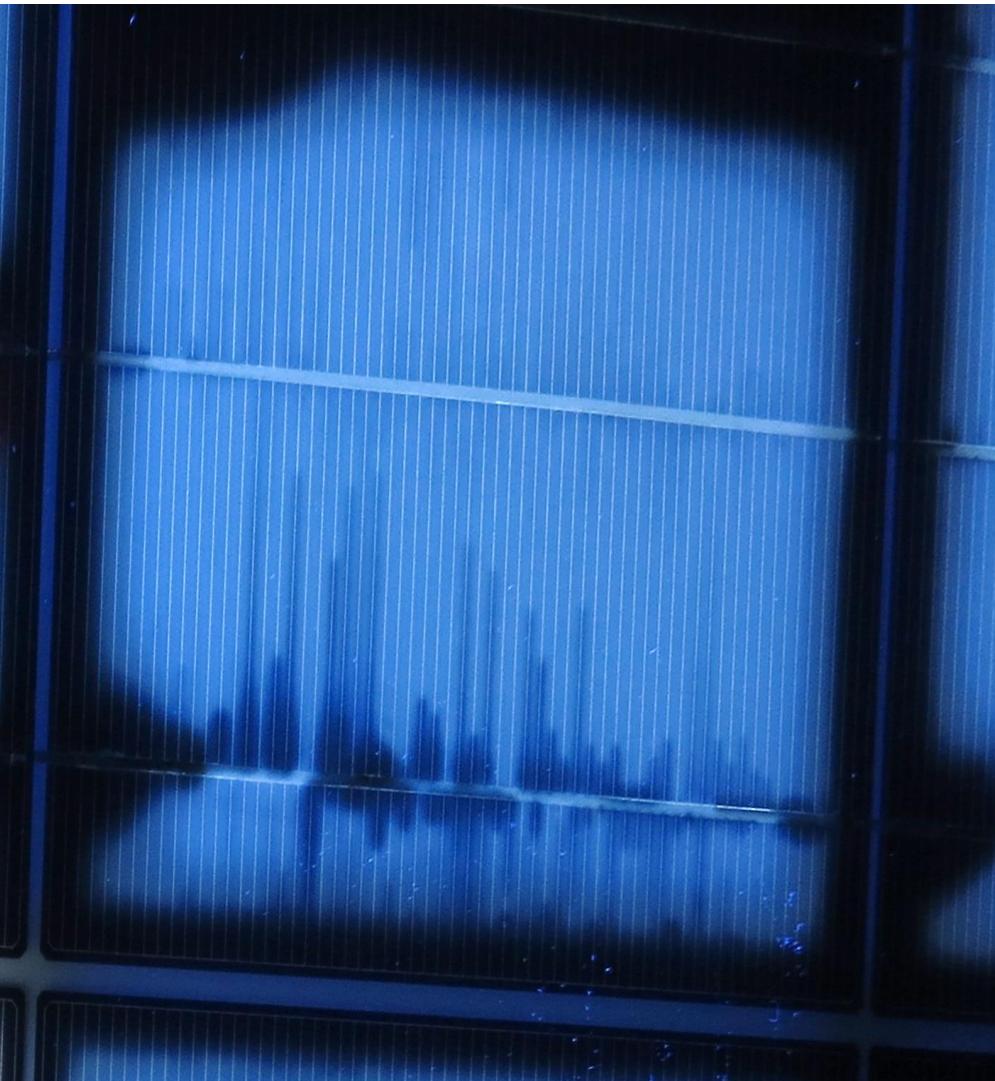
Fluorescing backsheets

- In extreme hot spots, the backsheets have visible defects.
- If there is browning, it is also visible in the UV-F
- Probably not very useful

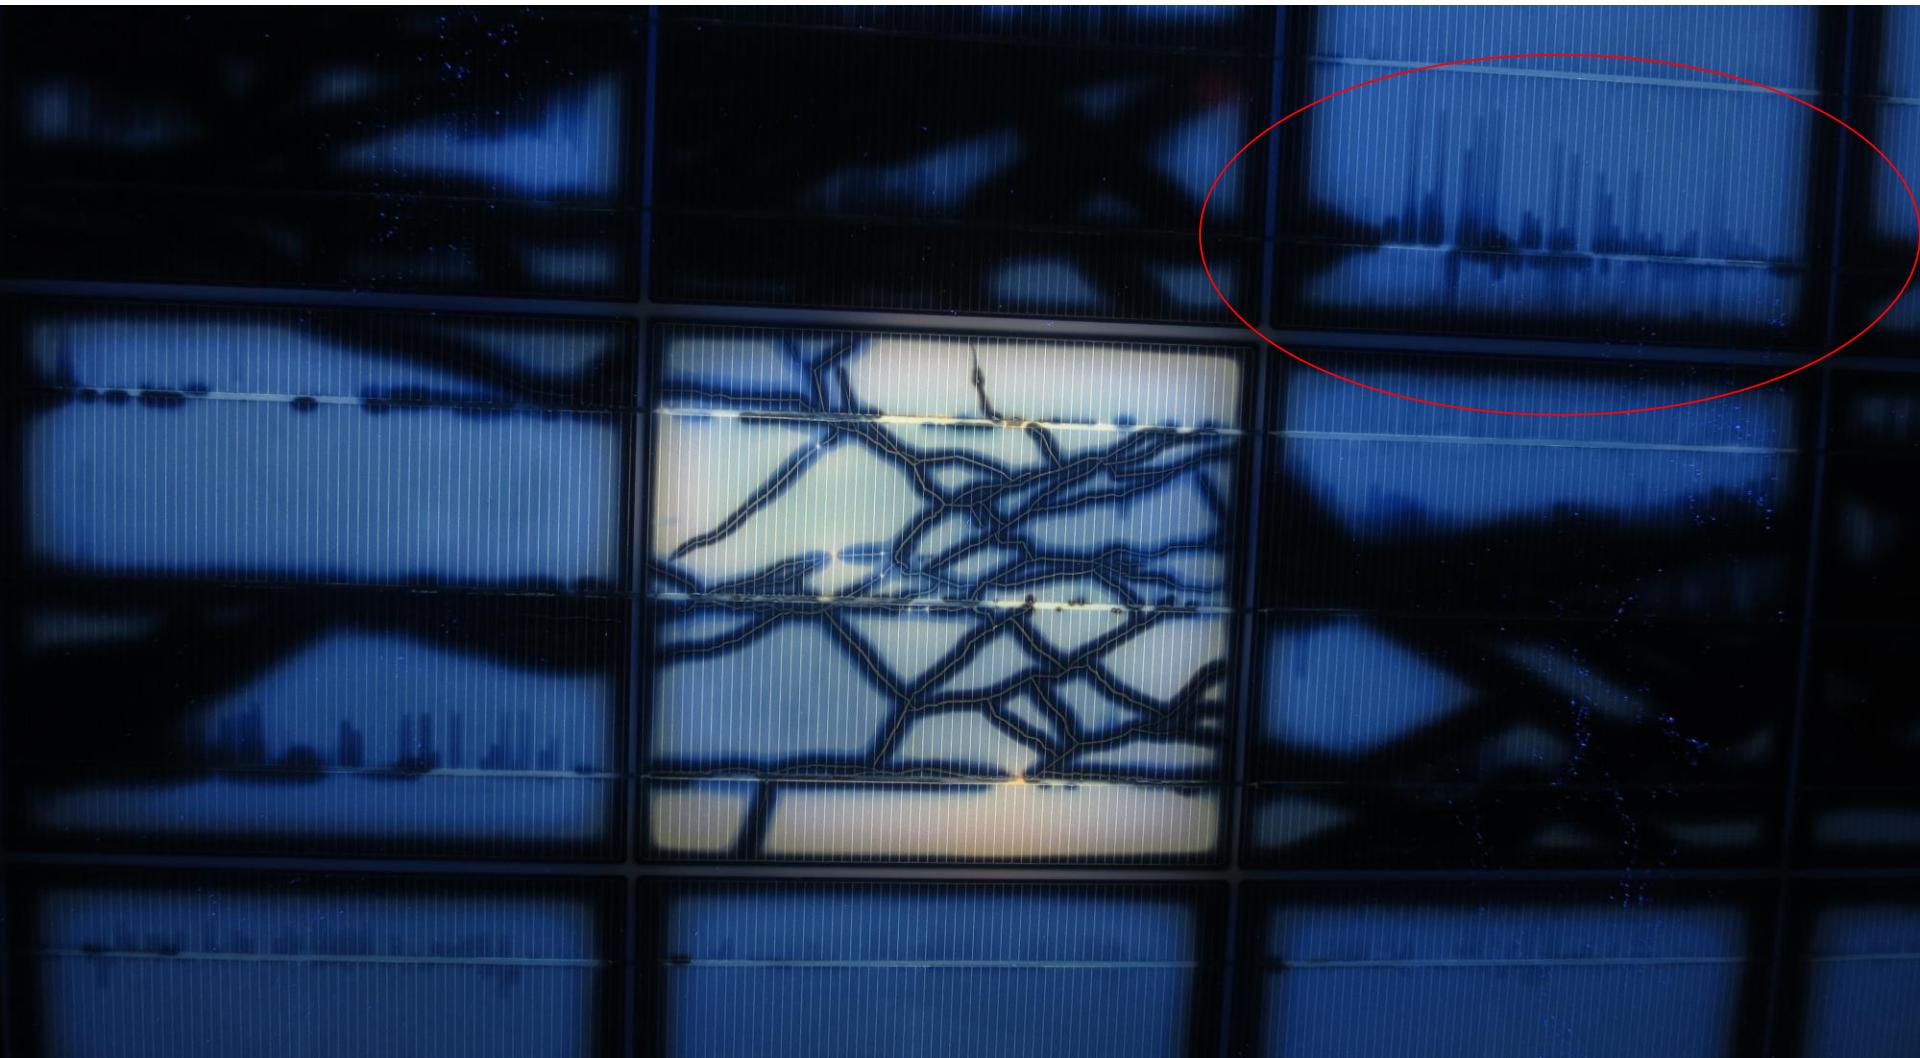
Finger Soaking

- Dark region propagates along some fingers
- Unproven Hypothesis:
 - Solder flux is sucked along the rough surface of the fingers. While in-field the solder flux might destroy the UV-Fluorescence

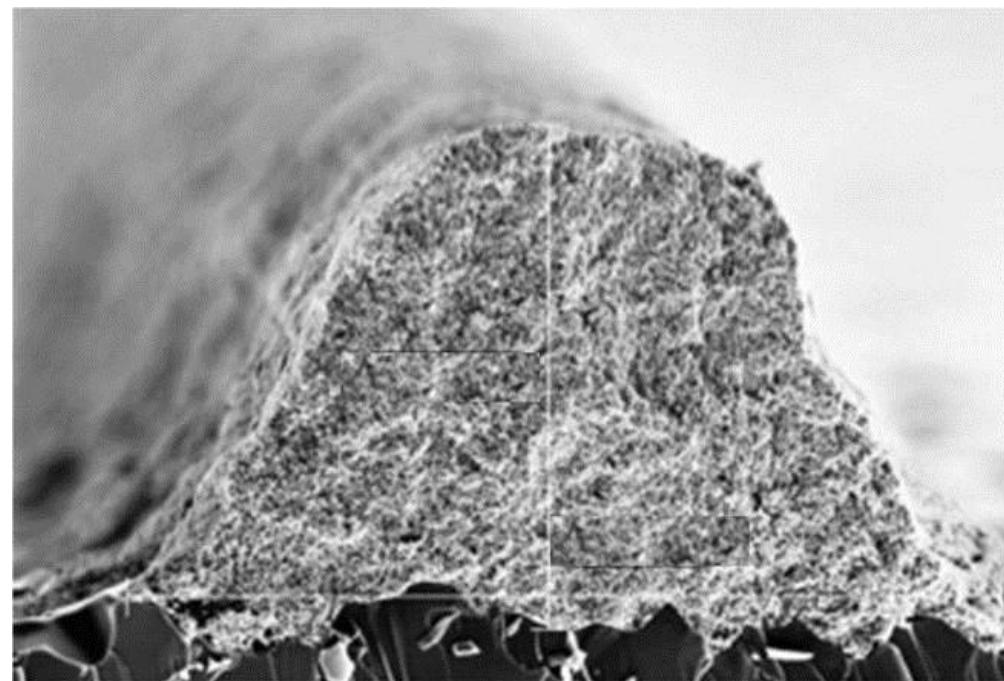
Diffusion along fingers

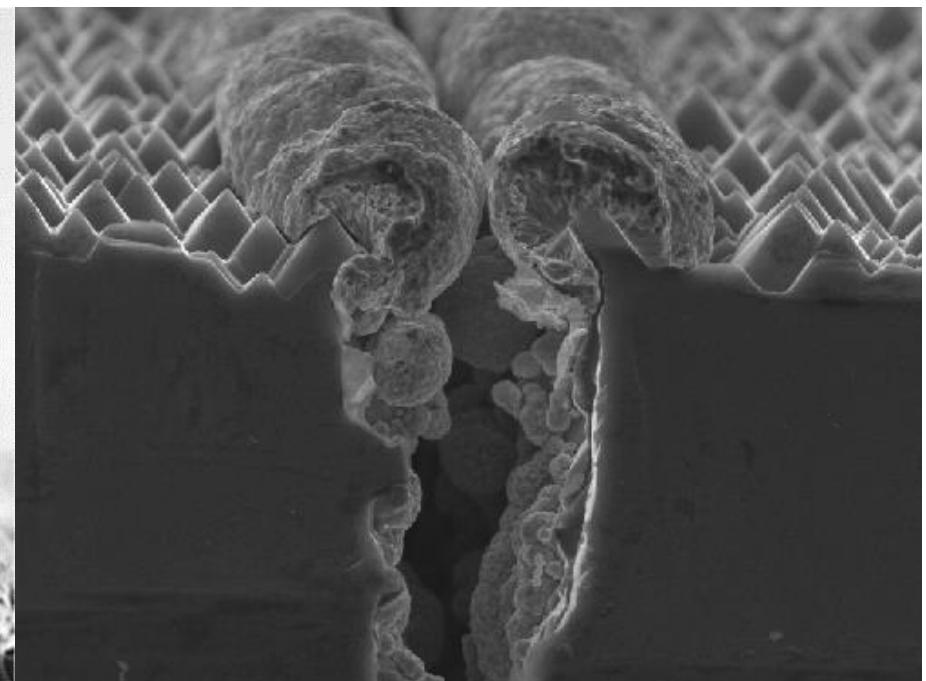
Rough Surface of fingers

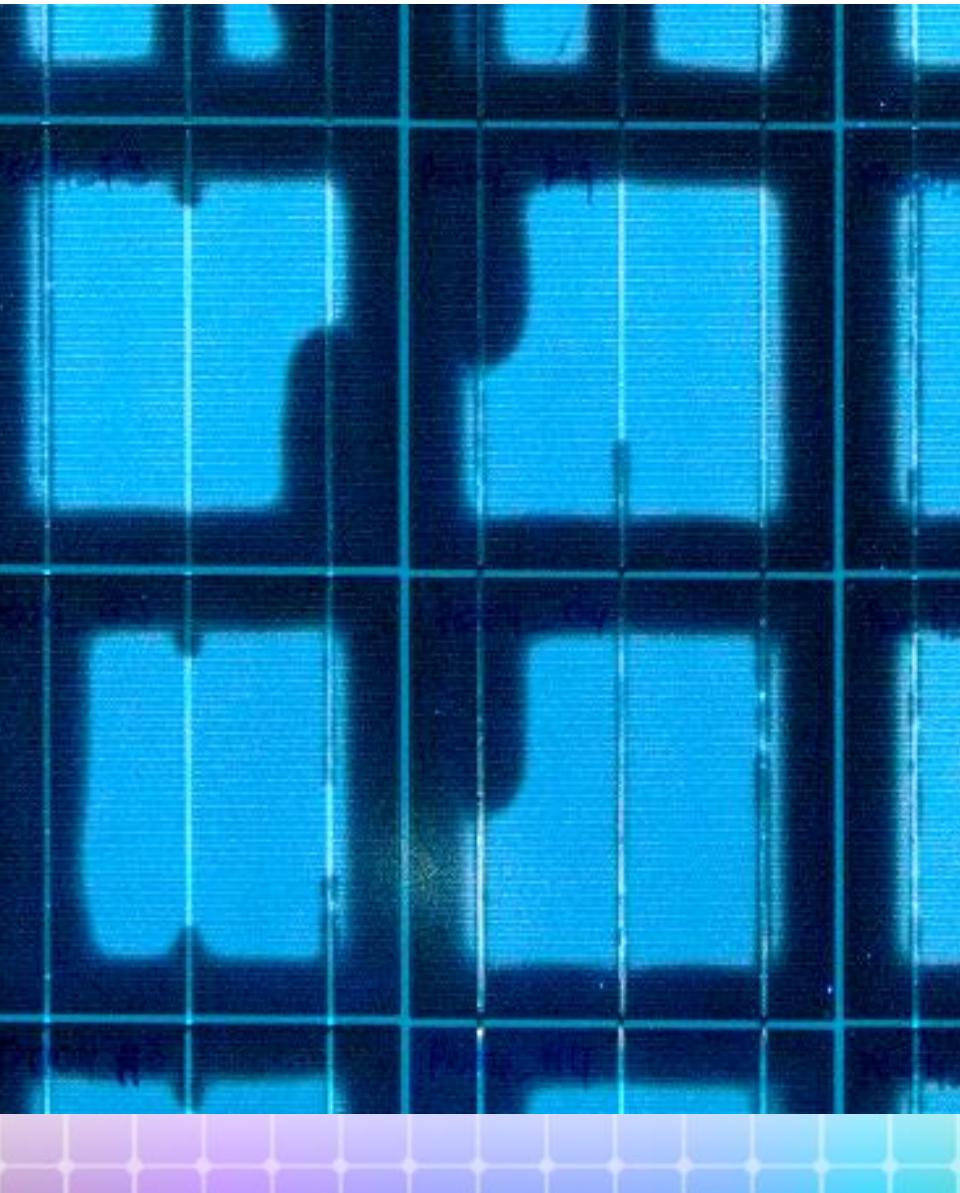
Buried Contact Source: PVEducation.com

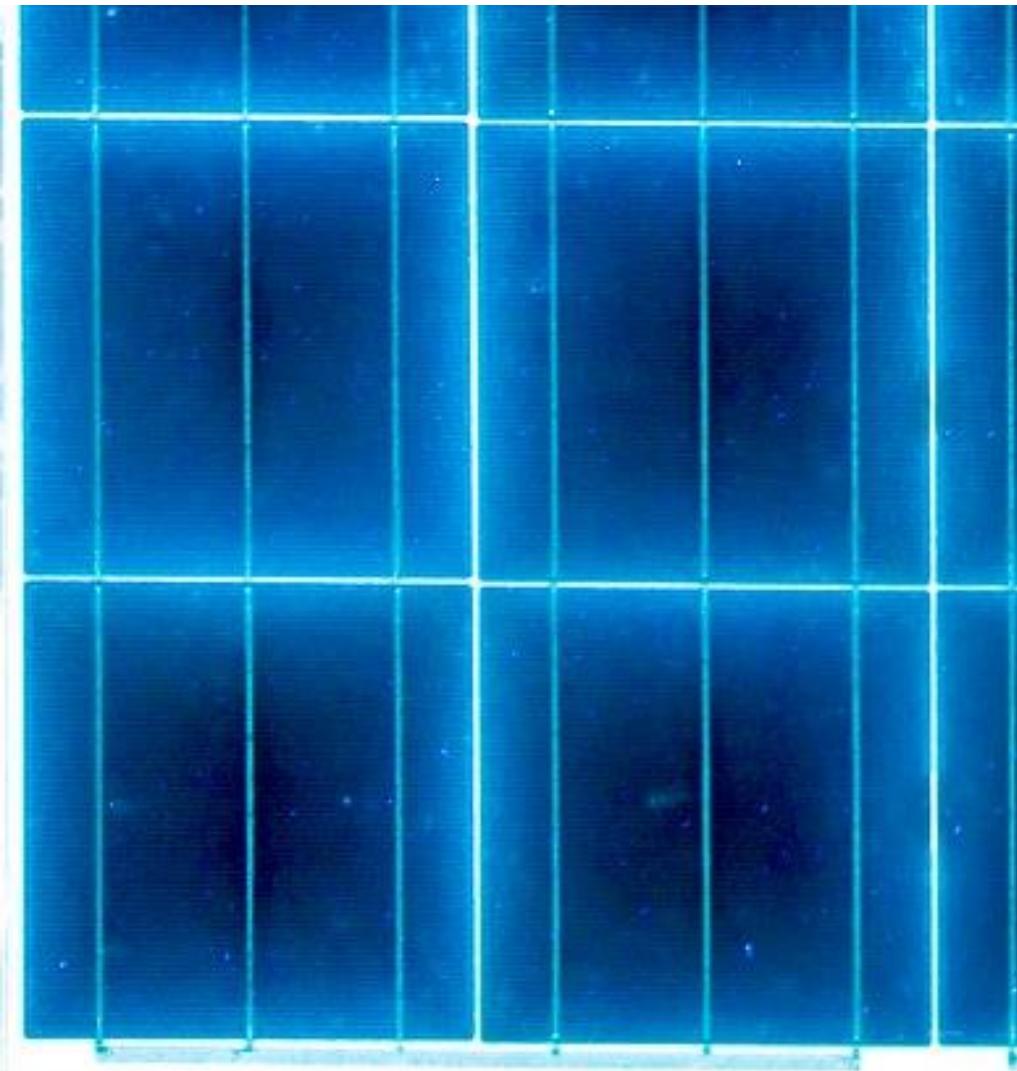
Busbar Conduction

- Dark region propagates along some busbars
- Unproven Hypothesis:
 - Airgap between busbar and cell
 - However measurements showed no soldering problems
- Alternative Hypothesis:
 - Cracks under the busbars due to soldering force
