Exceptional UV features in the Field

Review of Failures of
Photovoltaic Modules

Report IEA-PVPS T13-01:2014

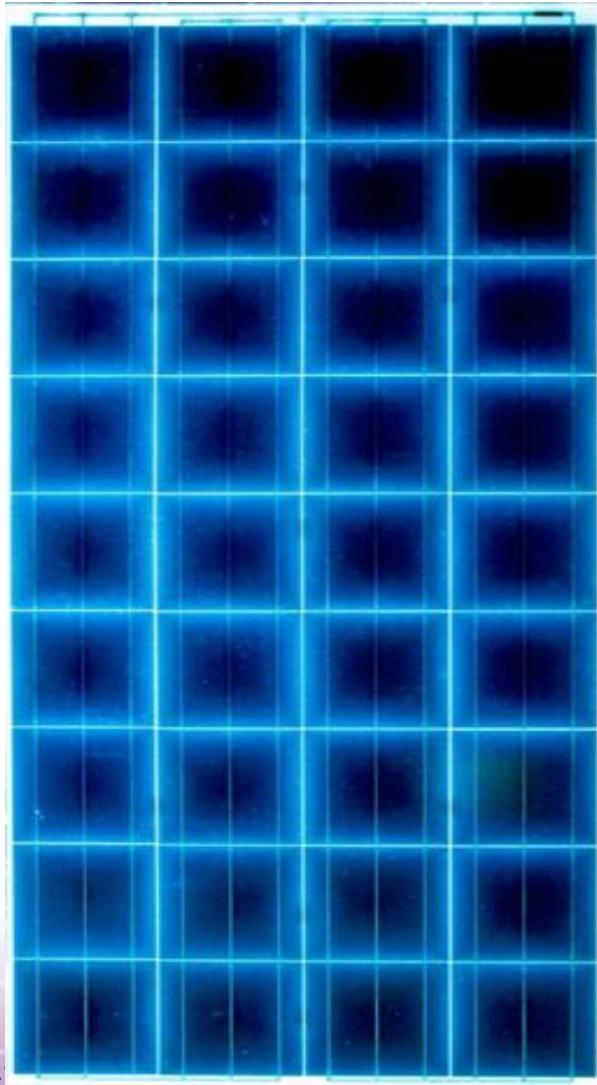
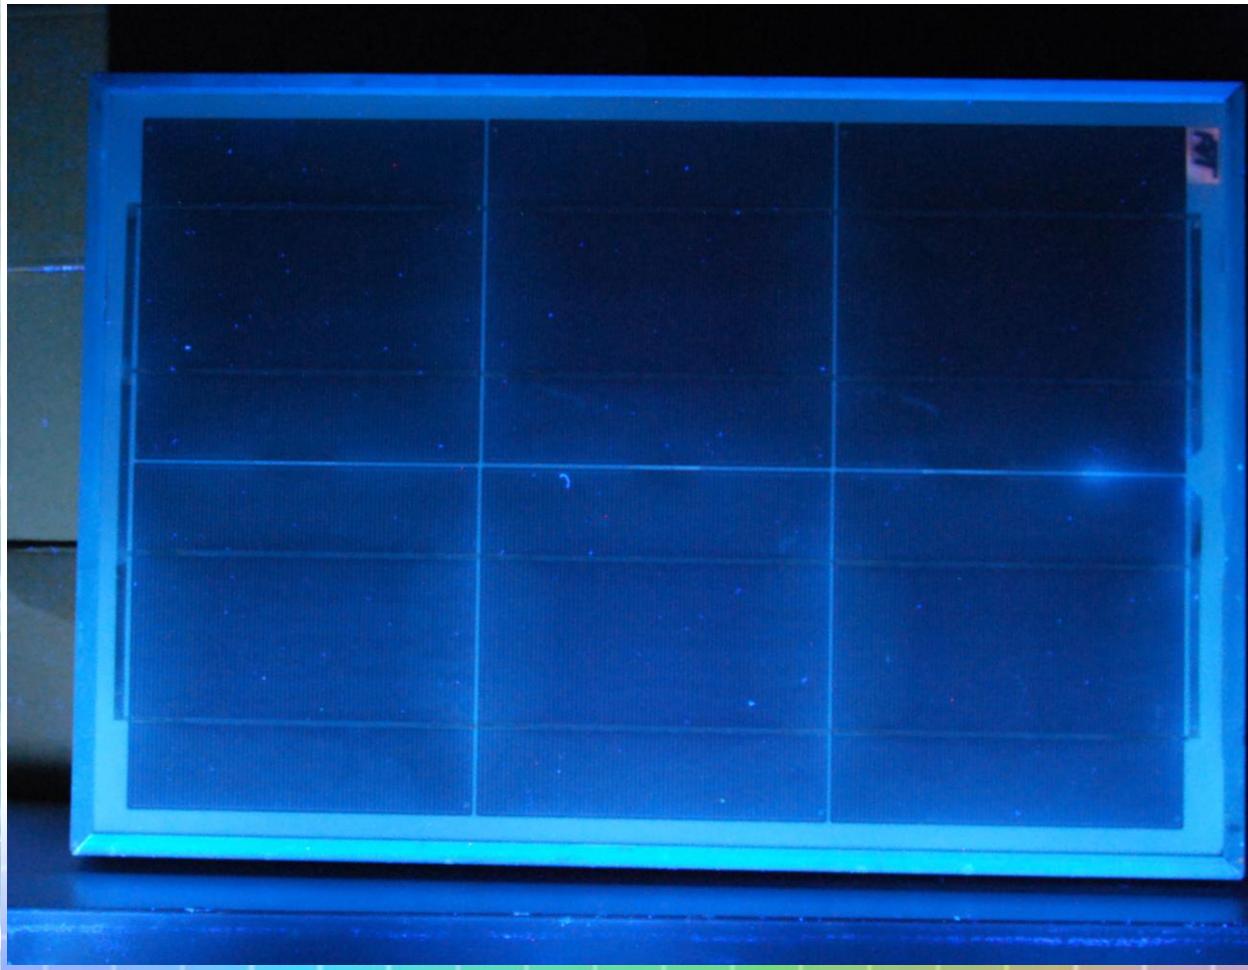
Indoor damp heat accelerated aging

- Cell gaps and sides are brighter
- Hardly visible with naked eye (only on long exposure)

Damp heat accelerated aging

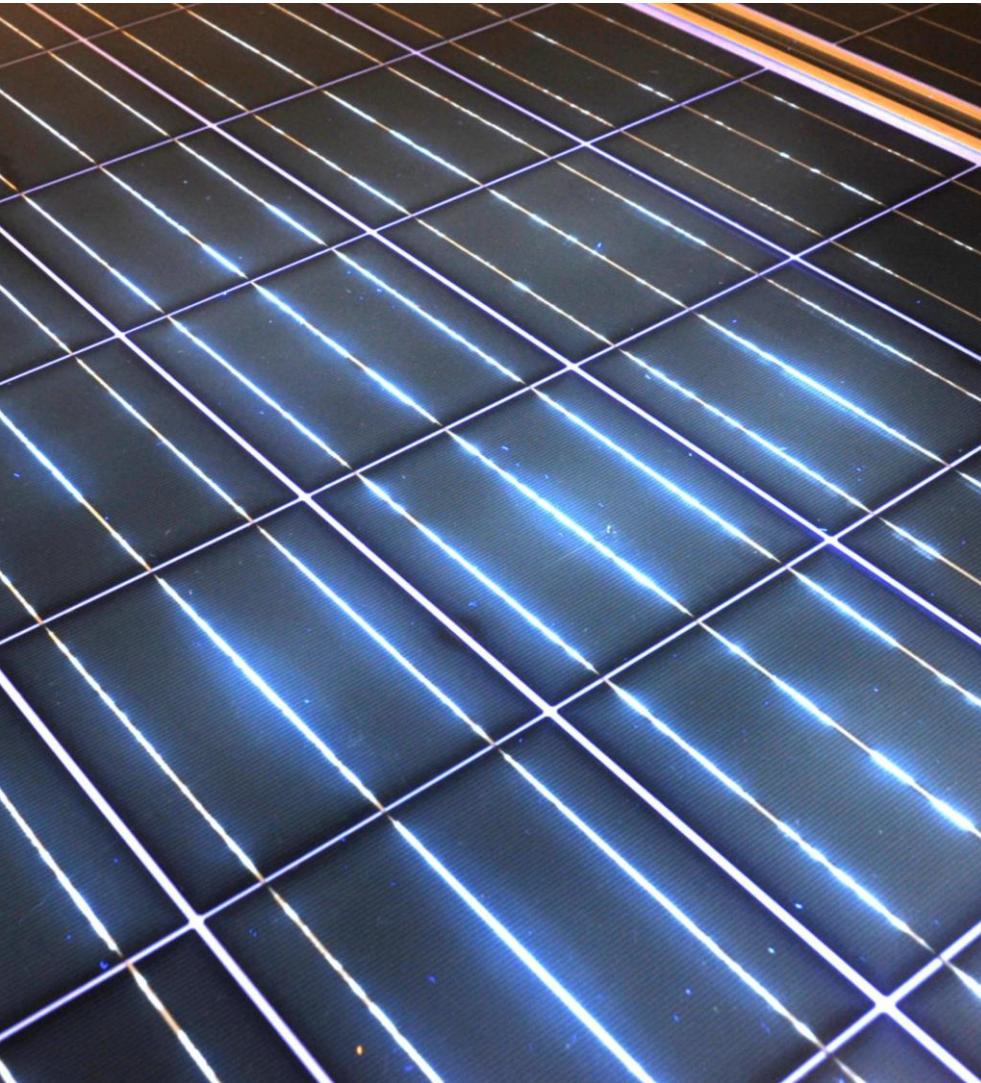
Punctual extinction, “Freckle”

- Either a local microcrack
 - Not visible in our EL in some cases
 - See IEA-PVPS T13-01-2014 “Review of Failures of Photovoltaic Modules”
- Or a droplet of e.g. solder flux, oil or similar during the production.

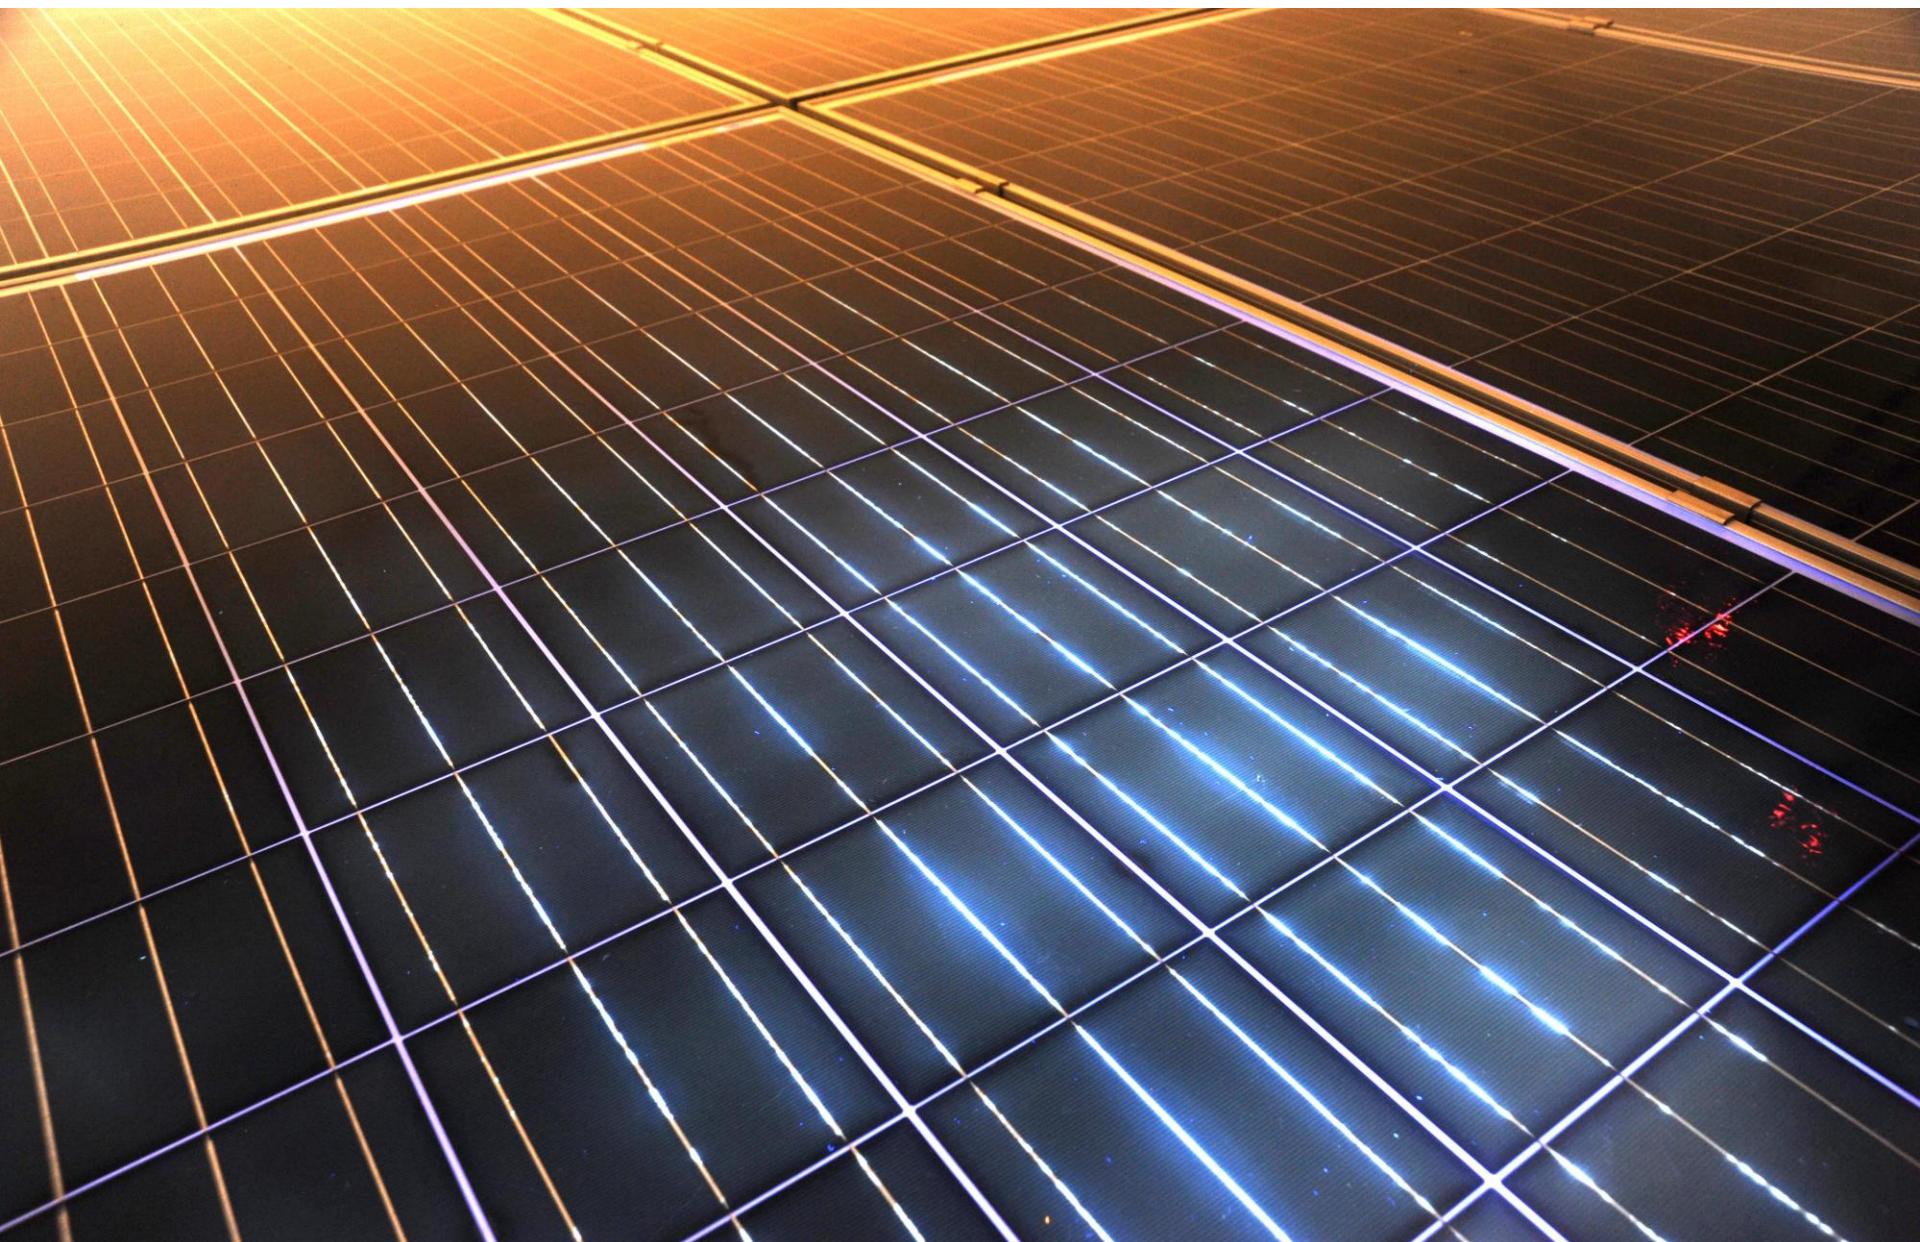
Bright Busbars

- Very likely residue of the solder flux

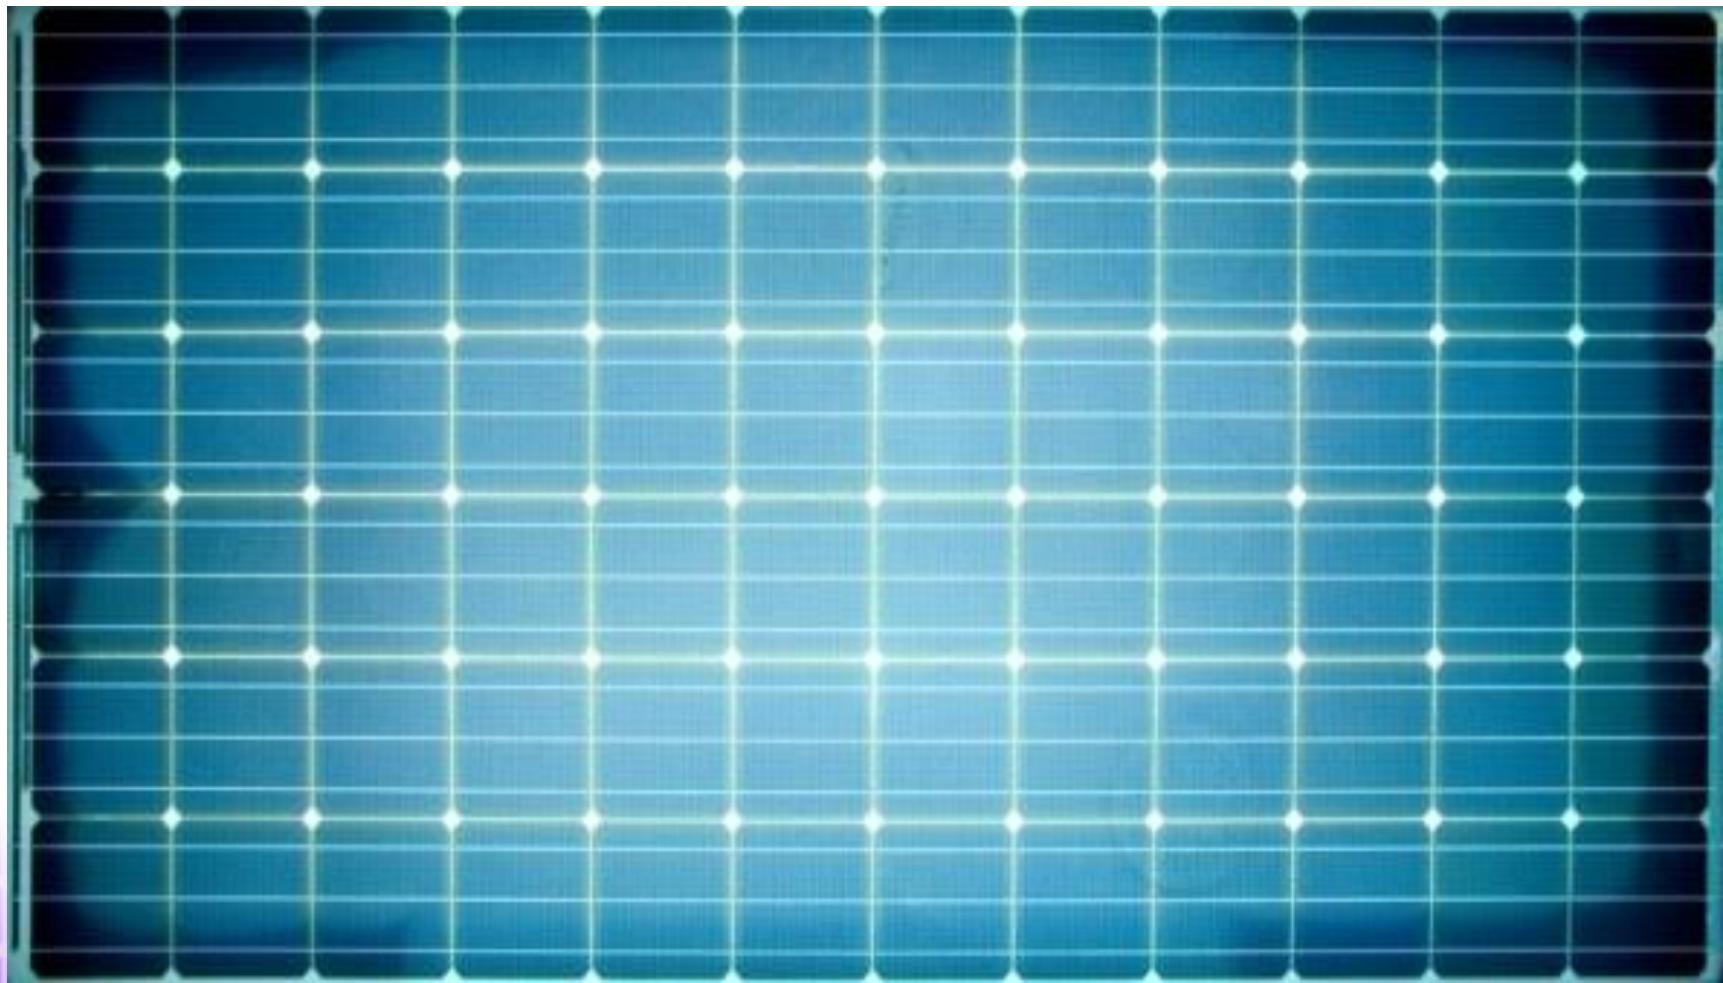
Impermeable aluminium backsheets

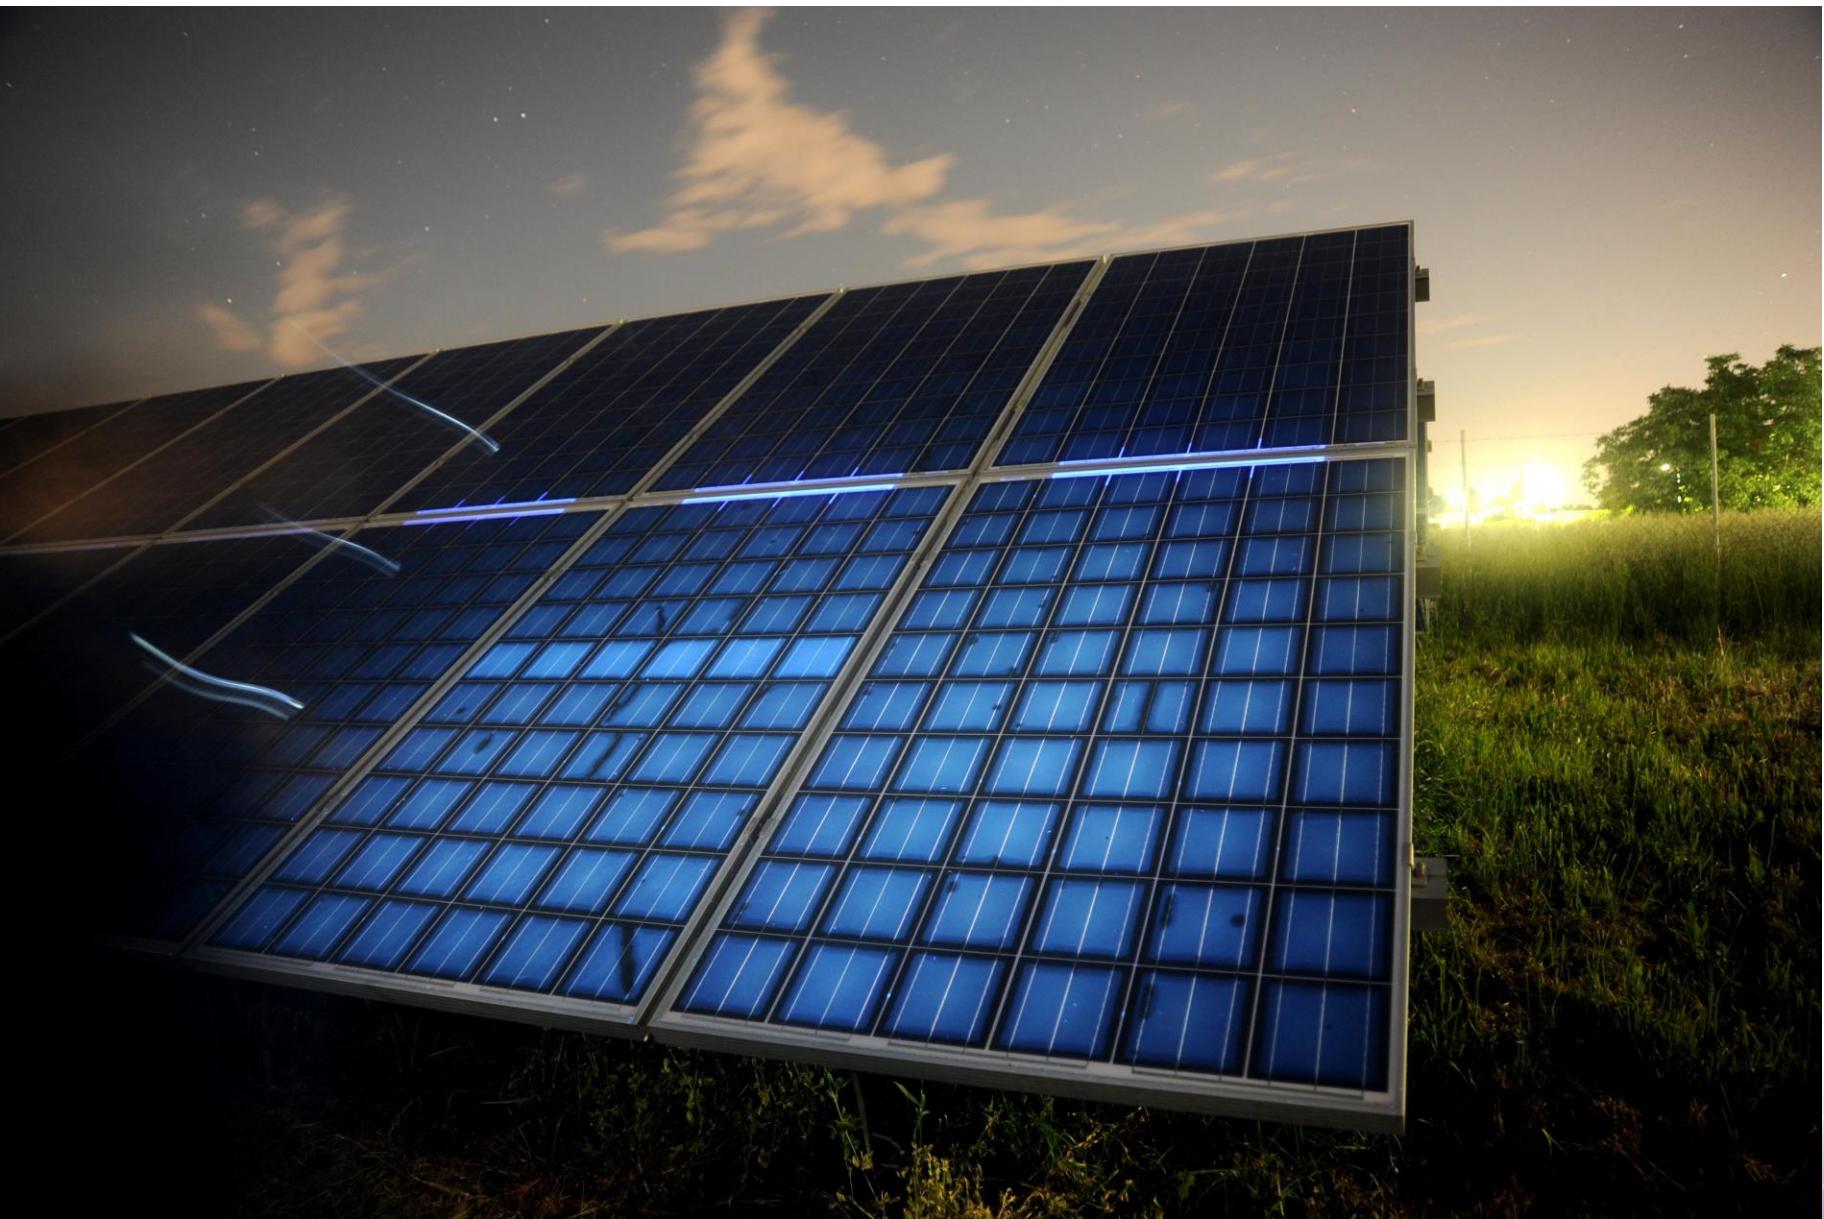
Brighter Cells

- Opposed to hot cells, the UV-F has the same color, but is just brighter
- No cracks visible
- Weak hypothesis:
 - ~~Maybe a double layer of EVA?~~
 - ?????????!!!!11

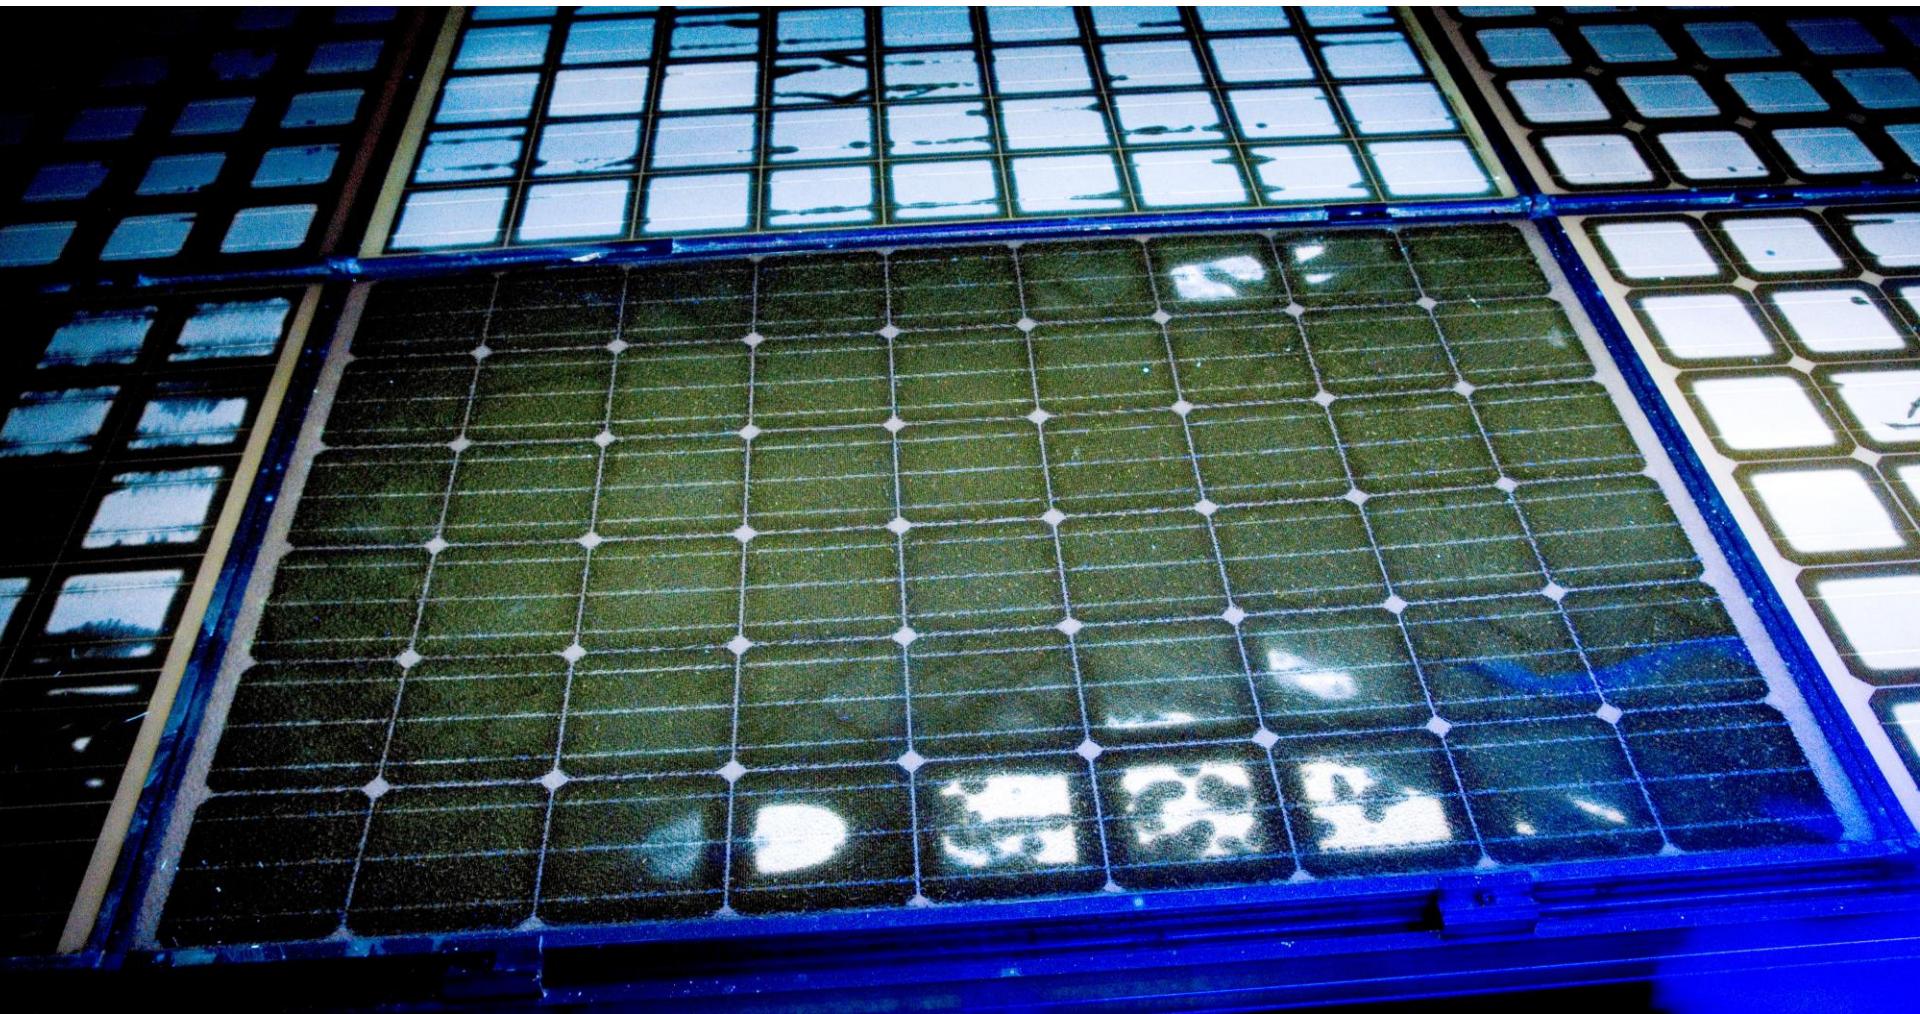
Broken glass

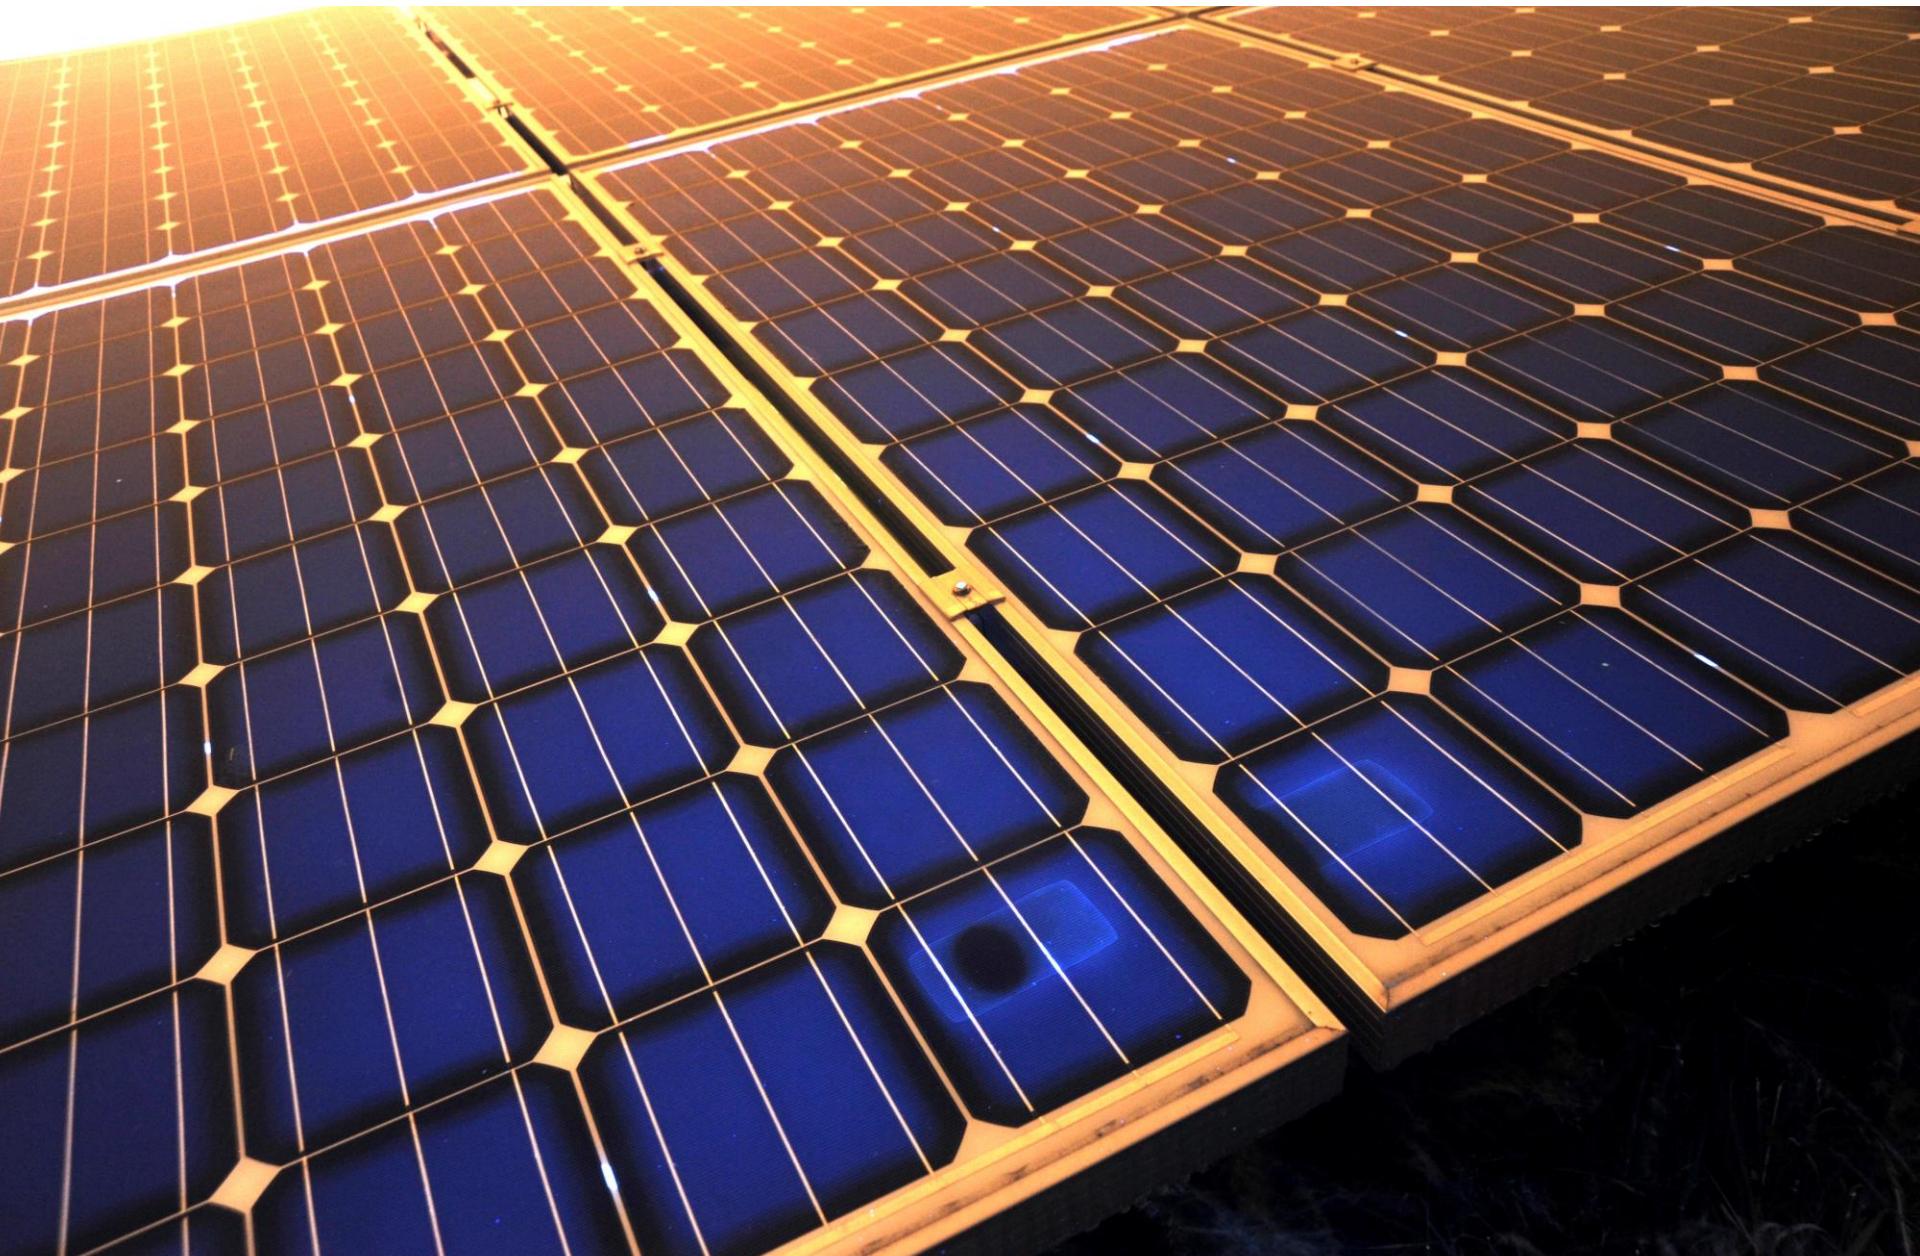
Residue of Glue

- Very likely the residue of a sticker/label either on the glass or on the EVA before lamination

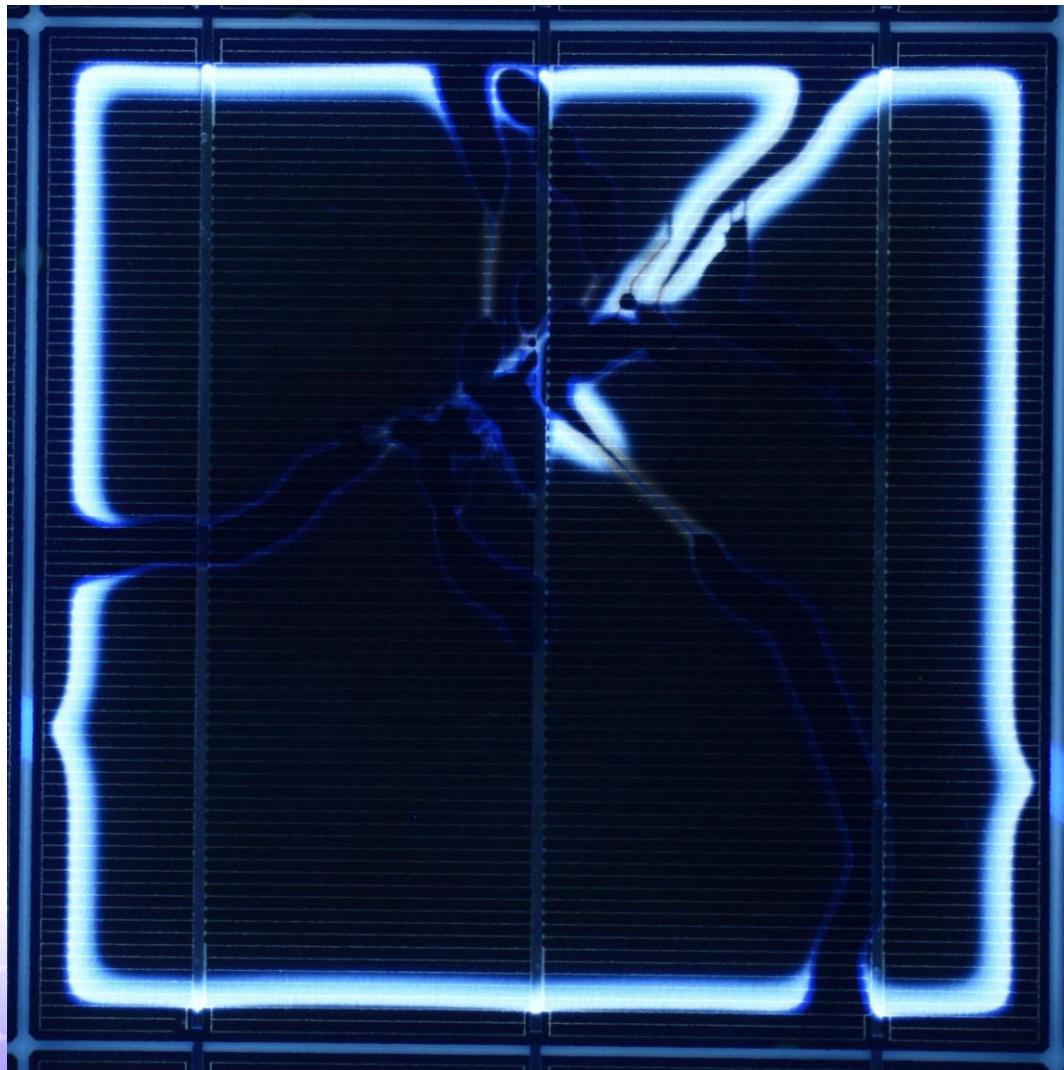
Cell of Module after UV-chamber ageing

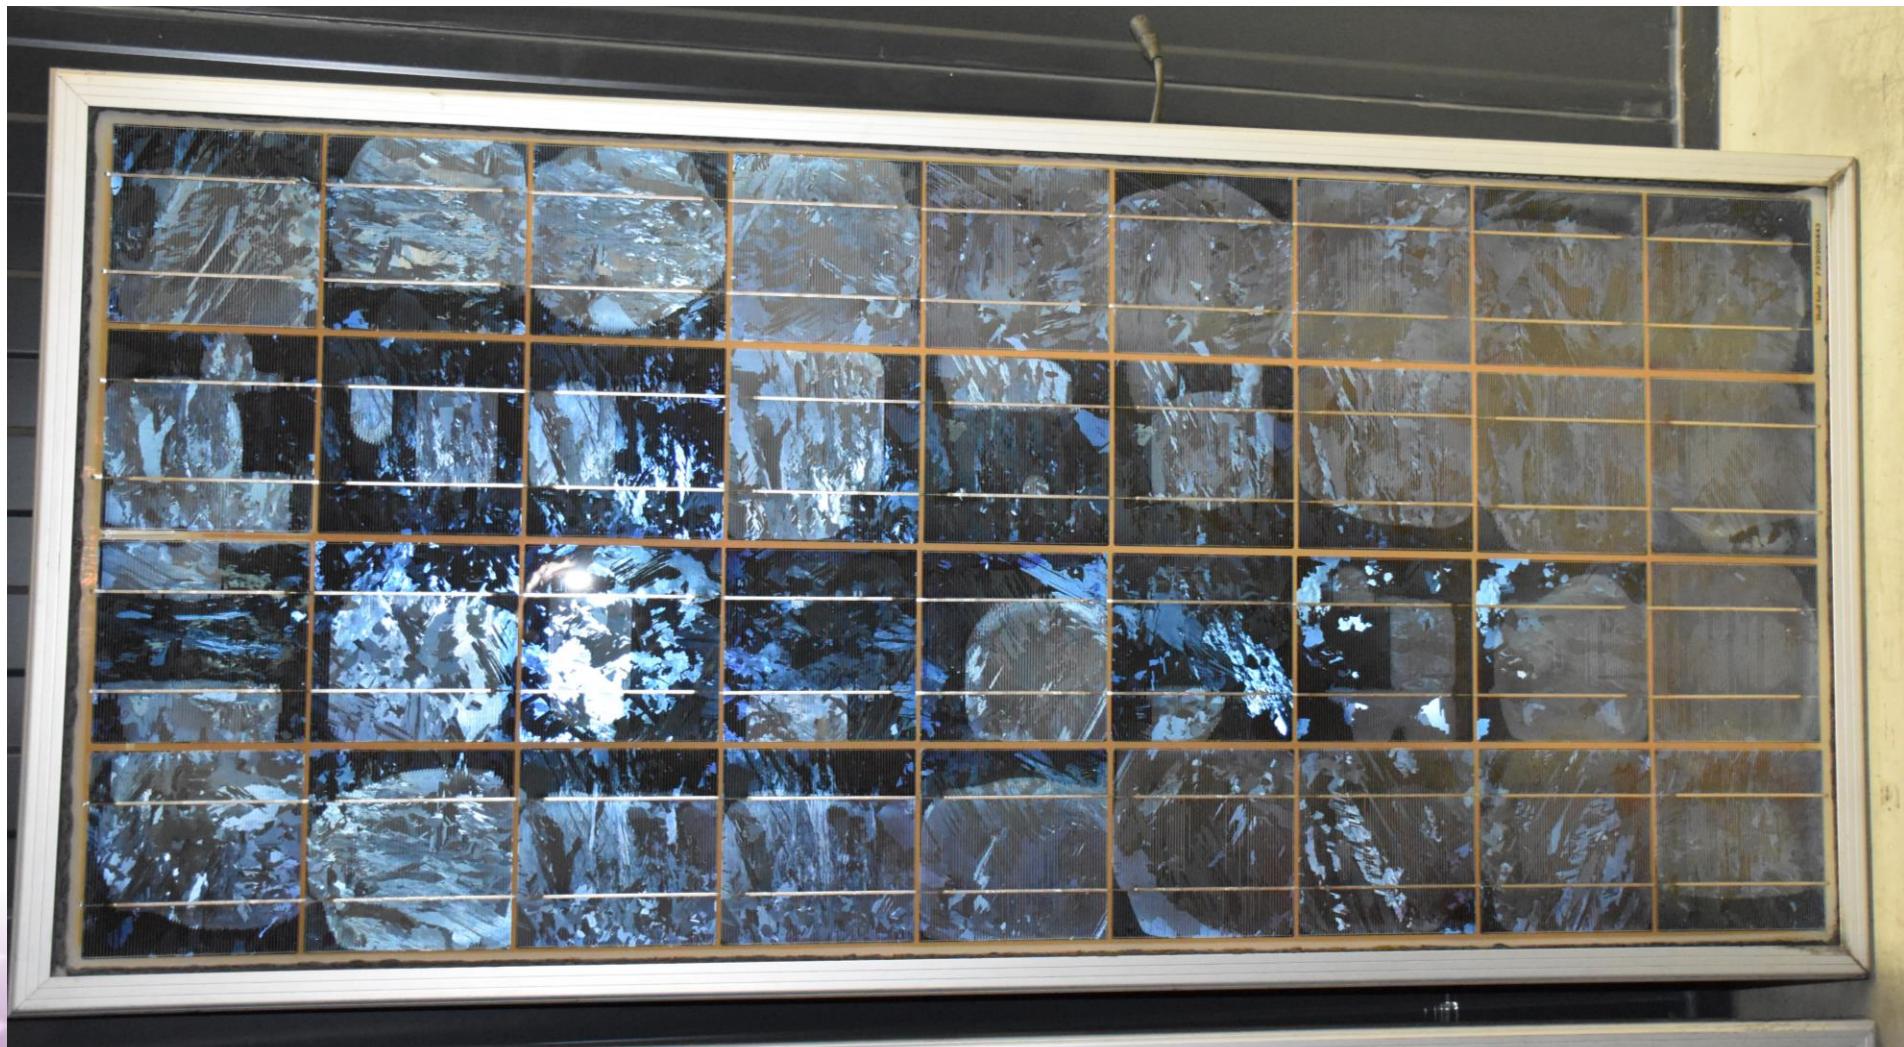
BONUS: Comparison of Methods

Extremely aged; delaminated
