# UVFL Inspection

## Drone and Tools

PV Guider

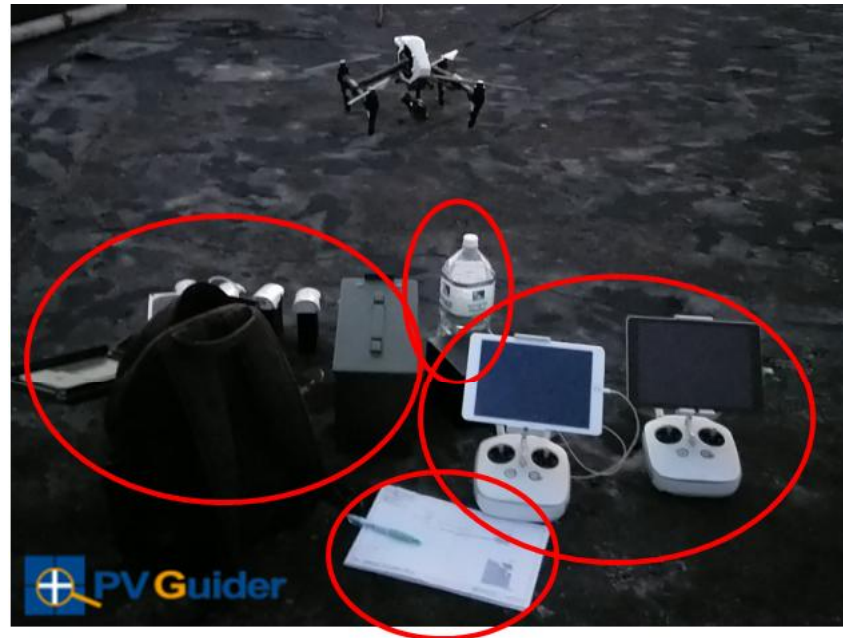
- u One pilot concentrate on flying, one photographer control camera
- u A lot batteries, and quick charger
- u Planned route (but frequently useless)
- u Drink....to keep you awake

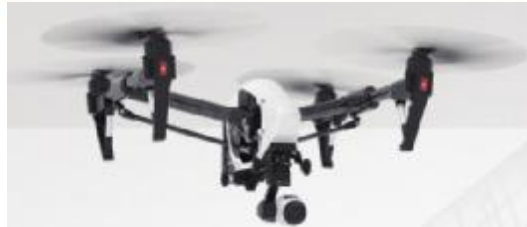
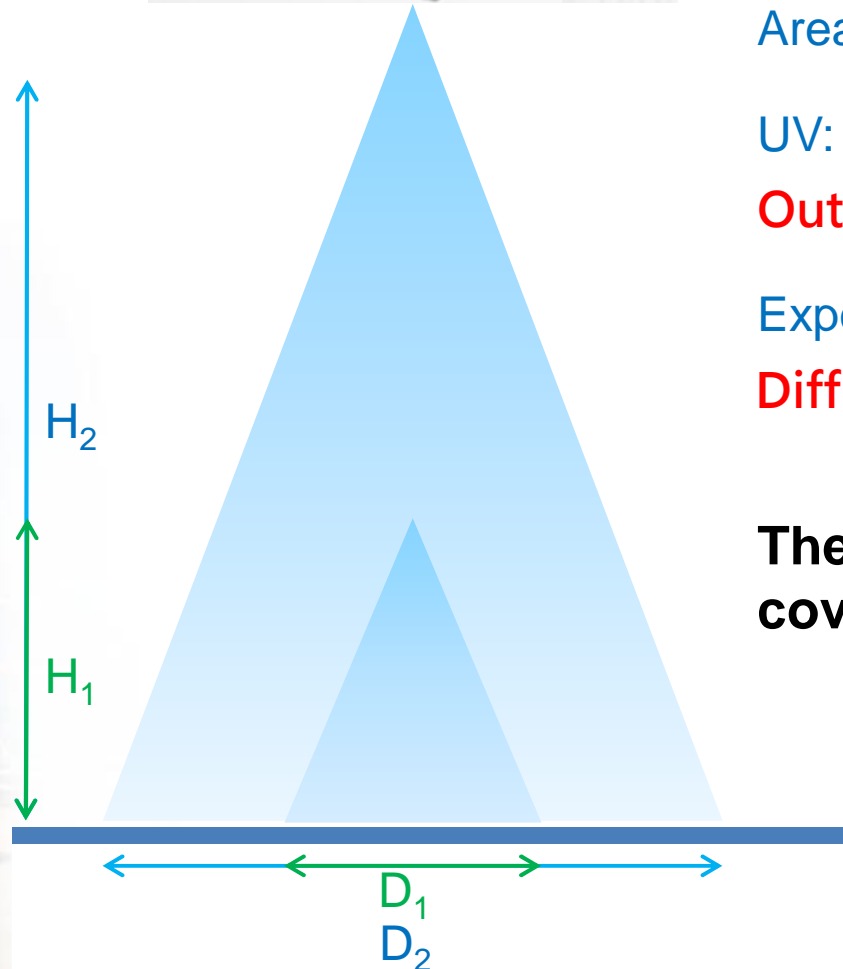
# Influence of distance

When drone fly **twice** higher:

Diameter:  $D_2 = (H_2 / H_1) D_1 = 2 D_1$

Area:  $A_2 = (H_2 / H_1)^2 A_1 = 4 A_1$

UV:  $I_2 = (H_1 / H_2)^2 I_1 = I_1 / 4$

**Outer area is even weaker**

Exposure time:  $t_2 = (H_2 / H_1)^2 t_1 = 4 t_1$

**Difficult to take pictures**

**The upper limit is about 5m,  
covers 20 modules (6x10).**

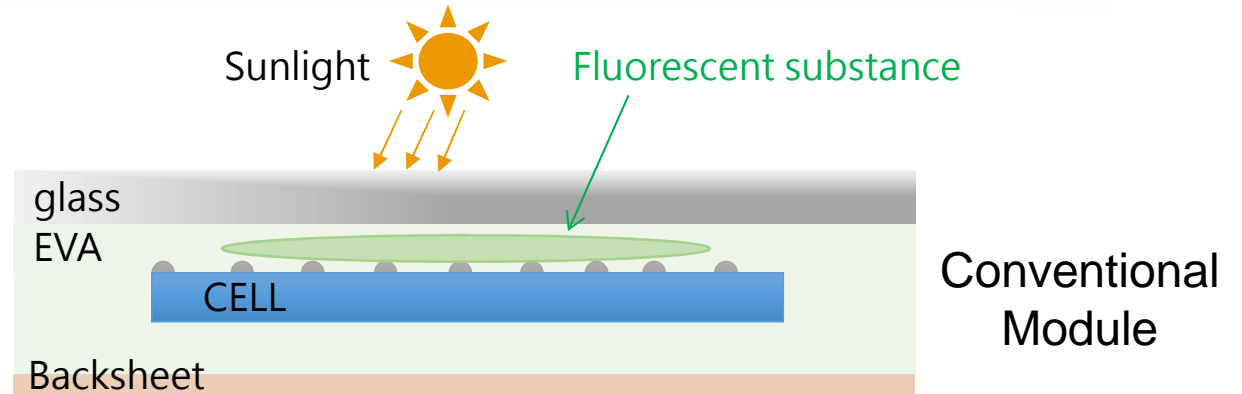
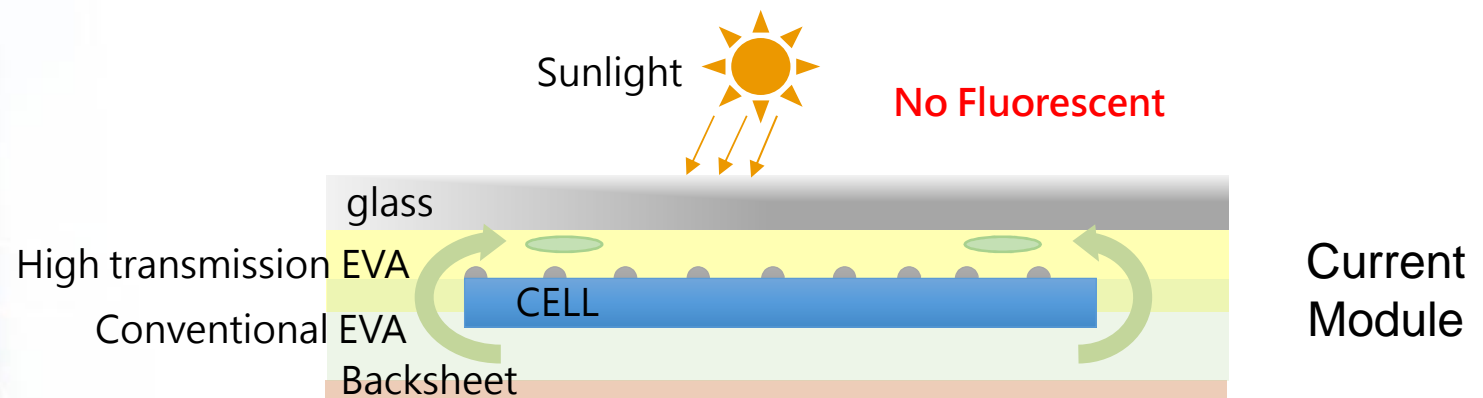
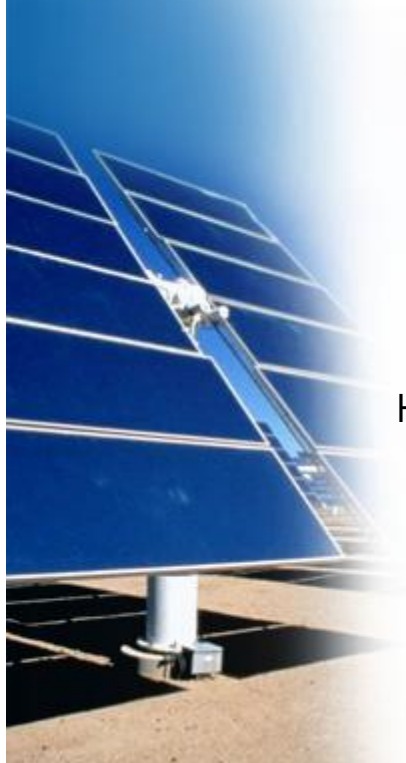
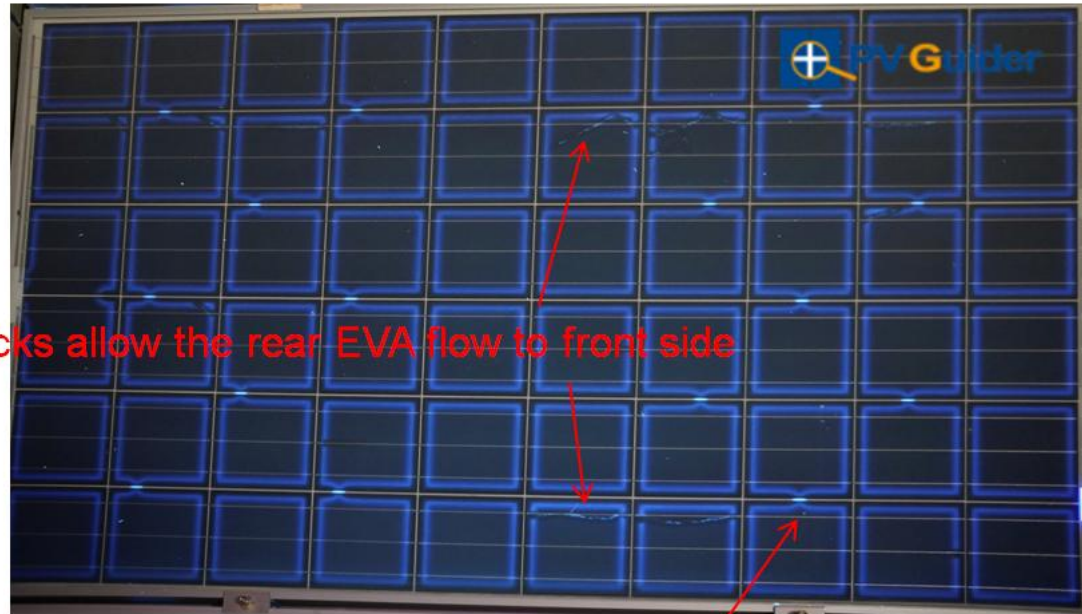
# Reason for low UVFL

Cracks allow the rear EVA flow to front side

Tape block EVA flow to front side

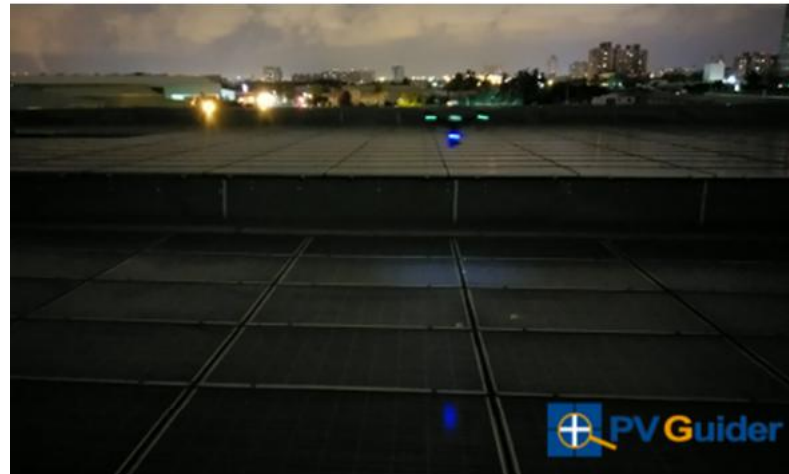
# The disadvantage of flying low

- u Dangerous, especially in windy days
- u Image quality is not good
- u Difficult to locate the defect module
- u Inspection speed too low
- u Consume more power for flying
- u Need more battery and quick charger

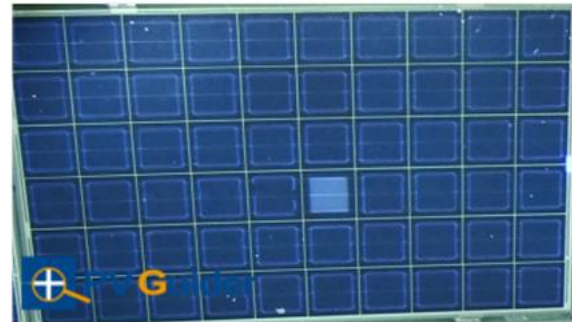
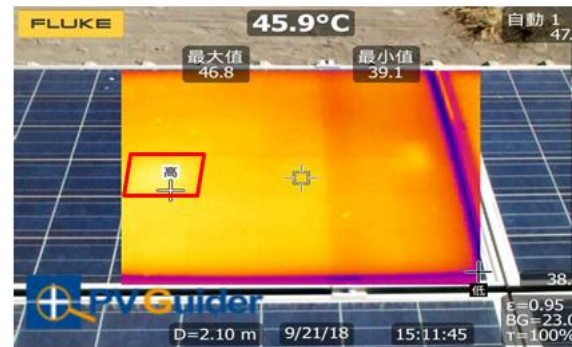
# Single cell with difference

Module rework, but not hot spot

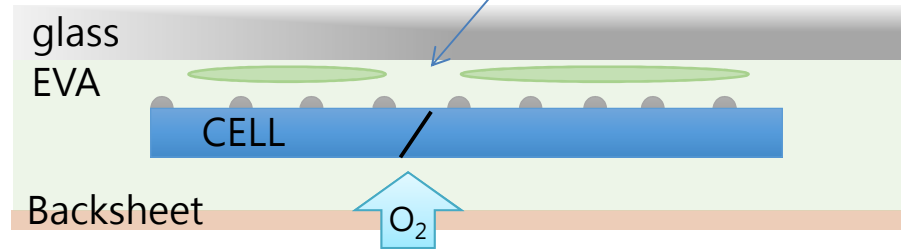
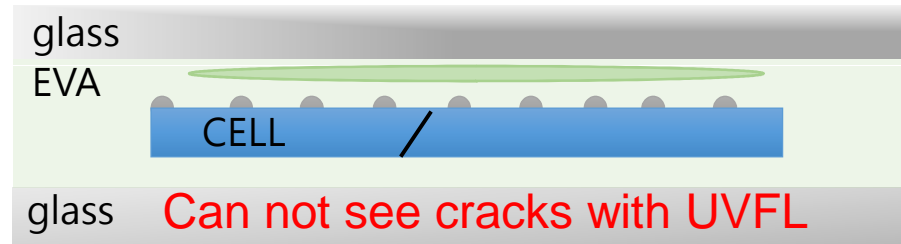
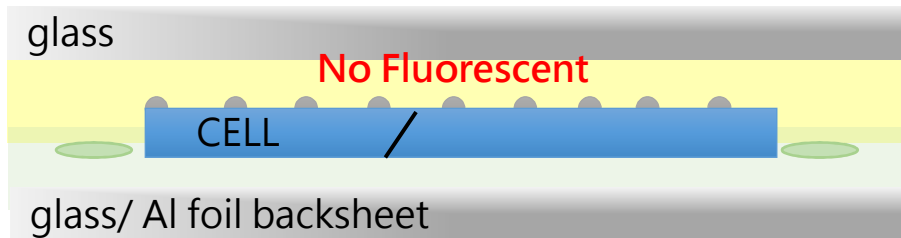
# UVFL of Double glass/ Al Foil backsheet

No fluorescent at crack position

High transmission EVA  
Conventional EVA

Can not see cracks with UVFL  
Fluorescence only appear between cells
