Review of Failures of Photovoltaic Modules

Report IEA-PVPS T13-01:2014

Performance and Reliability of Photovoltaic Systems

Subtask 3.2: Review of Failures of Photovoltaic Modules

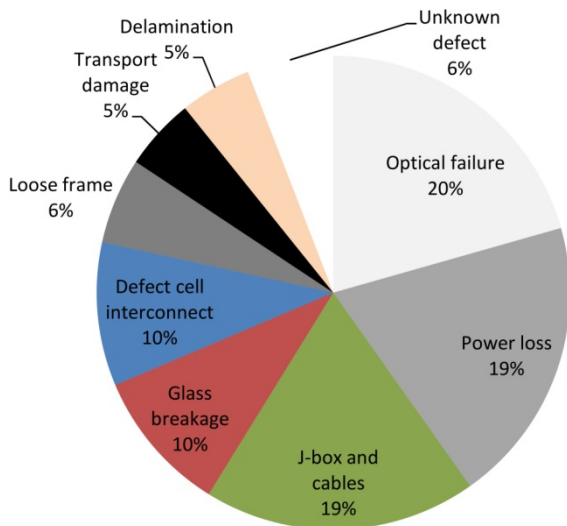
Fig. 3.2: Failure rates due to customer complaints in the first two years after delivery. The rate is given relative to the total number of failures. The PV modules are delivered by a German distributor in the years 2006-2010 [redrawn from Richter11]. The statistic is based on a total volume of approximately 2 million delivered PV modules. Categories not found in other module failure statistics are drawn in grey scale.

Infant-mortality failures occur in the beginning of the working life of a PV module. Flawed PV modules fail quickly and dramatically impact the costs of the module manufacturer and the installer because they are responsible for these failures. Figure 3.2 shows the distribution of the failure types at the start of the working life given by a German distributor. Due to transportation damages 5% of all failure cases occur. The most important failures in the field are j-box failure, glass breakage, defective cell interconnect, loose frame, and delamination. Unfortunately the other defects of the statistics are not well defined.

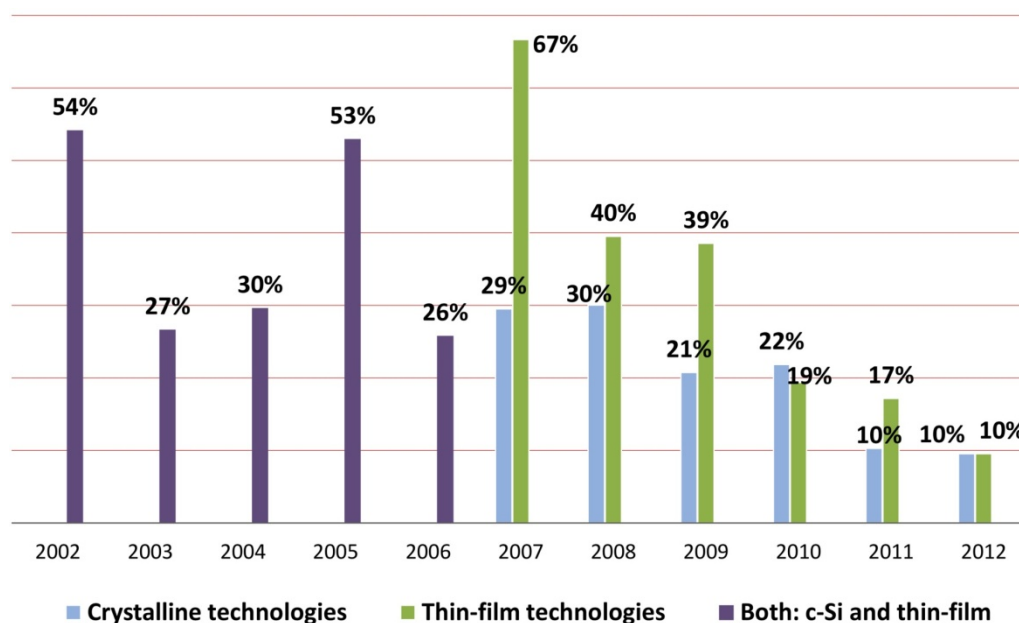
Fig. 3.5: Failure rates of 2000 certification projects for IEC 61215 and IEC 61646 type approval tests for the years 2002 to 2012. The given figures are the annual percentages of IEC projects with at least 1 module test failure compared to the sum of all conducted IEC projects. Since 2007 figures of crystalline and thin-film technologies are shown separately.

qualification in accordance with IEC 61730 [IEC61730]. A long-term trend can be clearly identified here as shown in Fig. 3.5. While 54% of all projects were still failing the IEC qualification certifications in 2002, by 2007 this had risen to 67% for the new thin-film modules and 29% for the new crystalline photovoltaic modules. In 2007/2008 many thin-film start-ups entered the PV market and contributed to these failure rates, possibly because they used the test labs to speed their screening of new product designs. Similarly, this high failure rate may be attributed to the large number of new module manufacturers on the market originating from Asia in particular, again, possibly because they had not fully tested their products before attempting certification. By 2012, the rate of failed IEC projects for both technologies had dropped to 10%. The experts ascribe this not only to the fact that manufacturers have learned to better fulfil the IEC standards when constructing new module types but also to the on-going developments of the market.

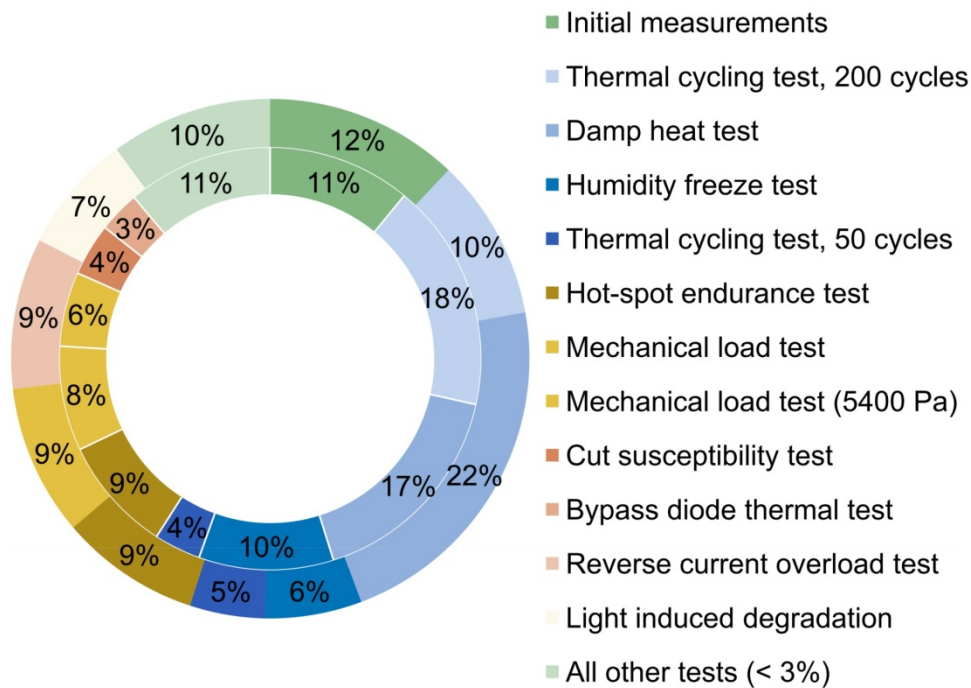
Fig. 3.6: Distribution of failed tests of 1740 IEC projects for crystalline PV modules (inner ring) and of 370 IEC projects for thin-film PV modules (outer ring) between 2006 until June 2013. A test is considered a failure, if one or more PV modules will not pass the specific test. One certification project may contribute to one or several test failures.

The distribution of failed tests as shown in Fig. 3.6 indicates parallels between crystalline modules (1740 projects) and thin-film modules (370 projects analysed): Of those projects in which tests were failed between 2006 and June 2013, 49% of all crystalline module tests (inner ring) and 43% of all thin-film module tests (outer ring) failed during the four test series in the climate chamber of the TÜV Rheinland test laboratory (marked in blue colours in Fig. 3.6), which include 200 cycles thermal cycling test (TCT200), damp heat test (DHT), humidity freeze test (HFT), and 50 cycles thermal cycling test (TCT50). The climate chamber tests are a good indication of the longevity to be expected, the quality of the materials, and the workmanship of the products. However, it is also notable that 11% (crystalline) and 12% (thin-film) of failures occurred during the required initial measurements, that is, before any stress tests had actually been carried out. These modules failed, for example, because the

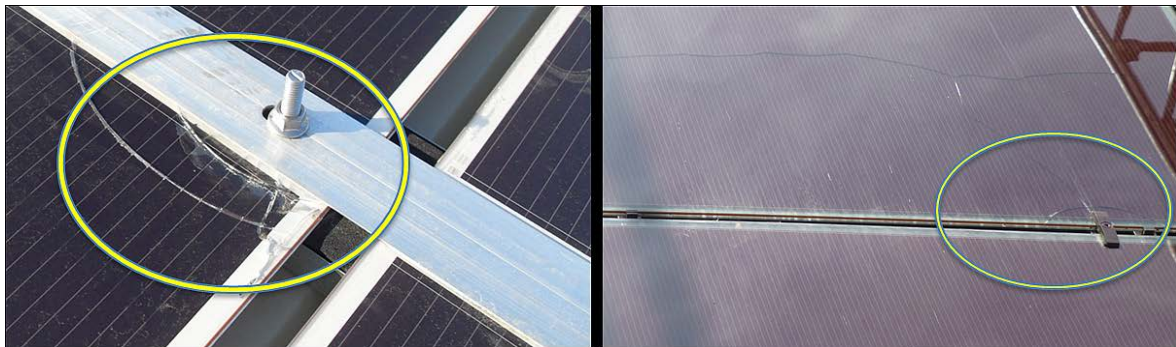
Fig. 4.3.1: Left figure shows glass breakage caused by too tight screws and the right figure a PV module that broke due to poor clamp design.

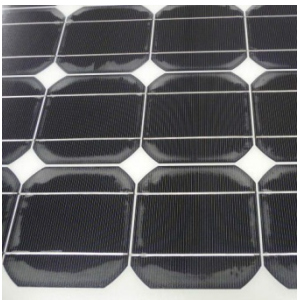
6.1.1	Delamination of c-Si module	B(e)	<u>D</u> / <u>E</u>

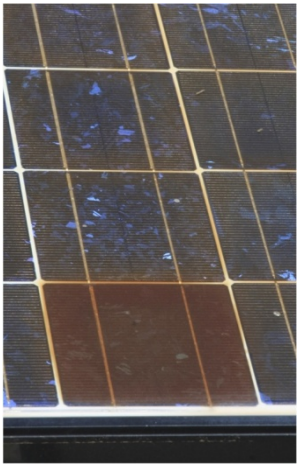
6.2.1, 6.2.2	Browned EVA on top of a cell with two cracks in a cell. Photobleaching takes also place along cell cracks therefore the crack is visible. The browning takes several year to appear. This may not be mistaken for Snail tracks.	B(f)	<u>C</u>

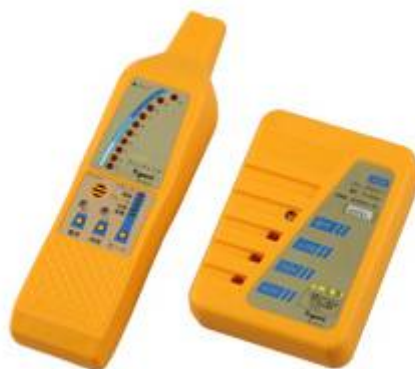
Fig. 5.6.1: An example of the Signal Transmission Device (STD).

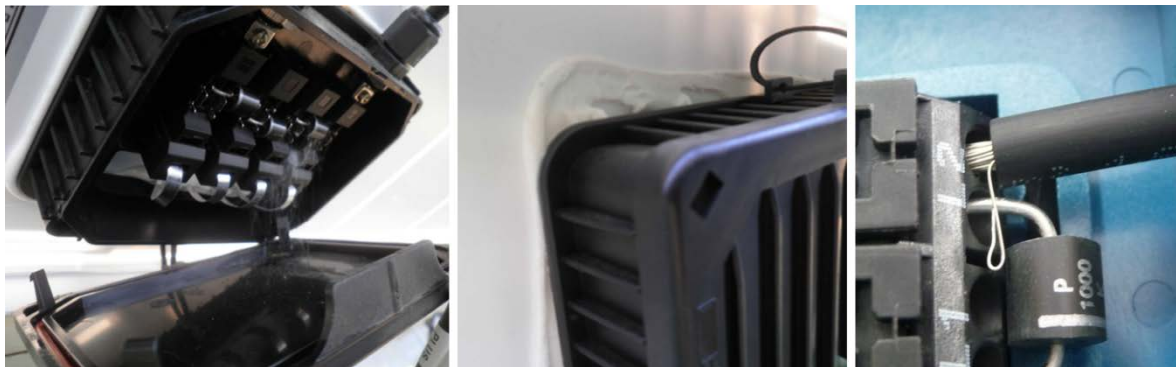
Fig. 6.1.3: Junction box failures: Left photo shows an open junction box in the field, the middle one a poorly bonded JB on the backsheet, and the right one a JB with poor wiring.

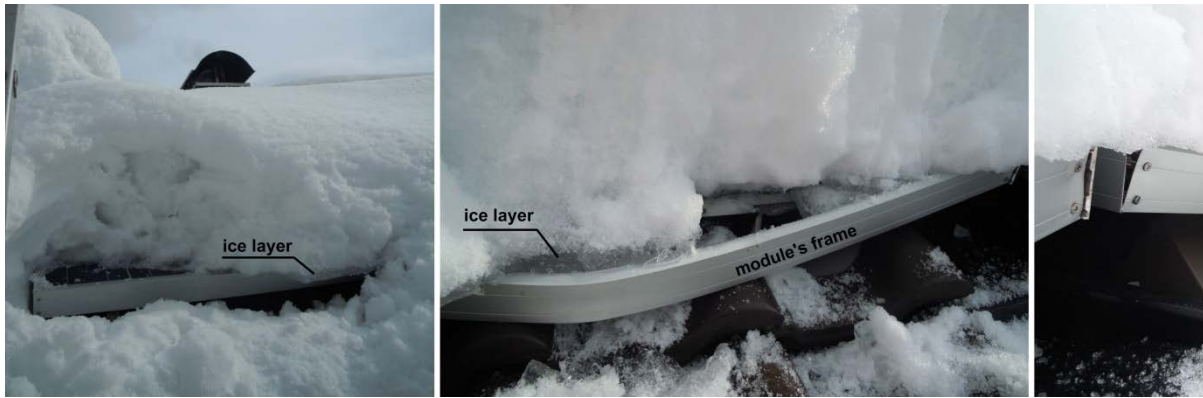
Figure 6.1.4: Damaged module frames after heavy snow load of 1.2 m, melted down to 35 cm, in winter 2012. Alpine location at 620 m a.s.l., tilt angle 25°. 60 cell modules with dimensions 1660 mm x 990 mm, 50 mm Al-frame.

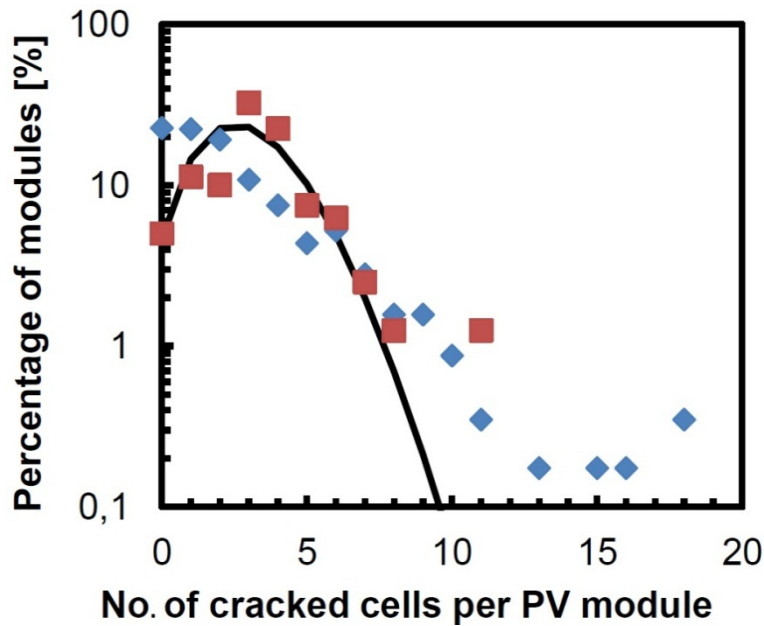
Fig. 6.2.1: Logarithmic histogram of 60 cell PV modules showing a specific number of cracks per PV module. The red squares show the crack distribution of PV modules (#80) directly after production from one manufacturer. The blue diamonds show the crack distribution (#574) of PV modules found in the field [Koentges2012]. The straight line depicts the binomial distribution of equation (6.2.1) for $p=5\%$.

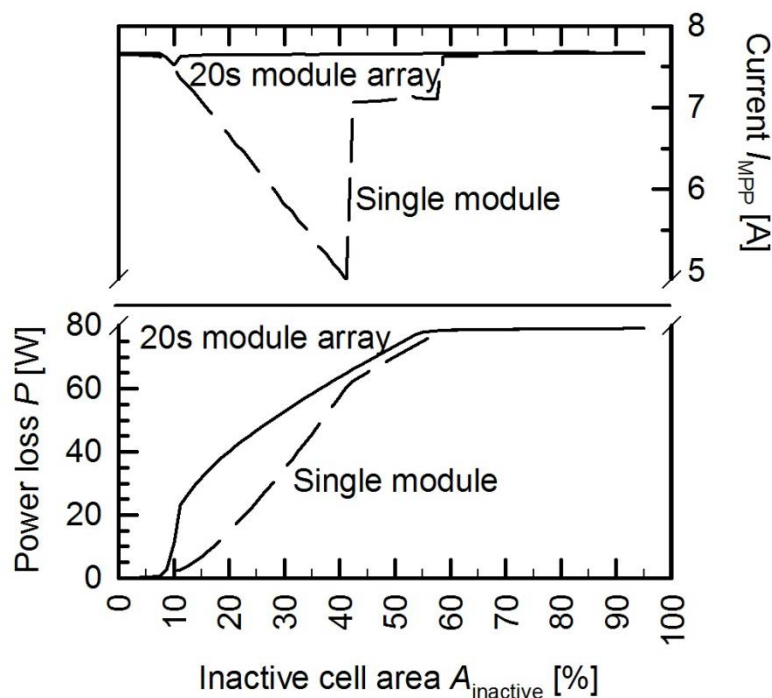
Fig. 6.2.2: Simulation of the power loss of a single 230 Wp PV module with a single solar cell having a varying inactive cell area. The simulated power loss of a 20 PV modules array containing this defective module is also shown. More than 8 % of inactive cell area in the 20s module array leads to a much higher power loss compared to the stand-alone PV module. These simulations depend on the reverse bias characteristics assumed for the silicon modules.

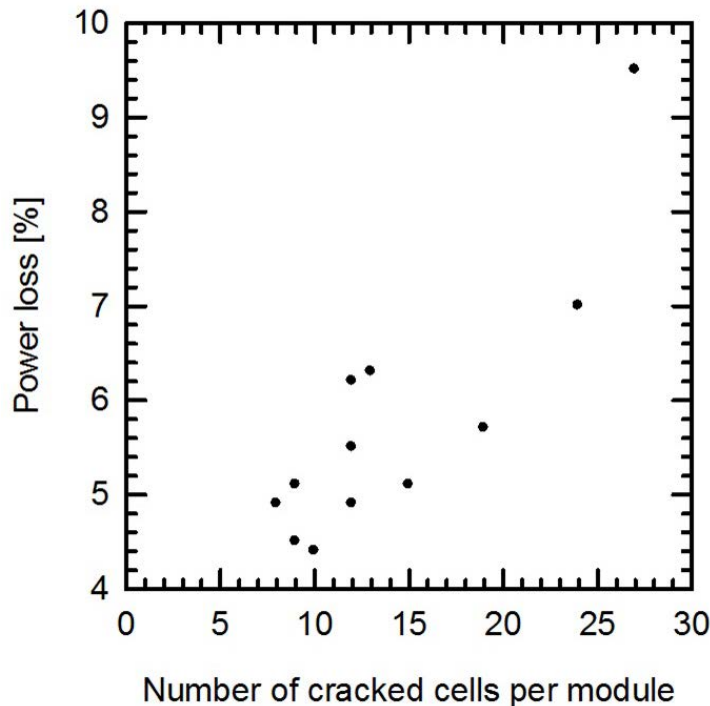
Fig. 6.2.3: The power loss after a test sequence of mechanical load and 200 humidity freeze cycles correlates with the number of cells cracked in the mechanical load test. Each point represents a single PV module. A bias power loss of about 3% is caused by glass corrosion.

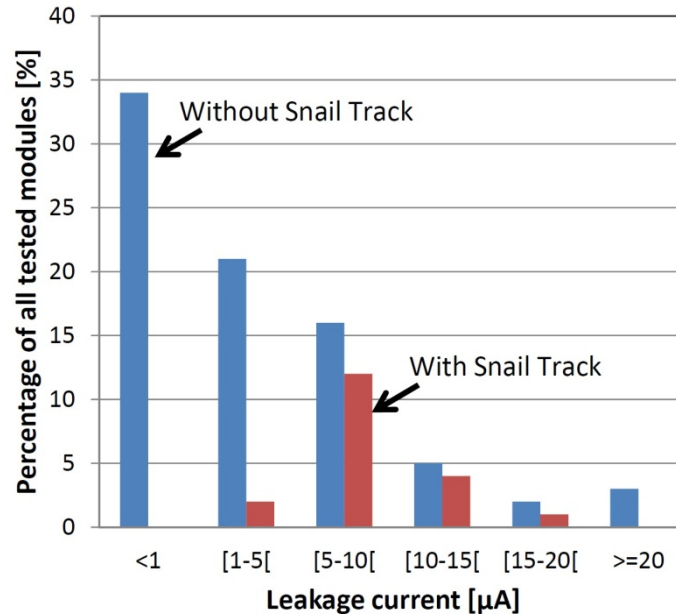
Fig. 6.2.5b: Histogram of leakage current measured in wet leakage testing for snail track affected panels. Given percentage values are relative to the number of all tested PV modules [Berghold12].

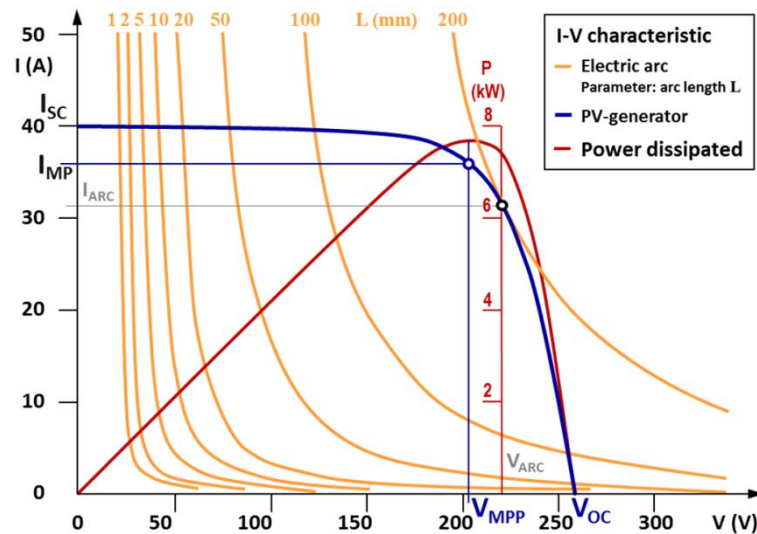
Fig. 6.2.6: I-V characteristics of free burning DC arcs in air on copper electrodes depending on arc length (in orange, from [Rieder55]) in comparison with typical PV system characteristics (blue curve).

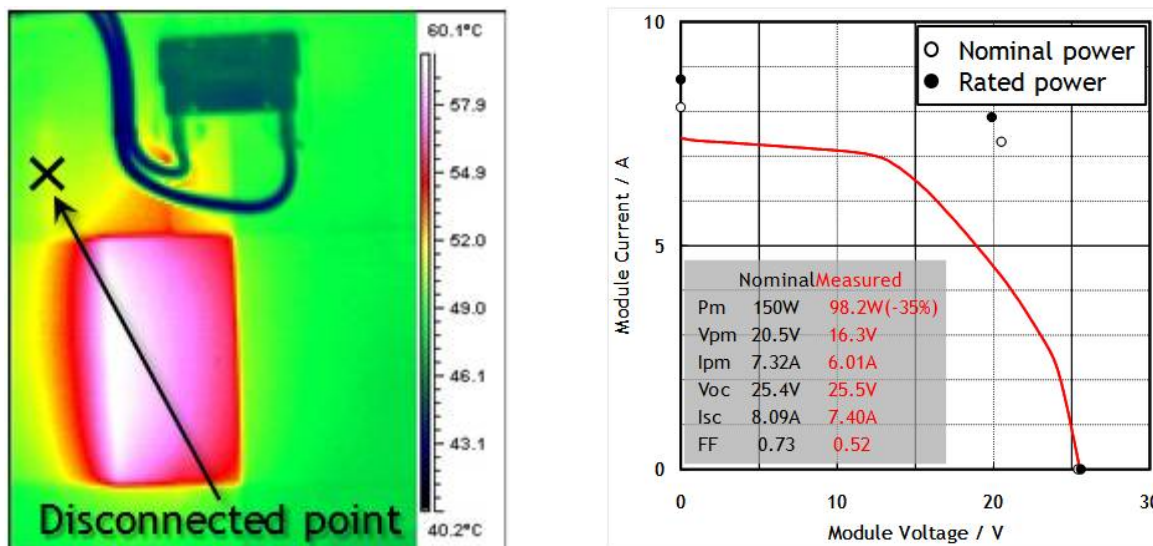
Fig. 6.2.15: Left: an IR image of a PV module where one interconnect ribbon is locally disconnected (“failure stage 1”). Right: I - V curve (indoor STD) of a PV module in which one interconnect ribbon is locally disconnected (“Failure Stage 1”). The Nominal and initial rated I - V curve parameters are plotted into the graph.

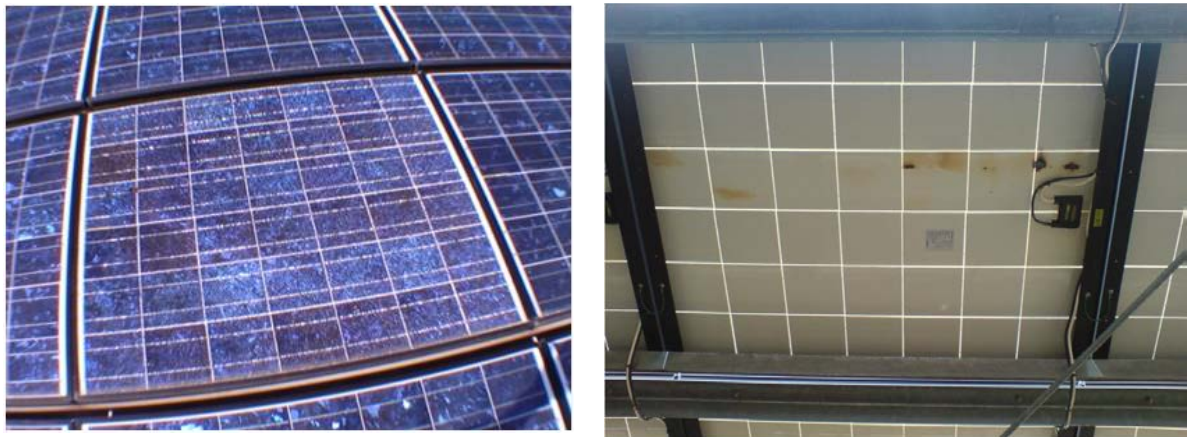
Fig. 6.2.17: Final stage. Left: glass breakage of a PV module caused by broken cell interconnect ribbons. Right: burn marks on the PV module rear side caused by broken cell interconnect ribbons.

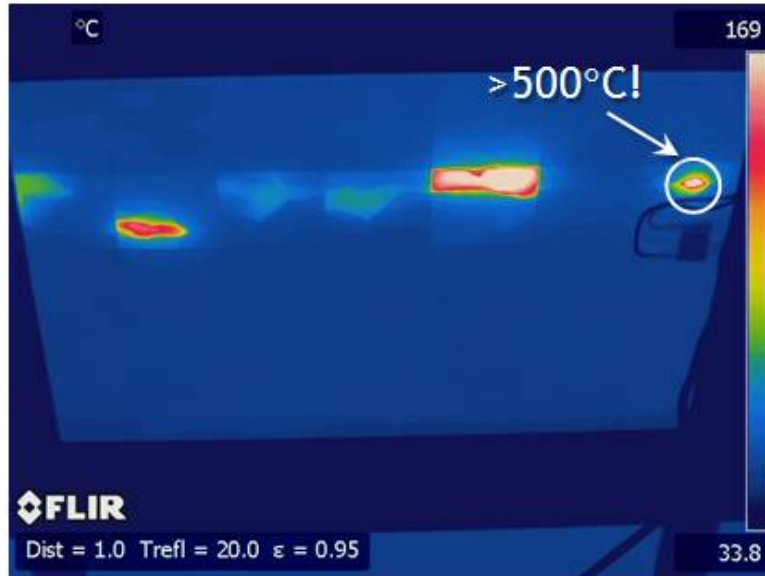
Fig. 6.2.18: An IR image of the “final stage” PV module (observed from rear side).

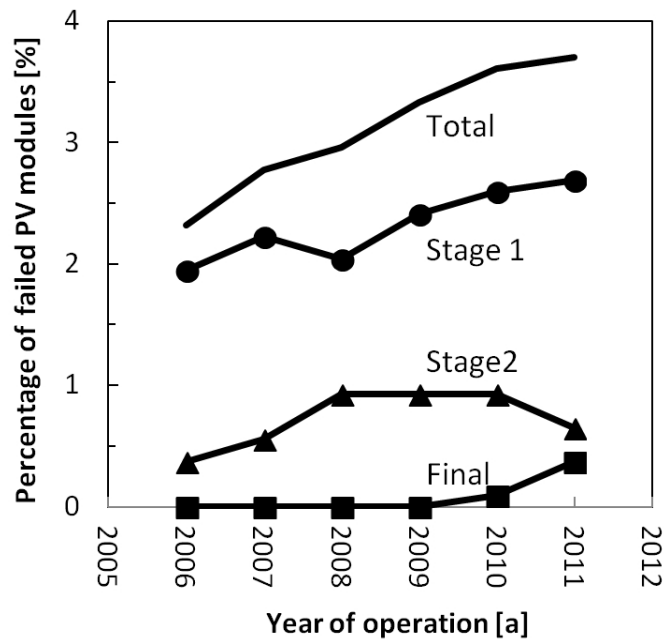
Fig. 6.2.19: Annual trend in number of modules with cell interconnect ribbon failures happening in a PV system. The system consists of 1080 PV modules in total and was built in 2004.

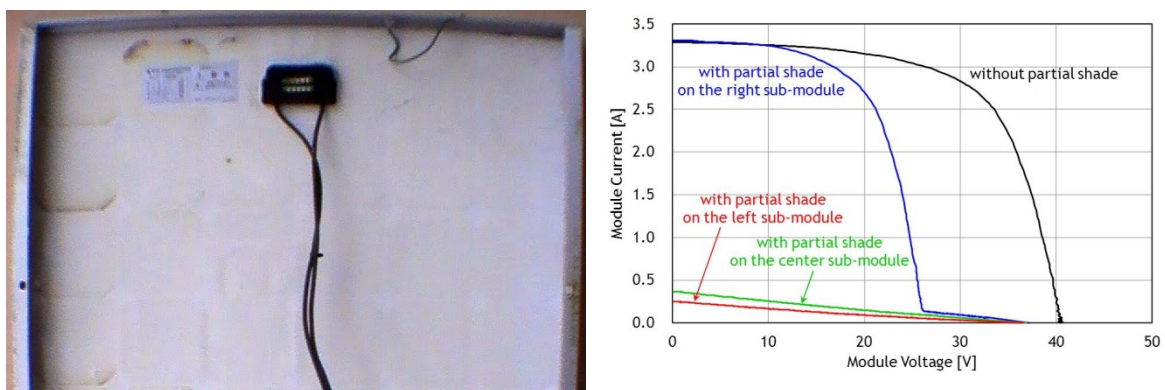
Fig. 6.2.20: A rear side view (left) and a measured I - V characteristic curve (right) of a PV module with burn marks.

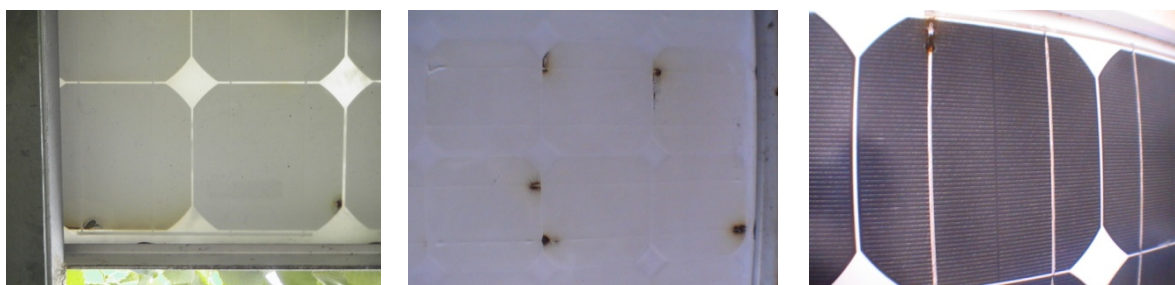
Fig. 6.2.22: Burn marks caused by open-circuit bypass diodes.

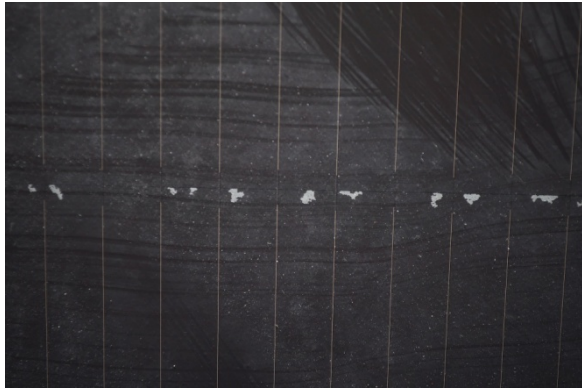
Fig. 6.3.3: Module damages and failures observed for hot-spot testing of thin-film modules in accordance with IEC 61646: a) Formation of hot-spot shunts along a laser scribing line, b) Formation of hot-spot shunts at the cell interconnection associated with large-area cell damage, c) Formation of hot-spot shunts associated with worm-like cell damage, d) Glass breakage through high temperature gradient and not tempered glass [Wendlandt11].

- a) At cell interconnection lines: Imperfect laser scribing process (scribe lines P1, P2, P3). The laser beam may cause crystallisation to some extent, see Fig. 6.3.3 a).
- b) Cell area: any particles or impurities generated during processing, particles on the glass surface or TCO surface roughness (pinholes).
- c) Edge of active cell area: imperfect edge insulation process (i.e. sand blasting).

Thin film PV modules	Crystalline silicon PV modules
Formation of hot-spot shunts	Cells are very sensitive to junction breakdown if operated under reverse bias voltage. Visual appearance of damages can be very different (pins, small area spots, worm-like trails). Figure 6.3.3 gives some examples of hot-spot damage observed during laboratory hot-spot testing (IEC 61646).	Cells are tolerant against reverse bias operation if protective measures with bypass diode are well designed.
Measures for prevention of hot-spot heating	Formation of hot-spot shunts cannot be avoided. The damage is clearly visible and is normally spread across the affected group of cells. Various technologies apply an additional laser scribe to divide cells into electrically isolated parts. This measure shall reduce potential hot-spot damage.	Bypass diodes are implemented in the interconnection circuit of cells. Reverse voltage at a shaded cell is limited to an uncritical value to prevent pn junction breakdown. For example, 20 serially connected cells per bypass diode can lead to reverse voltage up to approx. -12 V.

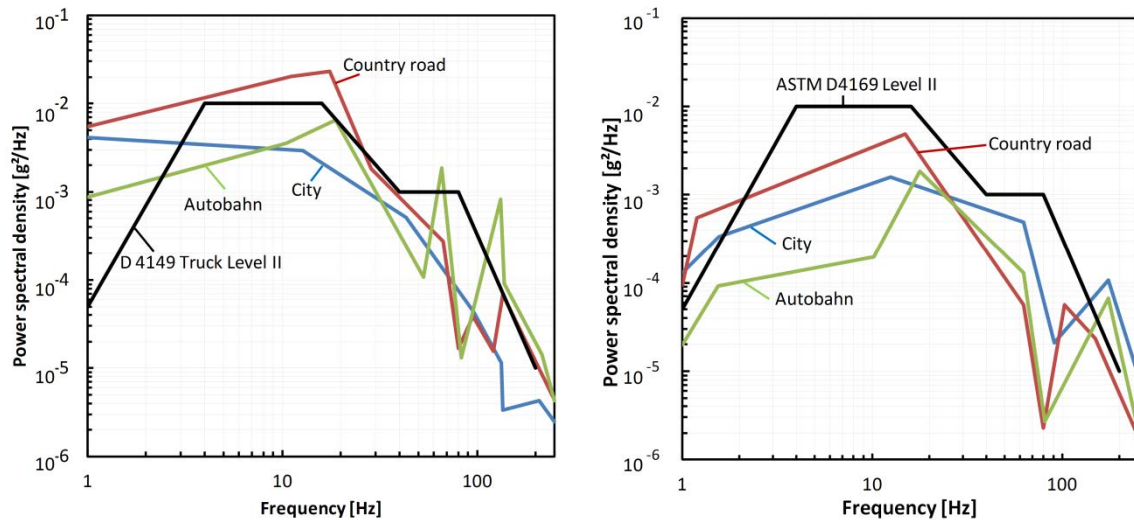
Fig. 7.1.5: Measured reduced PSDs in the corners of PV modules in a transport stack for sunny side down stacked PV modules. Left: Upper PV module in the stack, right: Bottom PV module in the stack. The reduced PSDs are created according to the standard DIN EN 154335 [DIN EN 15433]. The purple and black PSD spectra are similar standard spectra.

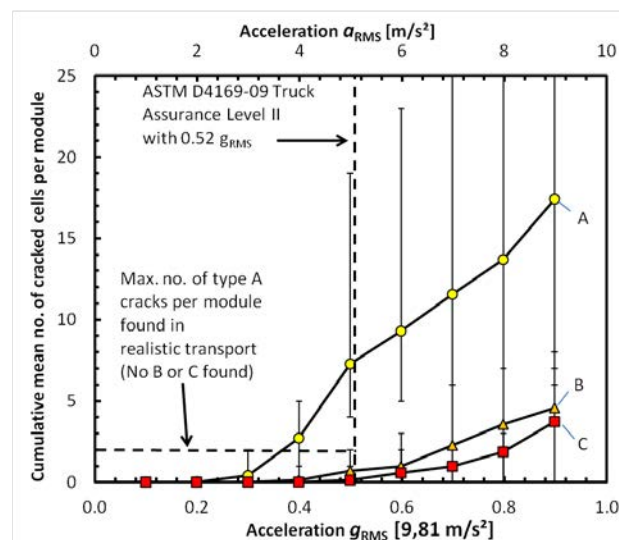
Fig. 7.1.6: The graph shows the cumulative mean number of solar cells with new cracks of type A, B, and C after a 15 min. noise test using the ASTM D4169-09 Truck PSD-spectrum [ASTM1]. The RMS acceleration amplitude a_{RMS} of the PSD-spectrum is varied in this experiment. The error bars show the maximal variance of the set of tested PV modules.

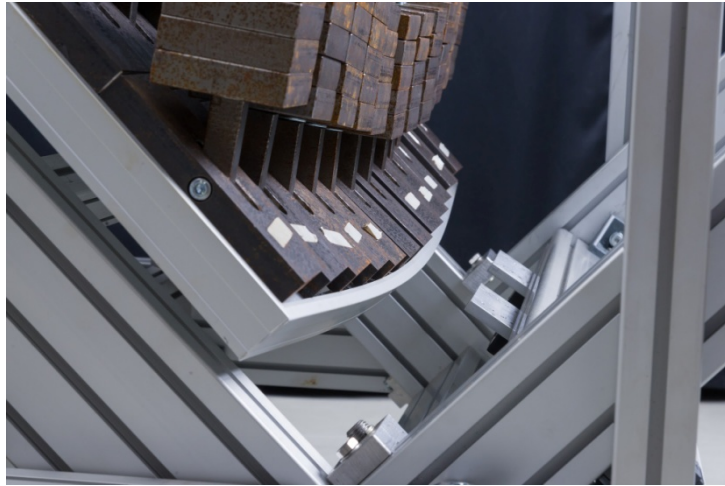
Figure 7.2.1: New test apparatus for snow load testing at TÜV Rheinland 2012: Application of load elements causing the bending of a PV module frame.
