Task 13 Reliability and Performance of Photovoltaic Systems

Degradation and Failure Modes in New Photovoltaic Cell and Module Technologies

2025

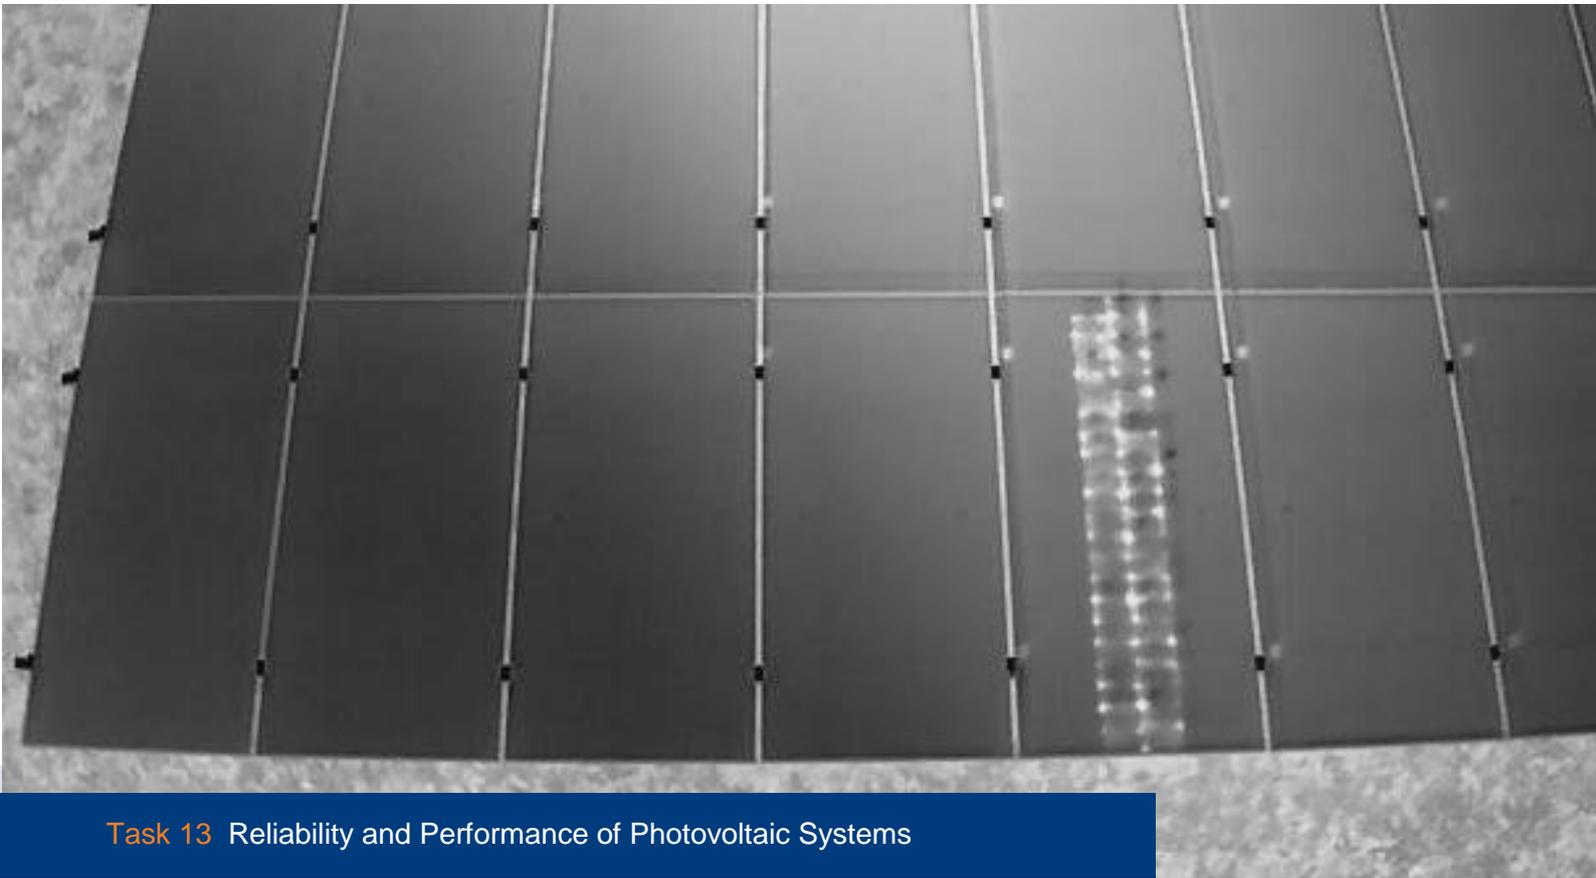
Infrared image of an energised module string at night. One module has a not connected bypass diode. Thanks to photovoltaikbuero Ternus & Diehl GbR for the permission to use the image.

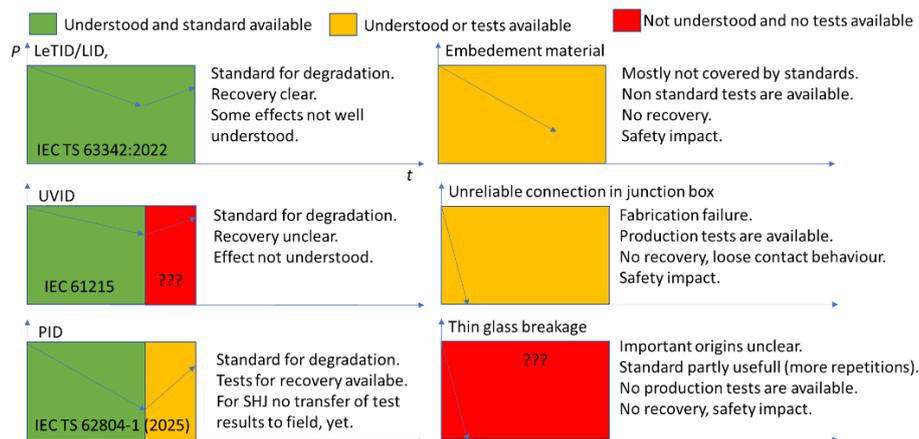
Figure 1: Overview of test availability and impact of currently relevant degradation modes of TOPCon and SHJ module designs.

The reliability situation of Tunnel Oxide Passivated Contact (TOPCon) and Silicon Hetero-Junction (SHJ) is shown in Figure 1 for selected degradation and failure modes. Especially semiconductor-related degradation modes show degradation and recovery paths: light (and elevated temperature)-induced degradation (LeTID/LID), UV-induced degradation (UVID), and potential-induced degradation (PID). Their impact can only be assessed if the degradation and recovery paths are understood, and a test method is available. Common degradation modes or failures related to embedment, glass and junction box are shown in Figure 1 on the right. Current standard tests, especially of the IEC 61215 standard, cannot reveal these degradation or failure modes. As these modes are safety relevant, it is important to understand the causes and develop standardized tests to identify these reliability problems.

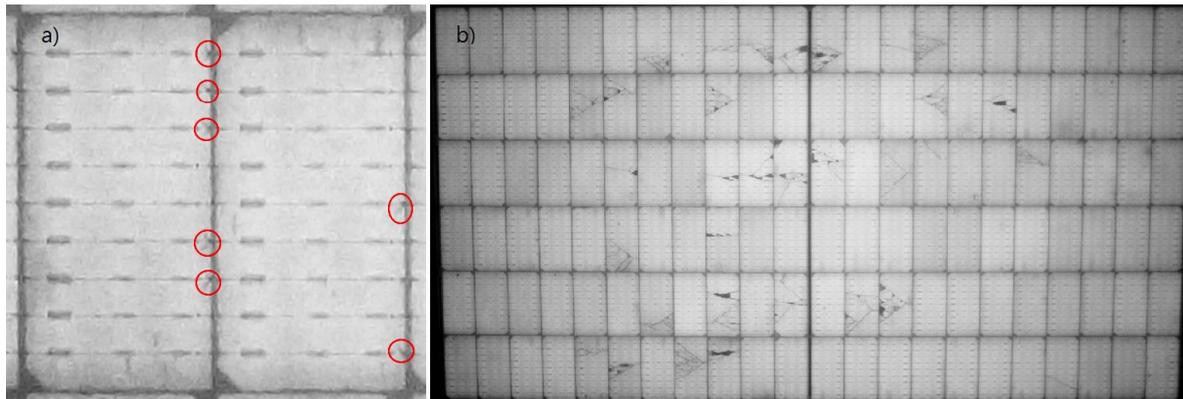
Figure 2: a) Cracks induced at the edge of laser cutting during module production. b) The cell cracks appeared after transportation while they were not seen in the final EL inspection in the module production line. The current inactive cell areas are below 5% per cell.

Figure 2 a) shows that small cracks induced at the cut edge may already exist after production. They are ignored at this stage but frequently grow into dendritic cracks during transportation and installation, as well as mechanical loads and temperature variations that may occur in the field. Figure 2 b) shows the electroluminescence (EL) image of one of these glass/backsheet modules tested on arrival at the installation site.

The same batch of modules was delivered to two different sites and an EL inspection of 50 modules was performed on arrival at each site. The defects are categorised as major defects when dendritic cracks are found, simple branch cracks are categorised as minor defects, and few single cracks are categorised as normal.

At one site the defect rate was 78% major, 18% minor and 4% normal, whereas at the other site the defect rate was 70% major, 30% minor, and no normal modules. Dendritic cracks per cell result only in ~0.2% of power loss in the module. However, this kind of cracks can occur

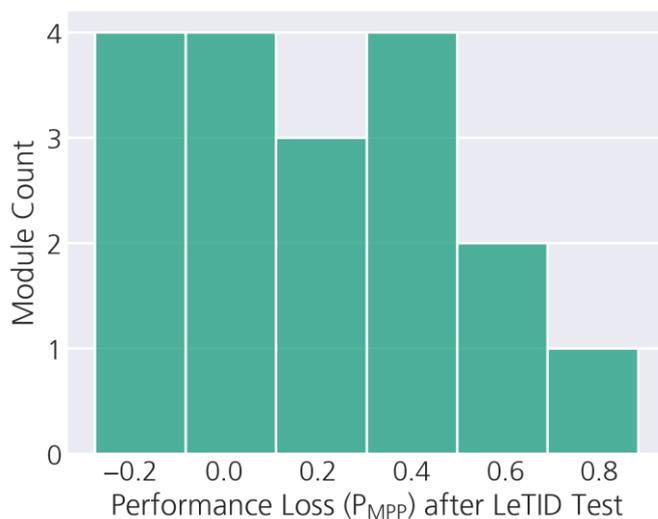
Figure 3: Performance loss (P_{MPP}) of commercial TOPCon modules after 322 hours of LeTID tests [18].

The above-explained reasonings for LID and LeTID have been demonstrated in the following experiment, where a large selection of commercial TOPCon modules was subjected to 322 hours of LeTID tests (IEC TS 63342:2022 for 2×162 h at $I_{SC} - I_{MPP}$) after LID preconditioning (IEC 61215-2:2021 gate 1), see Figure 3. The results show minor effects on the PV module performance.

At PV module and PV system level we expect no detectable degradation from the LeTID effect in current TOPCon modules based on Ga doped p-type wafers.

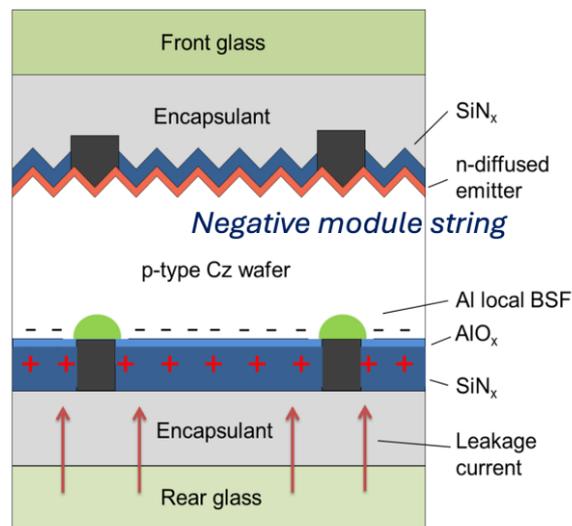
Figure 4: Schematic of the PID-p process in the PERC module rear. The red arrows indicate the motion of current (positive charge) through the encapsulation.

the dielectric stack. That net positive charge developing in the rear increasingly attracts minority carrier electrons in the p-type base towards the rear dielectric, resulting in an increased effective surface recombination velocity, see Figure 4. This mechanism results in a loss of photogenerated carriers, which reduces the photocurrent and the voltage of the cell, especially if the power is measured by light-current-voltage (light- I/V) characteristics from the rear.

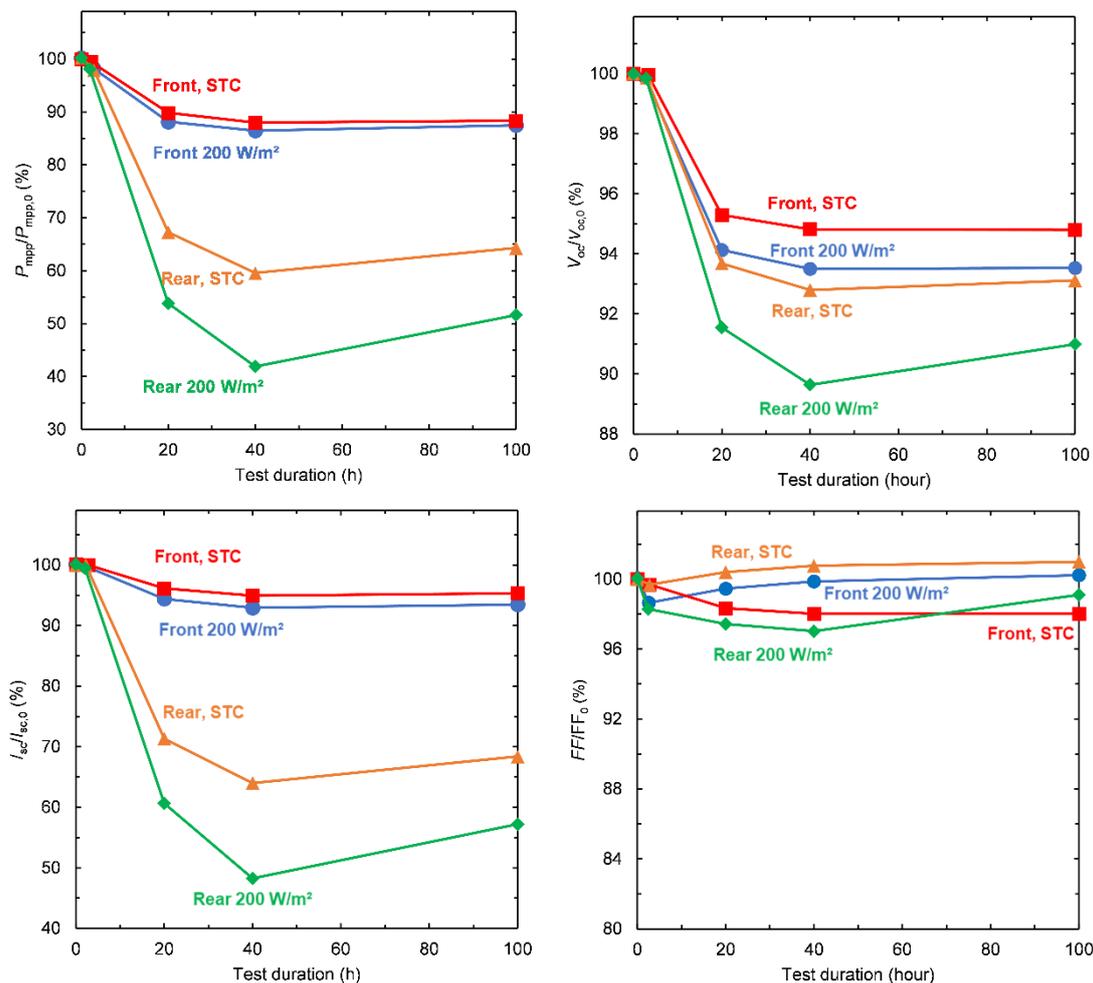
Figure 5: Normalized IV curve parameter of bifacial PERC modules with Ethylene-Vinyl-Acetate (EVA) encapsulant as function of test duration when biased with -1000 V applied to the cells and the rear glass face grounded. The values are obtained by flash testing under standard test conditions (25°C, 1000 W/m²) and under 200 W/m² from the front and rear as indicated in the figures. Values are from the averages of 3 samples. The solid lines are visual guides. The figure is redrawn from Luo et al. [20].

Several studies have demonstrated PID-p degradation under laboratory conditions. Since the rear side of the cell has weak doping and is therefore more sensitive, it has received greater attention in research studies. An example of the degradation magnitude of PID-p when effectuated on the module rear is shown in Figure 5. It can be seen that the degradation magnitude of PID-p is much greater for light $I-V$ testing from the rear than such testing with illumination incident on the front of the module, because the photogenerated carriers are largely generated close to the rear surface where increased recombination takes place. As the stress testing duration increases, a recovery in power output is observed. This is attributed to inversion at the rear surface, where the silicon base effectively becomes n-type [20], [21].

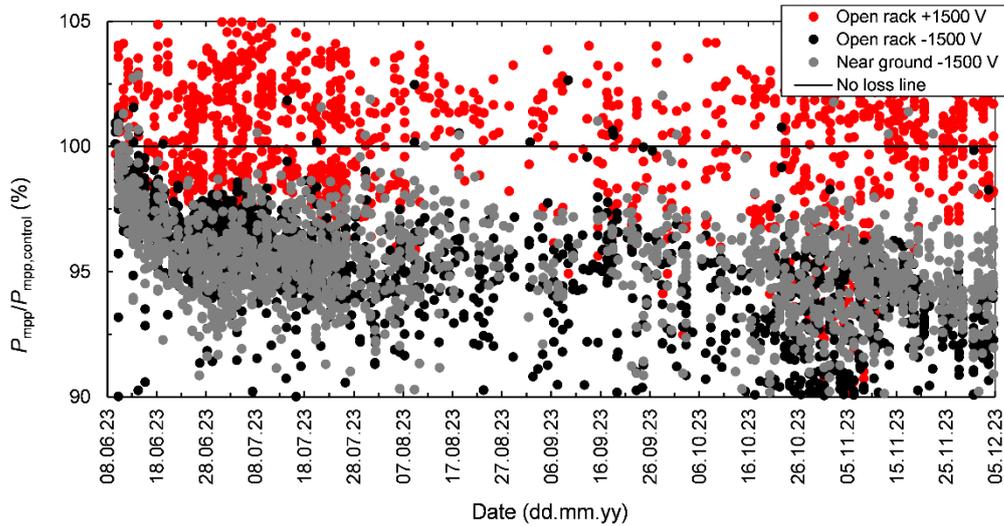
Figure 6: Normalized power to control sample for outdoor PID stress testing of PERC modules on two different racks with +1500 V and -1500 V system voltage between cells and rack in Cocoa, Florida USA (Cfa climate in Köppen Geiger classification 2006). Measured points are assembled from three samples per rack type. The figure is redrawn from Hacke et al. [23].

and with their maximum rated system voltage of -1500 V or +1500 V bias during the day. Modules in open racks, either close to ground or elevated in open racks with -1500 V exhibited PID-p within several weeks whereas modules with +1500 V did not exhibit such degradation, see Figure 6.

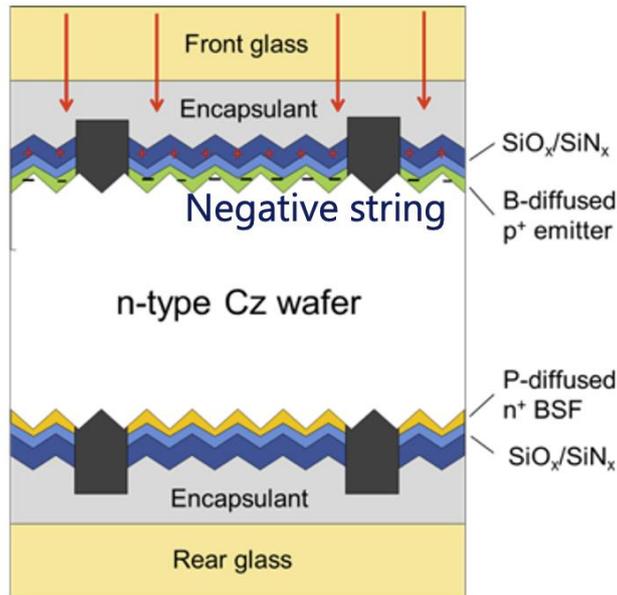
Figure 7: Schematic of the PID-p process in one manifestation of the PERT module front (the front ARC stack may differ, including with the use of AlO_x). The red arrows indicate the motion of current (positive charge) through the encapsulation. The mechanism is the same for the TOPCon front (which has an $\text{SiO}_x/\text{n-type polysilicon}/\text{SiN}_x$ rear side instead of what is shown here for a PERT module).

These cell types have significantly evolved over time. For example, the PERT type which came on the market earlier in time, tended to have SiN_x/SiO₂ front passivation stacks. Later module types added AlOx films to the stack, which have a built-in negative charge. This charge repels minority carrier electrons in the emitter, reducing sensitivity to PID-p [30].

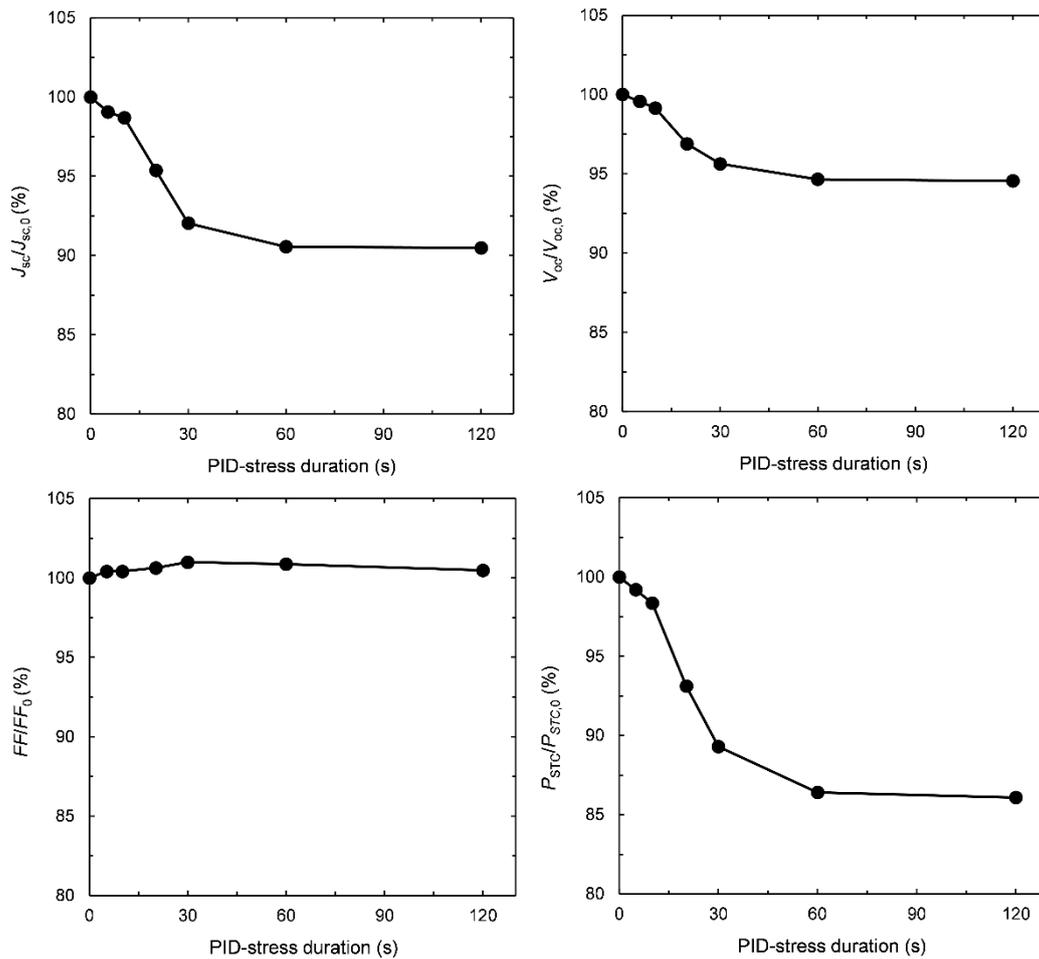
Figure 8: Change of $J_{sc}/J_{sc,0}$, $V_{oc}/V_{oc,0}$, FF/FF_0 , and $P_{mpp}/P_{mpp,0}$ of n-type c-Si PERT single cell modules as function of the duration of PID stress. The voltage bias and temperature in the PID tests are set to -1000 V and 85°C , respectively. The data points represent the mean values of three identical single cell modules and the solid lines are visual guides. The figure is redrawn from Yamaguchi et al. [31].

For PERT cell modules, there are several studies where extremely rapid degradation has been measured; for example, in the dark [31], and while varying the level of full spectrum illumination and encapsulant resistivity [32]. Figure 8 shows the relative degradation in cell parameters as PID-p occurs. PID-p in the case of a single cell consists of the loss in open-circuit voltage (V_{OC}) and short circuit current (I_{SC}), but a negligible change in fill factor (FF). Overall, this results in the loss of maximum power (P_{mpp}).

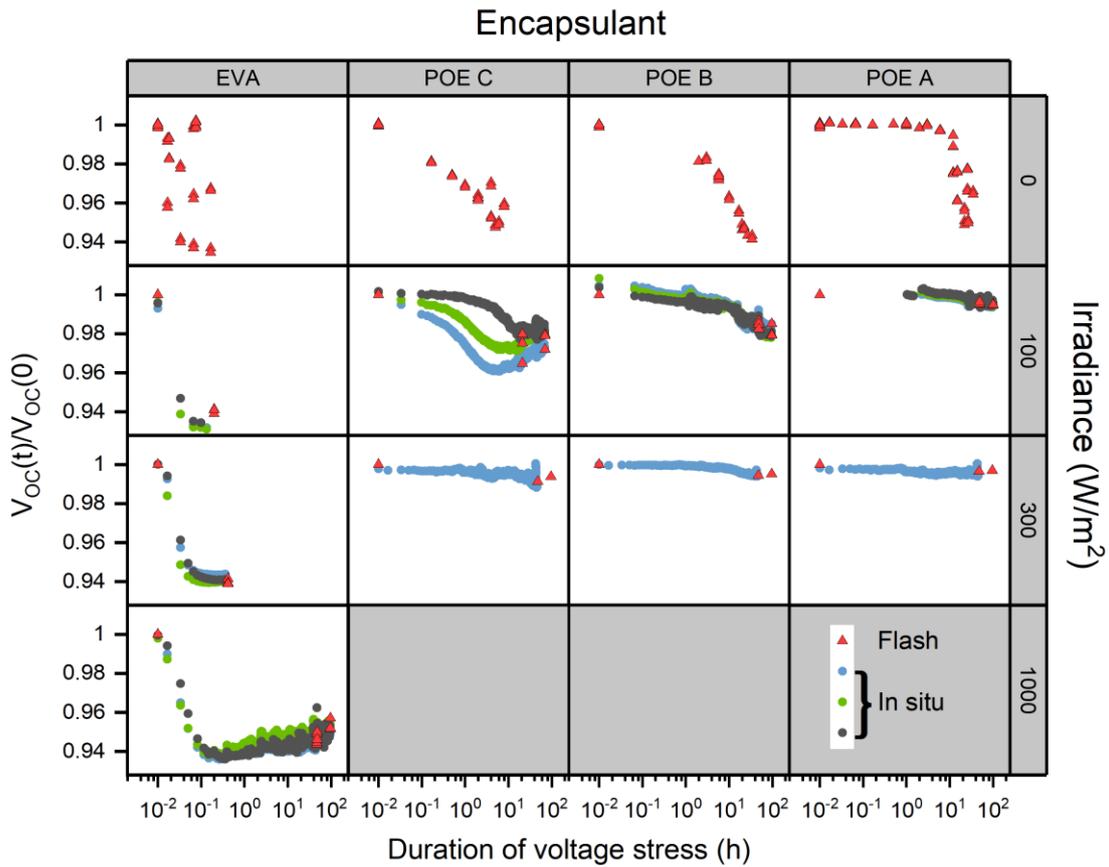
Figure 9: Normalised VOC of PERT single cell mini modules, measured via flash testing (triangles) and in situ (circles) during PID testing. Different coloured circles mark in situ measurements that were taken on each of three samples running at the respective illumination level. Thereby, 60°C and -1000 V were applied to the cells and the front glass face grounded. Resistivity in $\Omega \cdot \text{cm}$ for the encapsulant Polyolefin elastomer (POE) A 1.2×10^{16} , POE B 3.8×10^{14} , POE C 8.5×10^{13} , and EVA 1.1×10^{13} [32].

High resistivity encapsulants and the generally high level of front side radiation reduce PID-p effects for PERT and TOPCon solar modules. Figure 9 shows how increased levels of the encapsulant resistivity and illumination with the module surface maintained wet lead to a reduction of PID-p. In these modules the degradation occurs regardless of the irradiation using this low resistivity EVA encapsulant. Conversely, even the most resistant encapsulations will exhibit PID-p if they are kept under voltage stress in the dark for long enough.

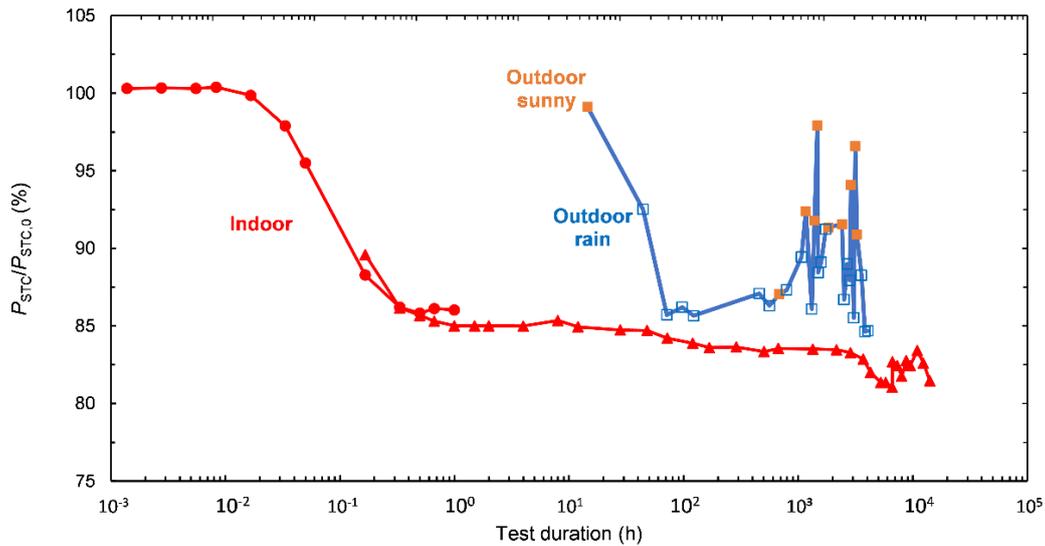
Figure 10: Normalized STC power to initial values of PERT PV modules as a function of the indoor (red) and outdoor (blue/orange) PID test duration at a voltage of -115 V. At the 10 h point indoor testing the slope suddenly changes indicating a shift from PID-p mode to PID-shunting mode. The open blue and filled orange square data points indicate the results for the outdoor PID test in or just after rainy and sunny days, respectively. The figure is redrawn from Ohdaira et al. [33].

For PERT modules tested outdoors, it has been reported that degradation occurs during periods of wet weather, when the module surface becomes conductive and facilitates coulombic charge transfer across the glass between the cell circuit and the ground, while there is a lack of full sunlight. However, after periods of sunny weather, the power of the modules is at least partially restored, see Figure 10.

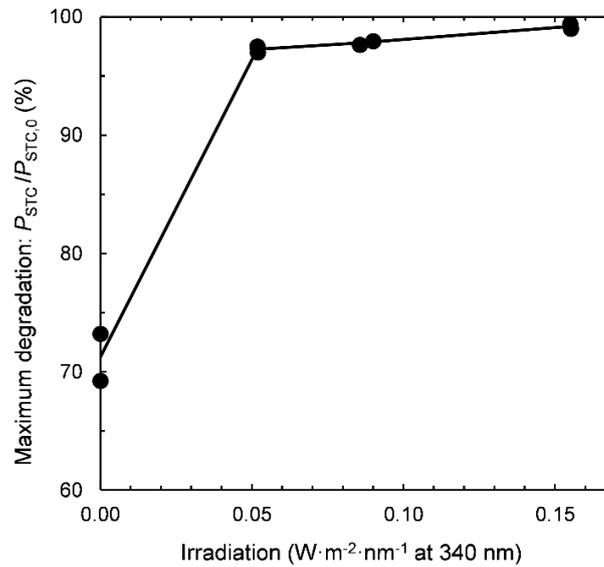
Figure 11: Normalized STC power P_{STC} relative to initial STC power $P_{\text{STC},0}$, observed with -1000 V applied at 60°C over a period of 96 h versus simultaneously applied UVA irradiance level at 340 nm. For reference, Air Mass 1.5 global spectrum according to ASTM G173-03 contains 0.502 $\text{W}\cdot\text{m}^{-2}\cdot\text{nm}^{-1}$ at 340 nm. Two repetitions were performed per irradiance level shown with markers (\bullet). The figure is redrawn from Hacke et al. [25].

TOPCon modules with EVA encapsulation show a maximum of $\sim 3\%$ PID p-front degradation with -1000 V applied to the solar cells and the glass rear face with the front glass face grounded in a test setup for the polarisation of the p+/n front structure over 96 hours in humid and cloudy (~ 0.1 sun) weather. However, under 0.1-sun-equivalent level with UVA illumination corresponding to $0.051 \text{ W}\cdot\text{m}^{-2} \text{ nm}^{-1}$ at 340 nm, they show progressively less degradation, see Figure 11. The cell rear side did not show any PID effect in that study [25].

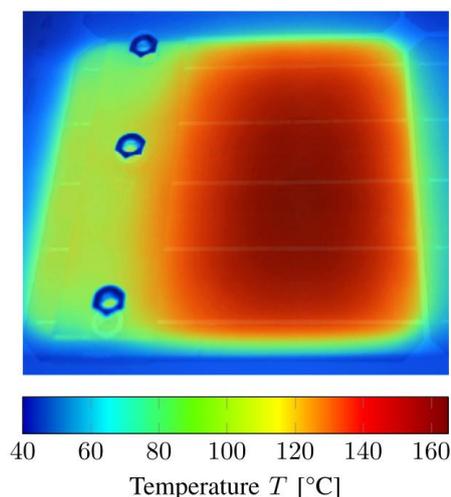
Figure 12: Temperature distribution of a partially shaded cell during the IEC 61215-2 MQT 09 Hot-spot endurance test [28], [35]. The shadow mask is shading the cell with a 4 cm wide cover strip.

Cell cracking or shading of PV modules can cause current mismatch and reverse bias voltages in underperforming solar cells, causing the cells to dissipate power and generate heat. The difference between the well-known hot spot and the hot cell effect is that the hot spot is mainly associated with multicrystalline silicon solar cells and causes localised heat generation (local junction breakdown), whereas the hot cell is associated with monocrystalline silicon solar cells and causes a homogeneous temperature rise throughout the cell area [34]–[36], see Figure 12. The most important junction breakdown mechanism in monocrystalline silicon solar cells is avalanche breakdown, which occurs at reverse bias voltages below -20 V for PERC cells [37] and even more negative for TOPCon, SHJ, and possibly for MHP/Si tandem [36]. A hot cell can cause heating above the typical module operating temperature of 50°C - 70°C, reaching temperatures above the highest module's lamination temperature of 150°C.

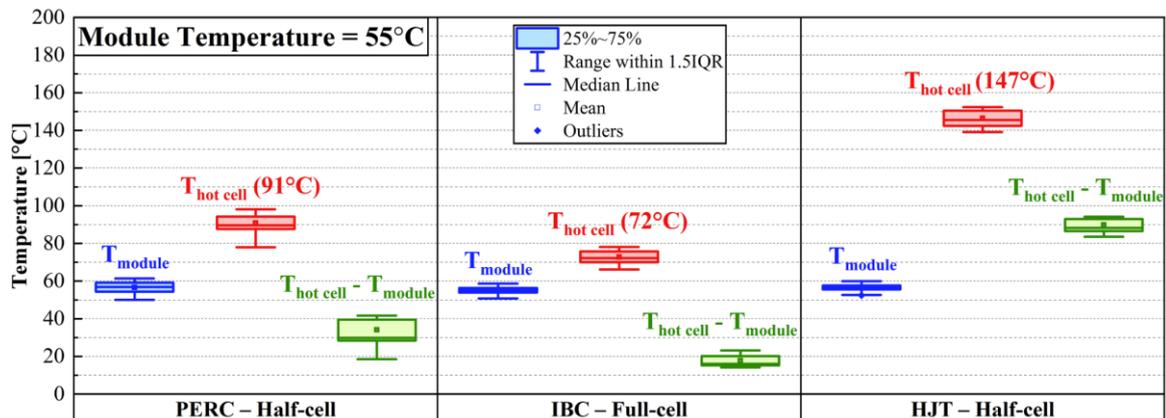
Figure 13: Module and hot cell temperatures of PERC - half-cell 365 W_p , IBC - half-cell 400 W_p and SHJ - half-cell 375 W_p modules from indoor hot spot tests performed at 55°C module temperature by following IEC 61215-2:2021 [28], [48].

In Interdigitated Back Contact (IBC) solar cells, the p^+ and n^+ regions can be designed to be in direct contact with each other, resulting in the formation of a Zener diode that functions as a built-in BPD and significantly lowers the breakdown voltage ($> -5\text{ V}$) of the cell [49], [50]. As shown in [48], during the indoor hot-spot test, the hot cell temperature of the IBC module was at most 25°C higher than the module temperature. Moreover, it was significantly lower than the temperature of the PERC and SHJ module technologies under the same conditions, see Figure 13.

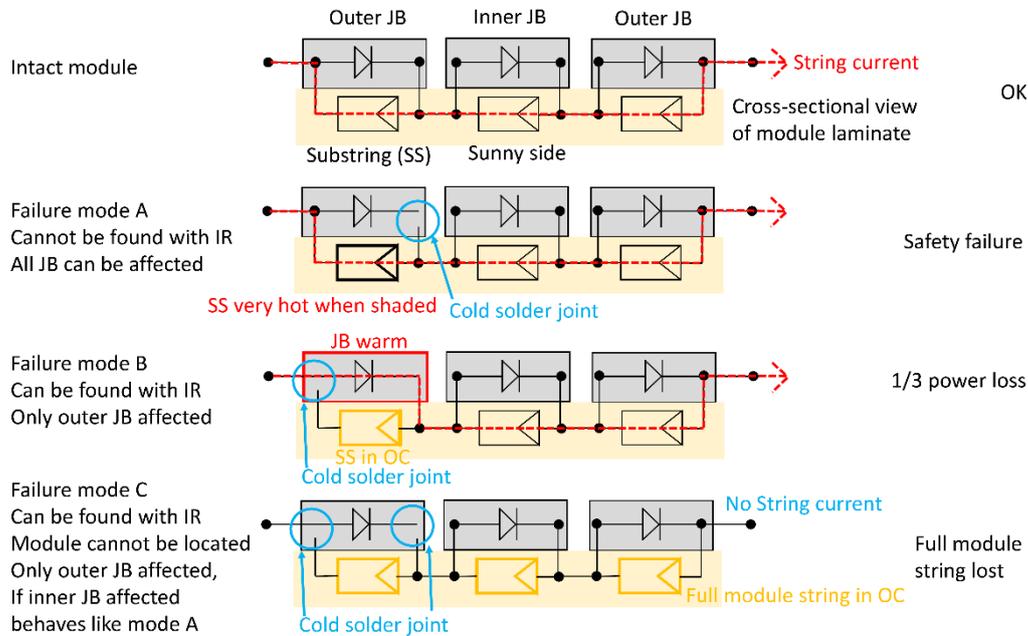
Figure 14: Failure modes of unreliable connections in separated junction boxes. Open-circuit (OC) substrings or module strings appear 5-10 K hotter in IRT inspection compared to active strings.

However, having a mixture of failure modes A and B in a fleet of modules indicates that a cold solder joint is the cause of the defect.

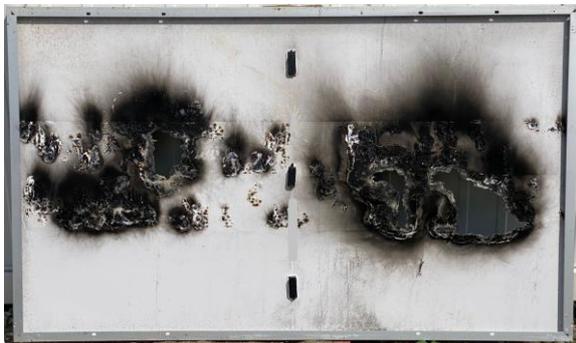
Figure 15: Rear side of TOPCon PV module with failure mode A being shaded by natural obstacles. Module has already been dismantled from the mounting rack.

However, as long as the likelihood of a cold solder joint is low, a combination of different failures in the same module is very unlikely. Failure mode A can occur at four different solder joints. Two of four solder joints are in the middle sub-string. Failure mode B can occur at two possible joints, whereas failure mode C needs two joints failing in parallel. Therefore, failure mode A occurs at least double as likely as failure mode B. Failure mode A cannot be detected by infrared thermography (IRT) inspection, but failure mode B and C can. This means that if failure mode B or even C is present, failure mode A is very likely to occur at a rate at least twice as high as that of failure mode B. However, without shade on the modules failure mode A will stay without notice. A shaded module with failure mode A can heat up very quickly (within seconds) and may char or even burn. The danger rises if the module is shaded at high irradiation level or if the shade is applied for many seconds. Figure 15 shows a high power TOPCon module with failure mode A after being shaded in a long module string. To find mode A failure or open BPD, a string wise BPD test at night is useful. Measure the reverse bias voltage achieved in the string when 3% to 5% of rated I_{sc} is applied. If a string with extraordinarily high reverse voltage is found, search for some Kelvin warmed up sub-string with night infra inspection to locate PV modules with mode A failure or open BPD, see Figure 16.

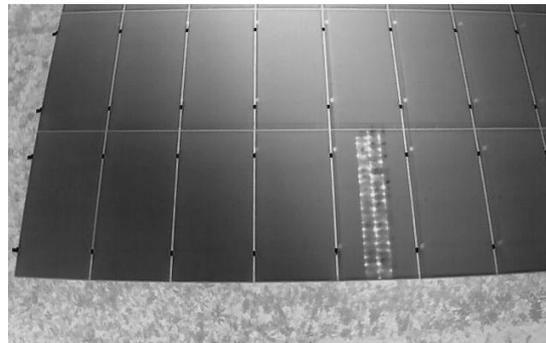
Figure 16: Not connected BPDs found by night IRT inspection while applying string wise reverse voltage with 3%-5% of rated I_{SC} . Image: photovoltaikbuero Ternus & Diehl GbR.

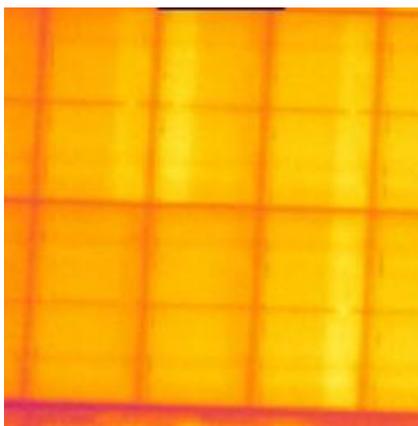
Figure 17: IRT of OC substrings resulting from an unstable connection of the outer junction box. Failure mode B can happen only in the outer junction boxes. Current flows through diode of outer junction box.

A cold solder joint usually appears in a certain percentage of modules in the production because the problem is typically the same for the whole batch of modules. Figure 17 shows the IRT image of multiple modules with failure mode B, with OC substrings resulting from cold solder joints in the outer junction box. It is frequently observed that this unstable connection appears for a small percentage of modules from the same production batch.

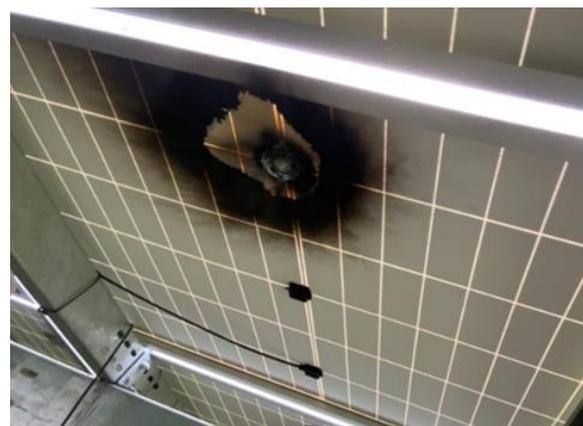
Figure 18: Module with burnt junction box resulting from unstable connection in the junction box.

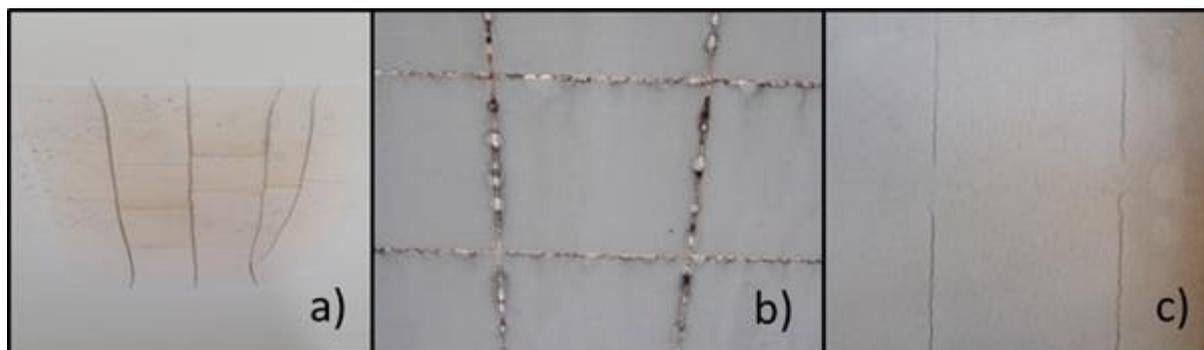
Figure 19: Backsheet crack types. a) cracked backsheet beneath a hot cell/temperature induced crack. b) squared cracks beneath cell interspaces; thermo-mechanical induced crack combined with photo-oxidative degradation. c) longitudinal cracks located beneath busbars; thermo-mechanical stress induced crack [69].

Various types of backsheet cracking can be distinguished [69], [77], [78] and are described in sections 2.5.1.- 2.5.3.

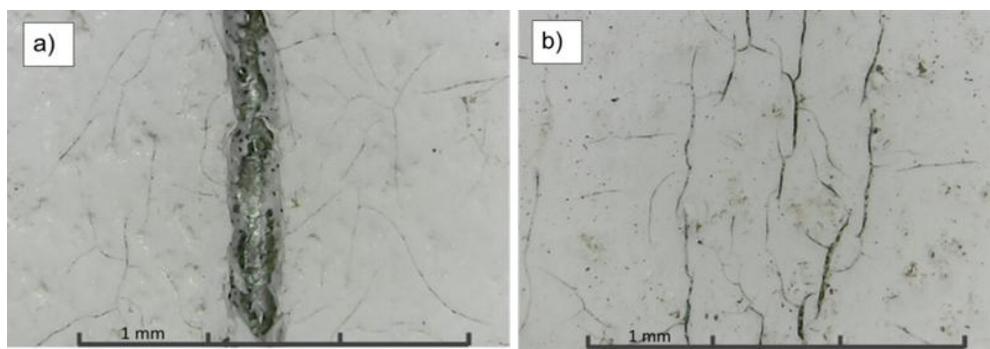
Figure 20: Light microscopic images of (a) longitudinal cracks (whole backsheet is disrupted) and (b) surface near microcracks [69].

UV photons can open chemical bonds at a surface and the open bonds subsequently react with oxygen leading to degradation and discoloration of the material. This process is called photo-oxidative degradation. Surface weathering can lead to photo-oxidative degradation of the outer backsheet layer, resulting in decomposition of the polymer and release of the inorganic filler (=chalking), see Figure 20 b). The root cause for cracking type I is insufficient weathering stability of the individual outer layer of the backsheet, e.g. missing or lack of UV-stabilisation, which can happen with different types of backsheets which have polymeric outer layers prone to photo-oxidative degradation, e.g. PA or PO. Chalking of the backsheet has no direct impact on module reliability or the performance of the PV system. However, in some cases, chalking can be an initial indication of later microcracking which in the long term could evolve on deep cracking, see Figure 20 a) and b).

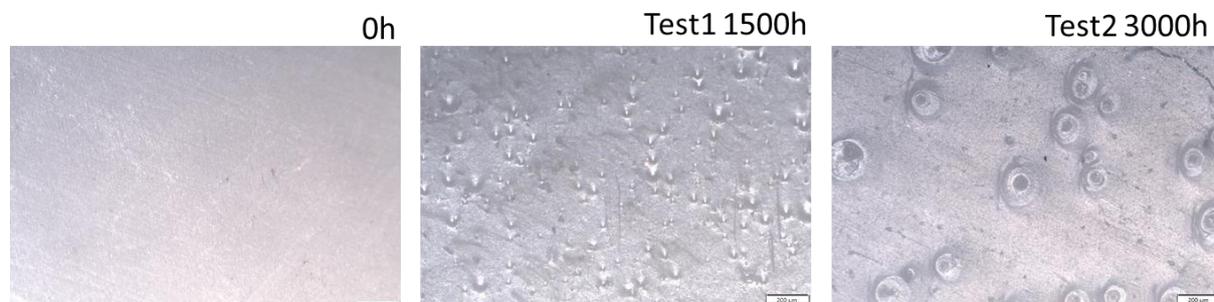
Figure 22: Detached surface of the PO encapsulant from the glass in the original state 0 hours and after two types of accelerated ageing tests. Test1: constant Xe-irradiation at 1000 W/m² at elevated temperature (chamber 65°C, PV module 96°C) and humidity (80%r.H.). Test2: sequential (i) 500 hours DH, (ii) 50 temperature cycles and (iii) 200 hours Xe-irradiation at 1000 W/m², 3 sequences.

Also, PV modules with PO encapsulants and Tedlar backsheets may show adhesion problems, since the adhesion of the encapsulant to the glass may deteriorate under accelerated aging, especially in areas without cells underneath (e.g., edge areas and cell gaps). Furthermore, light microscopy images show deposition of substances at the glass/polymer interface, see Figure 22. Na⁺-ions were detected at the depositions on the detached surface of the encapsulant by X-ray diffraction (XRD) and carboxylic groups were found by Infrared-spectroscopy. Thus, migration of an unwanted carbon acid or ester from the backsheet to the encapsulant/glass interface took place, weakening the adhesion.

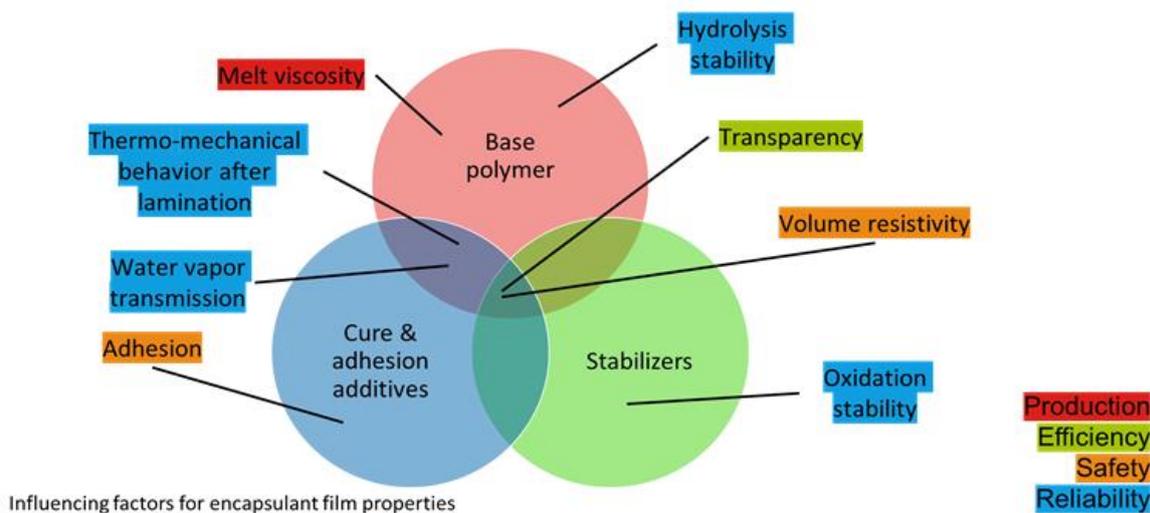
Figure 23: Influencing factors for encapsulant film properties [99].

The most recent developments resulted in the market introduction of so-called EPE films, which are co-extruded films combining the benefits of EVA (E) and POE (P). The outer EVA layers provide better adhesion to glass and the solar cells, whereas the POE core layer provides lower WVTR values. However, as of September 2024, only one publication about the properties of modules using EPE films [100] and no publications on long-term outdoor behaviour are available. Yang et al. reported excellent stability of the EPE film after exposure to different accelerated test conditions [100].

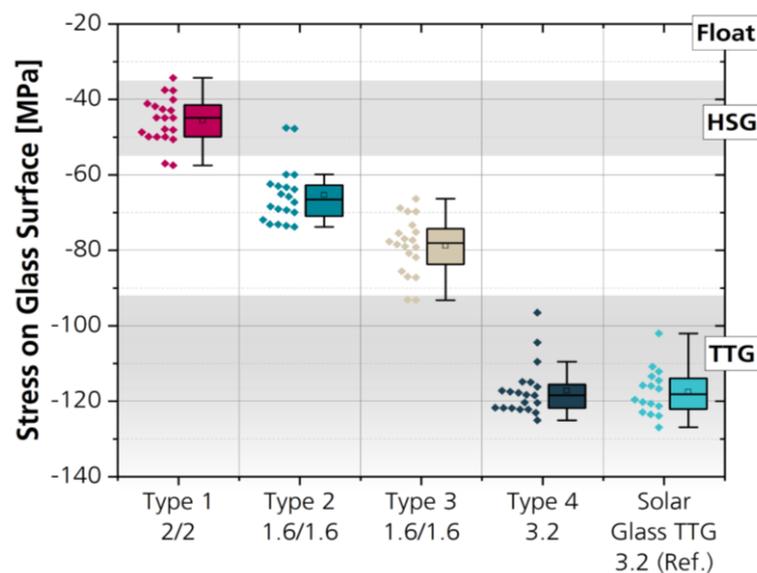
Figure 24: Results of SCALP measurements on the front glass of PV modules, revealing the surface stress [110]. The grey shaded areas characterise the typical compressive stress level for production methods of Heat Strengthened Glass (HSG) and Thermally Toughened safety Glass (TTG).

As the root cause of the glass cracking is not known yet, new measurement/testing techniques for characterising the compressive stress of the glass surface are needed. One attempt to measure this characteristic is to use a SCALP-05 [109]. This device couples a laser into the glass, where the present stress causes a rotation of the polarization plane. This, in turn, reduces the scattering intensity orthogonal to the initial polarization plane, which can be detected perpendicularly to the initial beam. As a result, the surface stress of the glass in the module compound can be measured. Figure 24 shows results of PV modules with different glass thicknesses, where significantly different glass surface stress levels are detected.

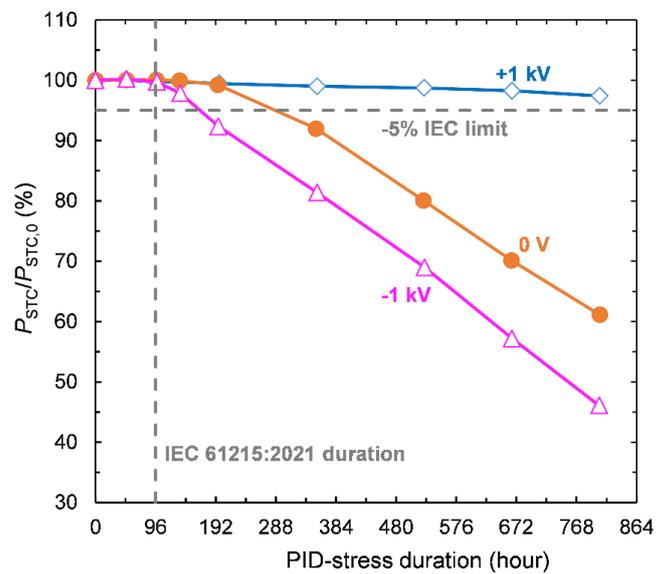
Figure 26: Normalised STC power to initial power of the front-side of SHJ 1-cell glass/glass laminates with EVA, after 800 h of PID testing at 85°C/85% RH for the bias conditions -1 kV, 0 V, and +1 kV. Figure is redrawn from Arruti et al. [134].

Another degradation mode related only to SHJ is studied by Arruti et al. [134]. Arruti et al. have shown that bifacial rear-emitter SHJ solar cells encapsulated in EVA in glass/glass laminates degraded in damp heat (DH) tests. However, DH tests with negative bias applied show a slightly accelerated degradation compared to no voltage applied, see Figure 26. The degradation of the cell under negative bias is shown in the EL images in Figure 27. Modules in positive bias voltage or positive bias voltage with periods of illumination [22] consistently exhibit no degradation during the DH test. The prerequisite for degradation is explained by molecular NaOH from the glass either diffusing through the EVA, which has absorbed moisture, or by Na^+ ions drifting due to the electric field when a negative bias is applied to the cell circuit. Furthermore, with positive bias applied to the cell circuit, apparently Na^+ ions are driven away from the cell and therefore no degradation is observed. In the study by Arruti et al., the sensitivity to migrating Na^+ seemed to be greater on cell fronts than on the rear side [134].

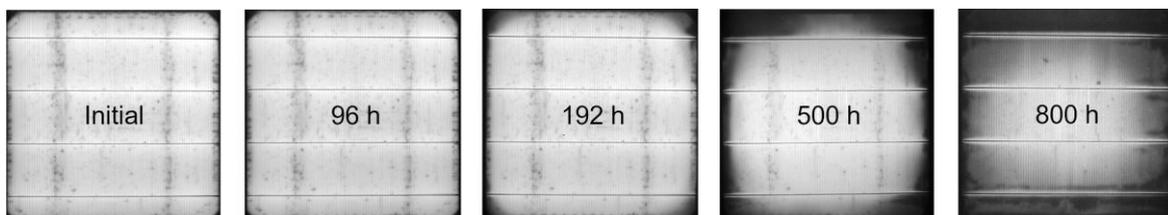
Figure 27: EL images of SHJ glass/glass mini-modules with EVA subjected to PID testing at 85°C, 85% RH and -1 kV bias for up to 800 h. EL images show that degradation starts at the edges of the cell, gradually expanding inward, associated with moisture ingress facilitating Na^+ transport [134].

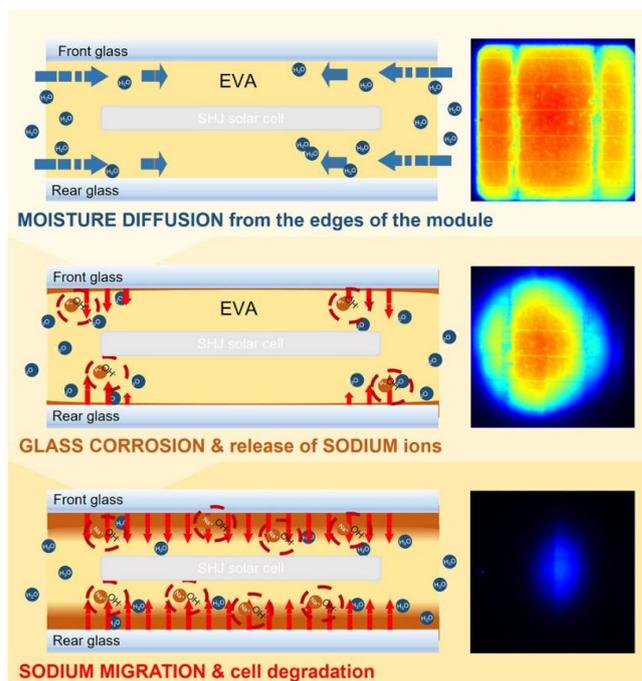
Figure 28: Left: physical model explaining the sensitivity of SHJ to water. The observed degradation mechanism is specific to the SHJ technology [135]. Right: Photoluminescence image of one SHJ cell glass/glass laminate taken at 0 h, 500 h and 1000 h of DH testing.

The mechanisms of moisture damage are multifaceted, and have recently been explained by a corrosion mechanism, see Figure 28 [135]. The adoption of encapsulants with a relatively high water-uptake, such as EVA, favours a corrosion reaction of the glass cover(s) releasing Na^+ ions that, in combination with water, form molecular NaOH . Na^+ ions can diffuse through the grain boundaries of the indium tin oxide (ITO), reaching either the front or rear hydrogenated amorphous silicon (a-Si:H)/c-Si interface creating recombination centres for charge carriers, see Figure 29.

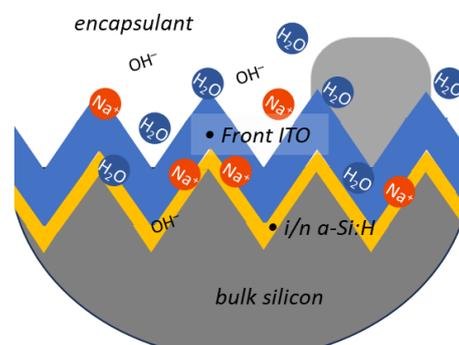
Figure 29: Schematic of the microscopic model proposed to explain the sensitivity to water of SHJ cells encapsulated in a glass/glass structure with EVA encapsulant. Na^+ and OH^- ions cross the ITO and degrade the passivation layer at the a-Si:H/bulk Si interface. Adapted from [135].
