Assessment of Photovoltaic Module Failures in the Field

Report IEA-PVPS T13-09:2017

IEA PVPS Task 13, Subtask 3
Report IEA-PVPS T13-09:2017
May 2017

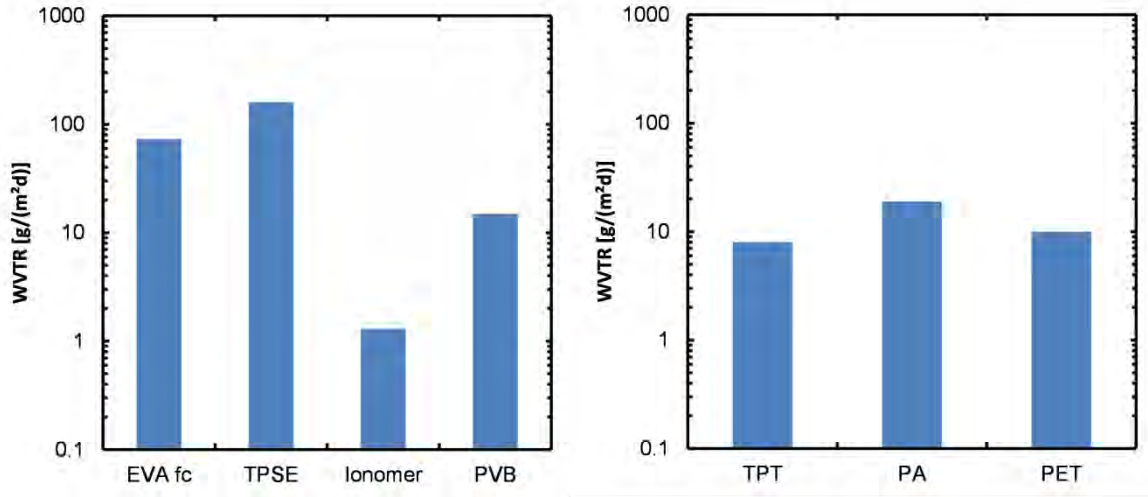
Fig. 2: Water vapour transmission rate (WVTR) through encapsulants, ethylene vinyl acetate (EVA), thermo-plastic silicone elastomer (TPSE), an ionomer, and polyvinyl butyral (PVB), and through backsheets Tedlar-polyester-Tedlar (TPT) foil, a polyamide (PA) sheet, and a polyethylene terephthalate (PET) composite films. Adapted from [16].

Relative water vapour transmission rates are needed to understand the environment within a PV module. With the exception of the ionomer encapsulant, it can be seen in Fig. 2 that moisture generally transmits much more rapidly through encapsulants than through backsheets when measured at 85°C [16].

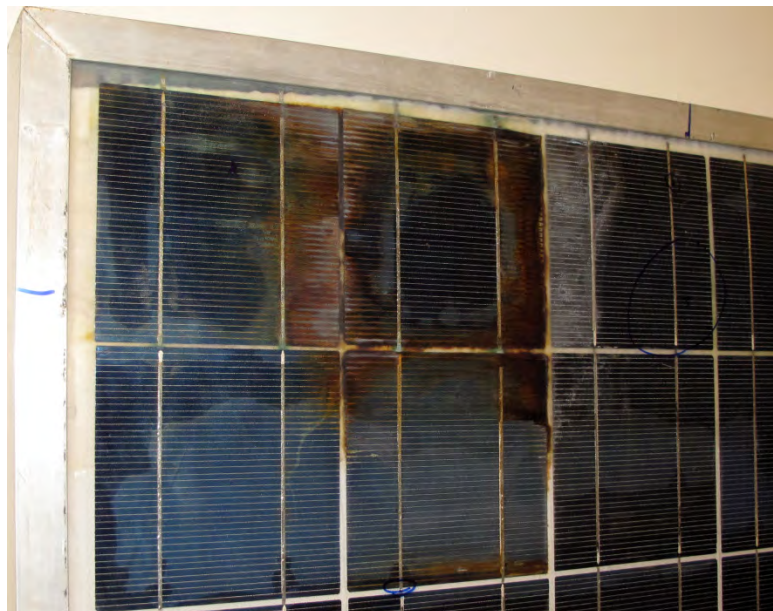
Fig. 4: Glass/glass module with specific ionomer encapsulant type that has proven to have insufficient adhesion, showing delamination and corrosion.

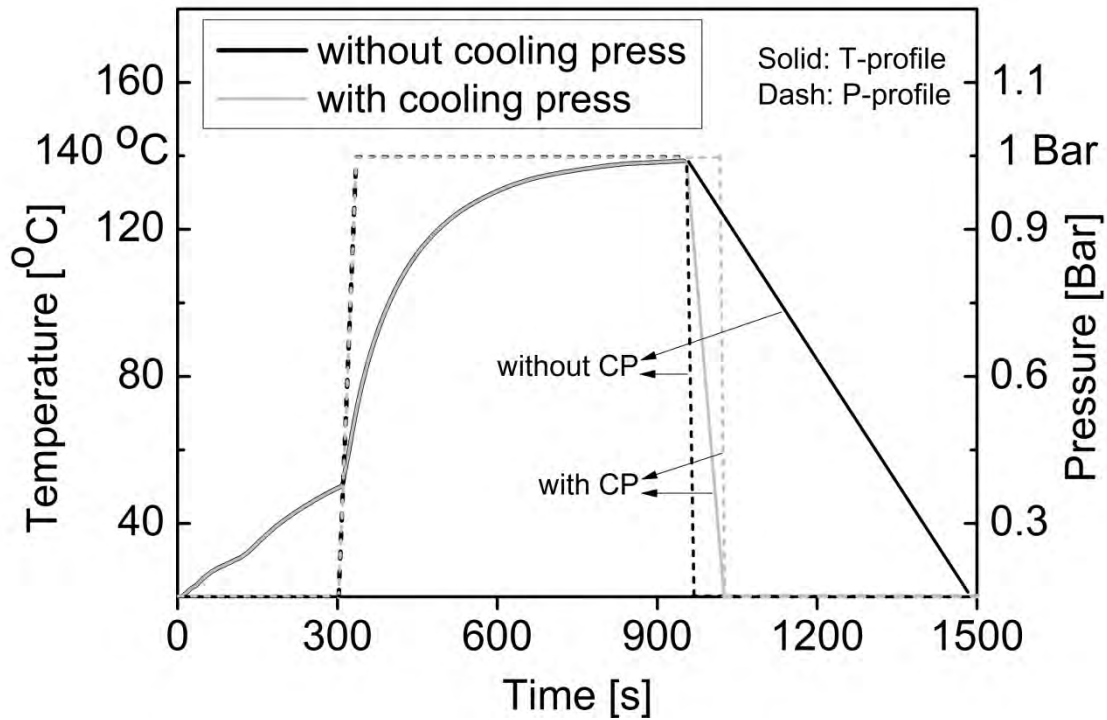
Fig. 6: Temperature and pressure profiles of the EVA encapsulation process of PV modules with cooling in air and accelerated cooling under pressure.

After the curing step, the lower chamber is vented to 1 bar. After that, the module is removed from the curing chamber and cools either uncontrollably in the air or in a controlled cooling press. The temperature - pressure - time (T-P-t) profile of both processes are shown in Fig. 6.

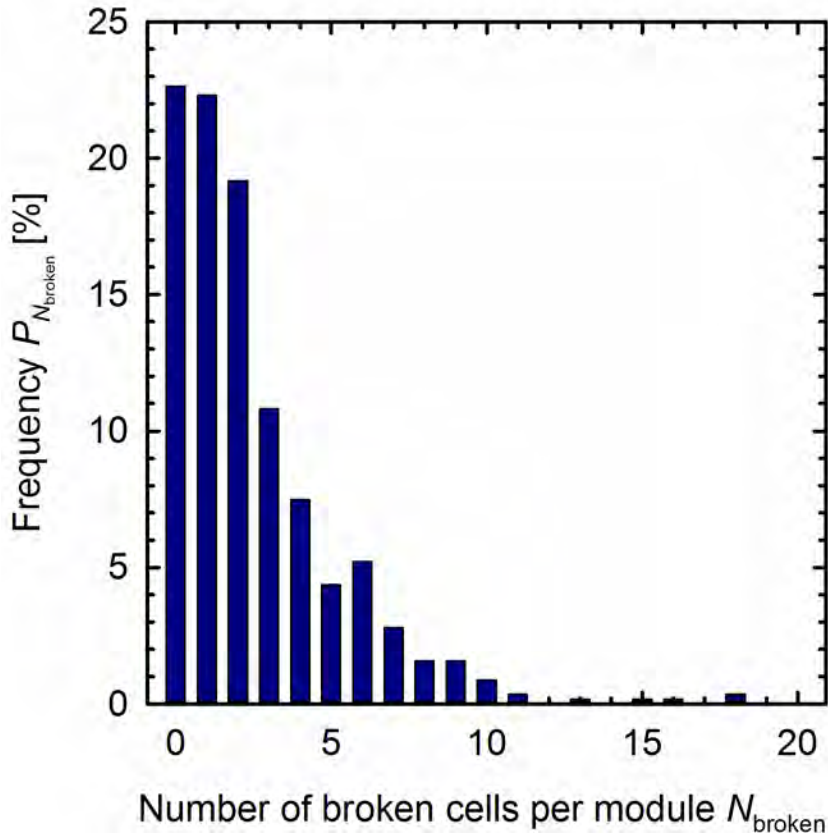
Fig. 10: Typical distribution of cell cracks per module in a PV-system.

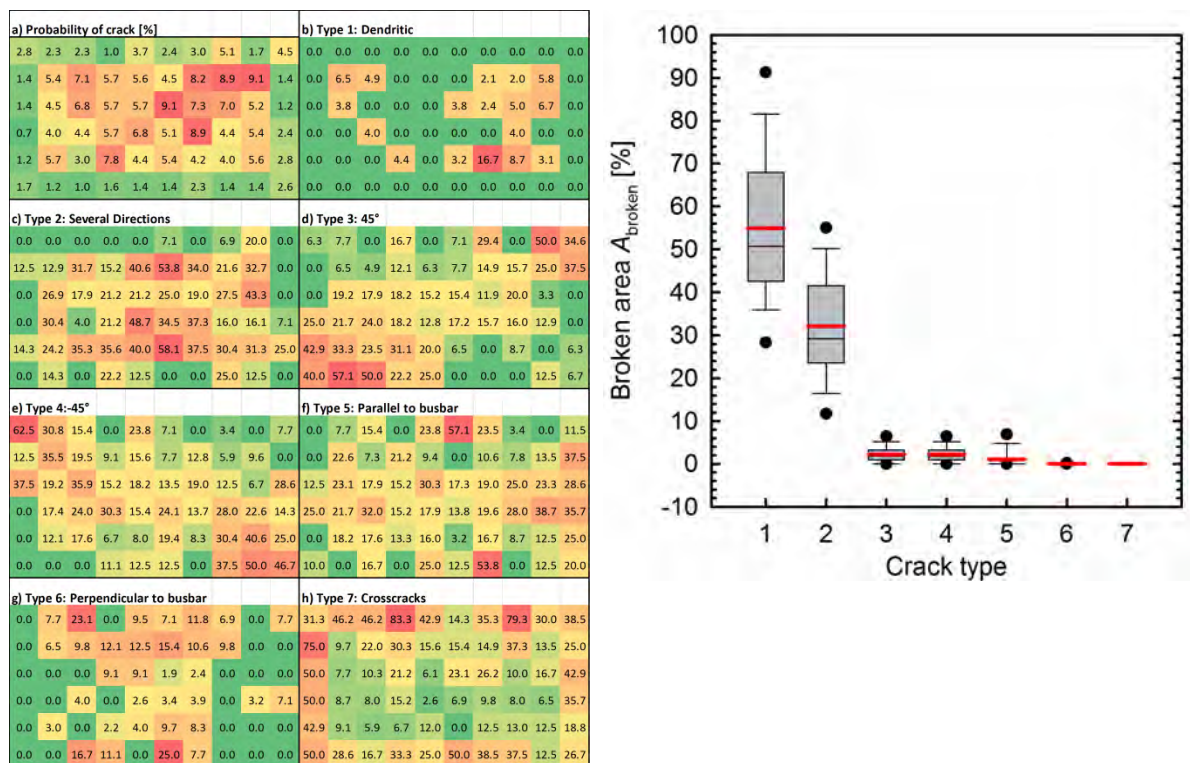
Fig. 11: The distribution of the isolated cell parts is described with these two graphs. The left graph shows the distribution of various cell crack classes over the measured modules. The right graph shows the distribution of the broken area for the seven crack classes.

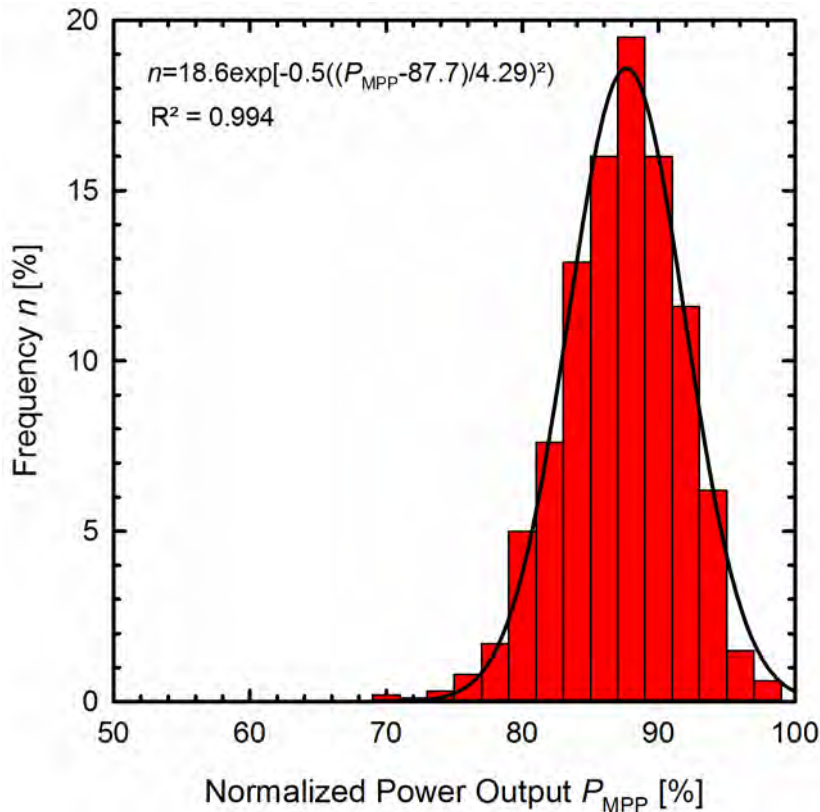
Fig. 12: Power output distribution of PV module strings with cell cracks. The power output is normalized to the power of a defect free string.

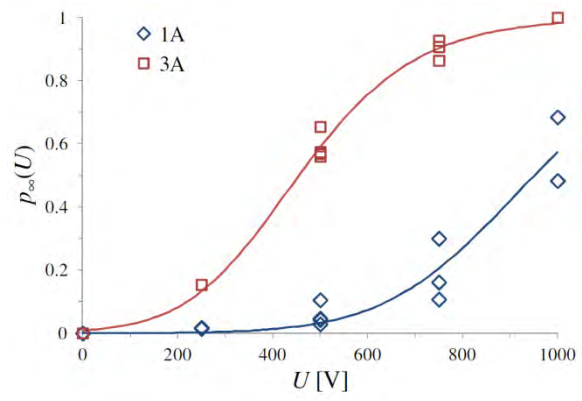
Fig. 14: Final power value as a function of the applied voltage with the module type as parameter. Reprinted from Hattendorf 2012 [131].

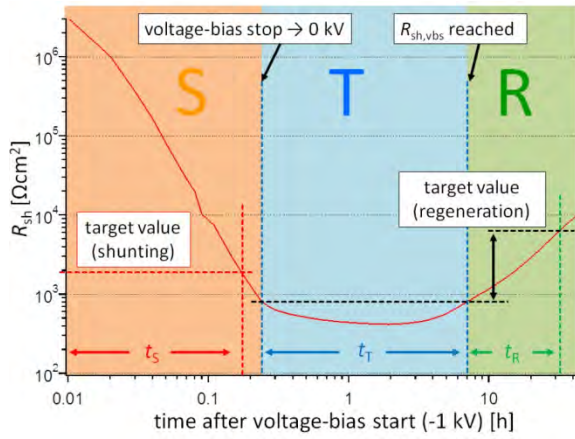
Fig. 17: Evolution of the shunt resistance with sequenced applied voltage. Reprinted from Taubitz 2014 [133].

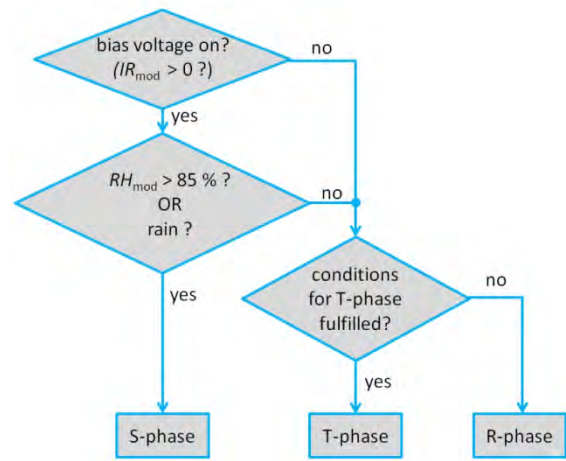
Fig. 18: Phase assignment process. Reprinted from Taubitz 2014 [133].

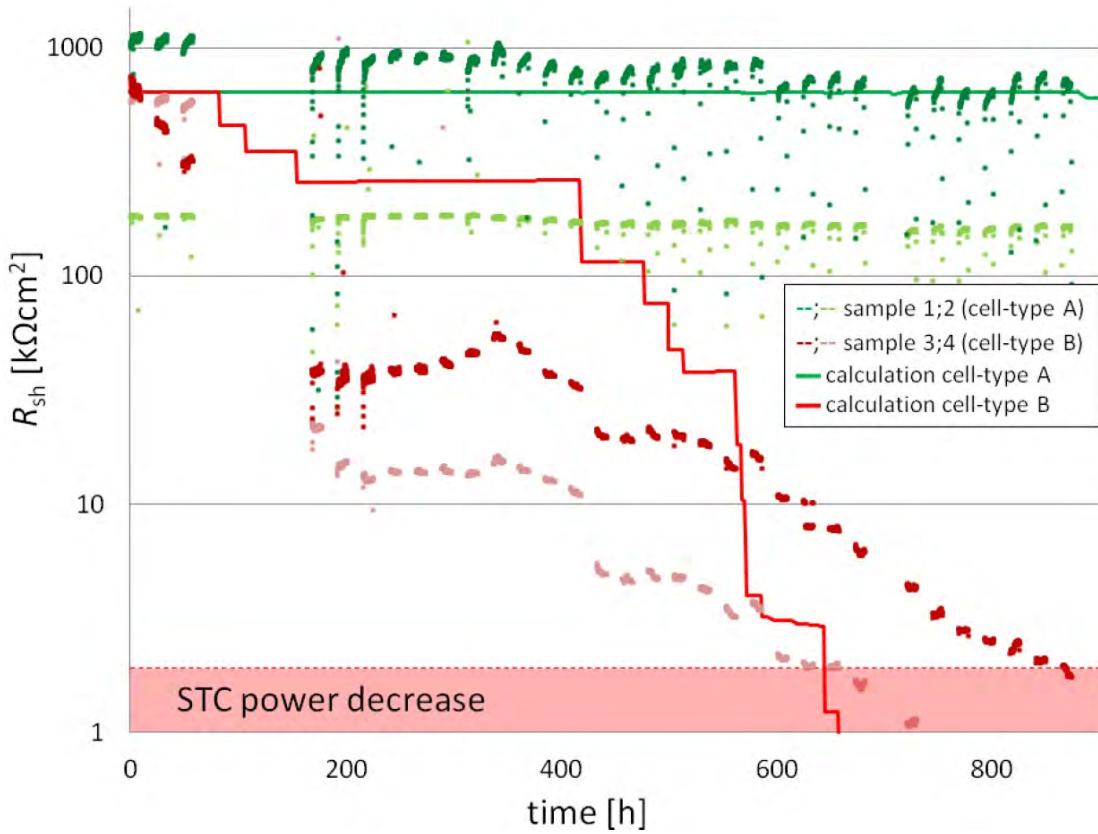
Fig. 19: Measured and modeled R_{sh} evolution. Reprinted from Hacke 2016 [135].

This model has been compared to outdoor experiments with quite a good correlation (Fig. 19).

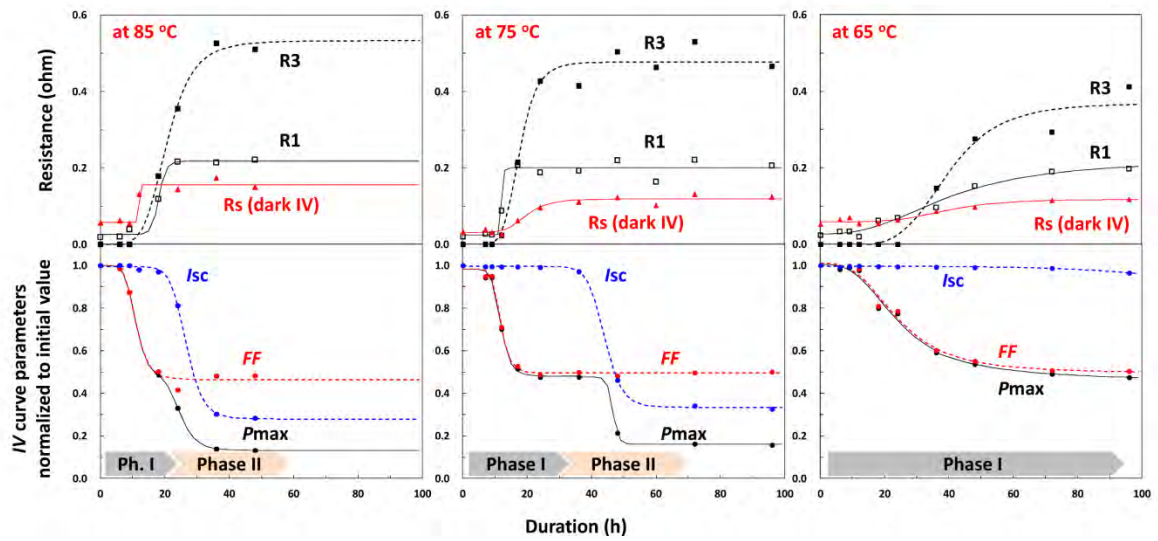
Fig. 24: Phase transition of cell parameter during exposition of PV cells to HAc vapour.

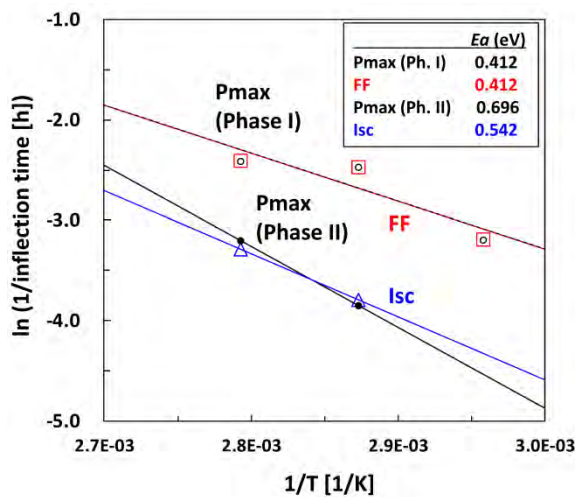
Fig. 25: Arrhenius plot and activation energies for I/V curve parameter during the degradation of PV cells exposed to HAc vapour.

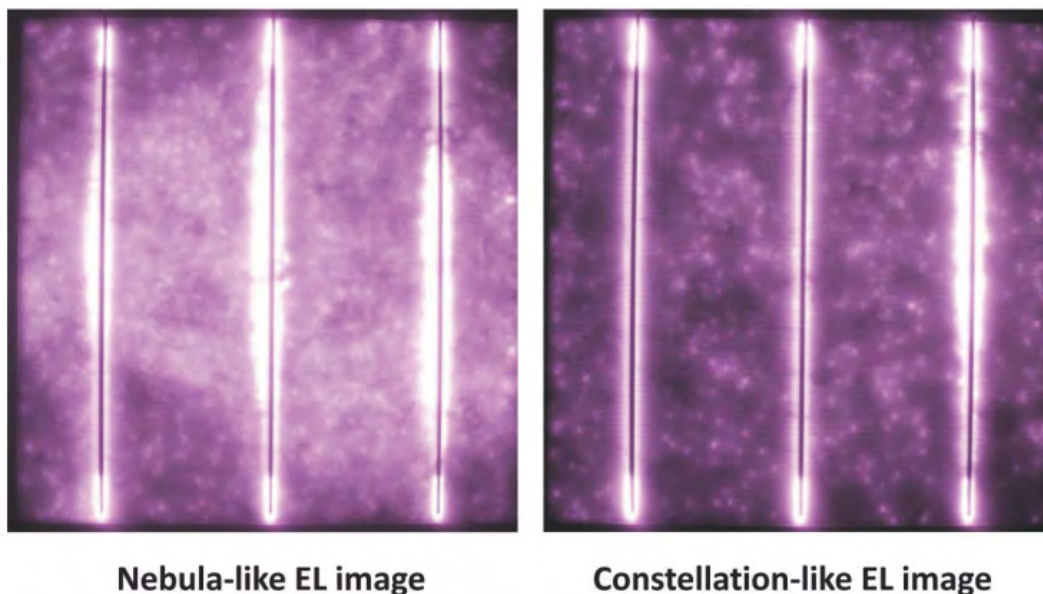
Fig. 27: Evolution of EL image during degradation of PV cells exposed to HAc vapour.

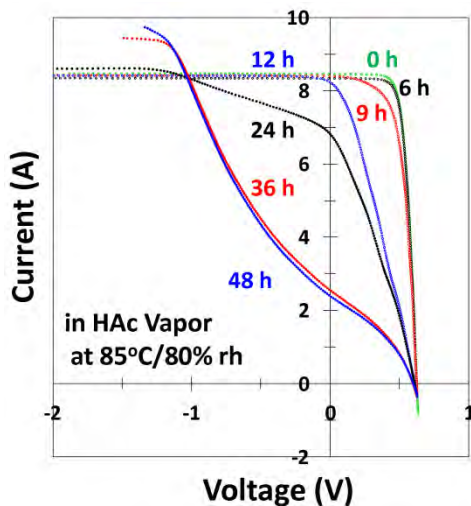
Fig. 29: Evolution of I-V-curve in PV cell exposed to HAc vapour at 85°C/80% rh. The cell starts to lose its diode blocking characteristic in reverse bias after 24 h.

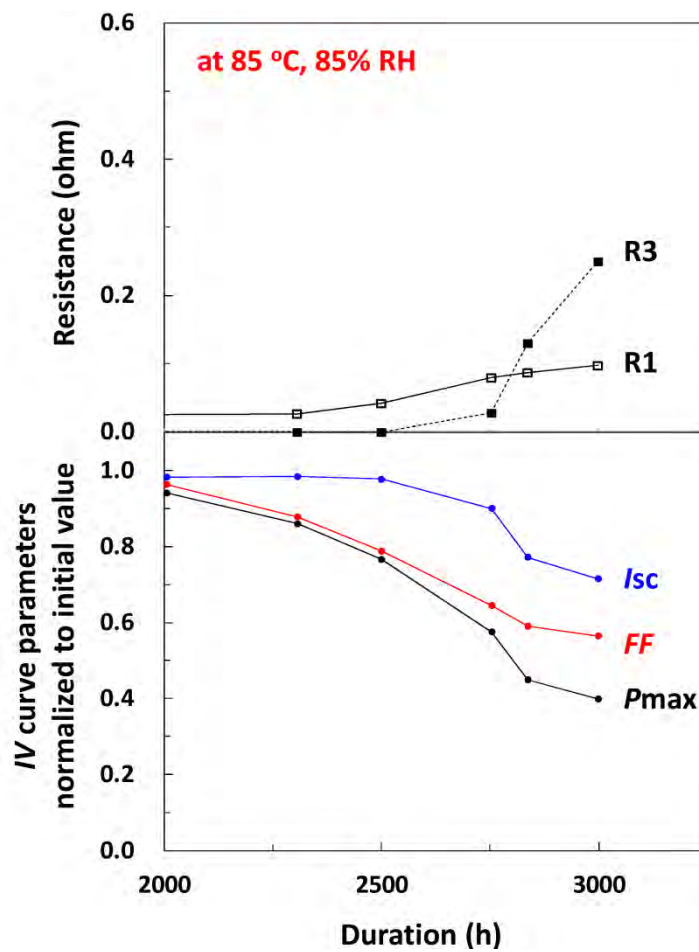
Fig. 31: *IV*-curve and AC impedance parameter of a PV mini-module as function of the damp heat stress duration.

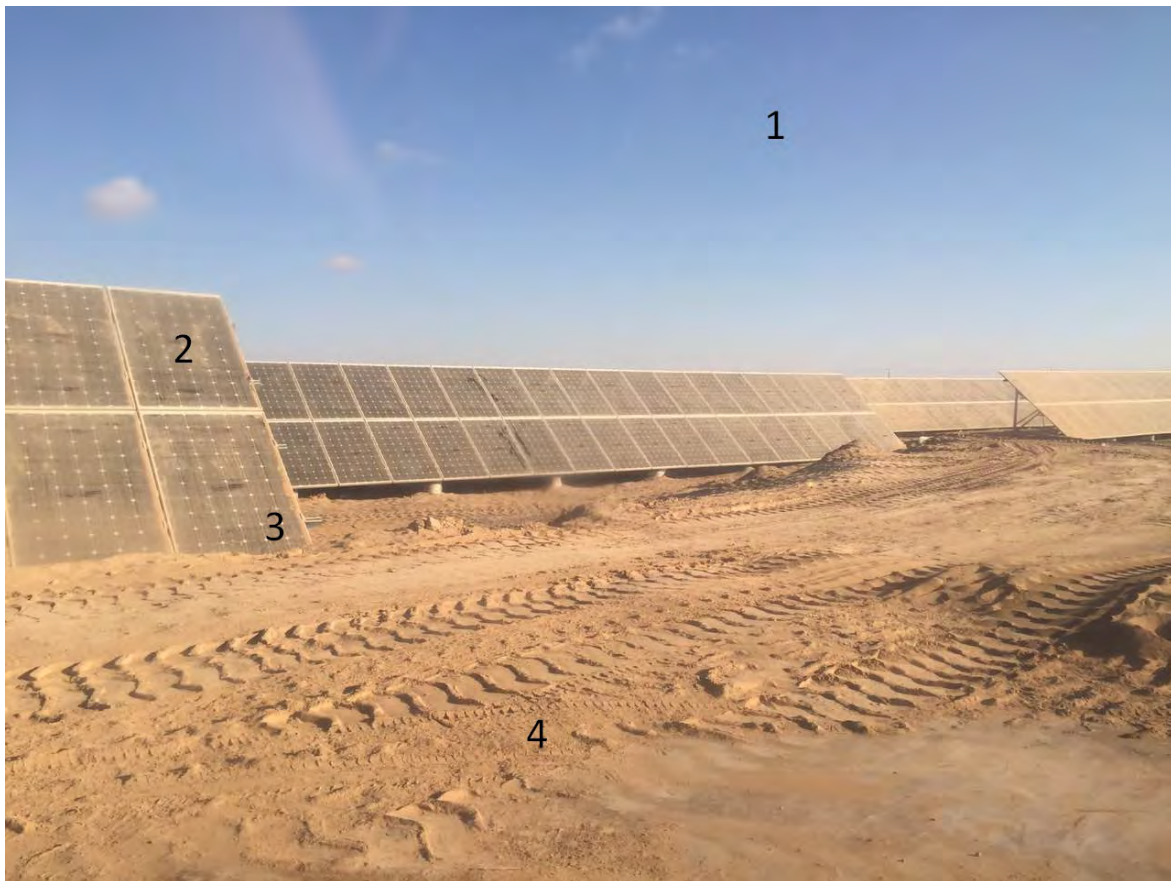
Fig. 32: Factors influencing dust soiling of PV modules in desert regions: 1 Climatic impact, ambient dust concentration, 2 Glazing characteristics, adhesion effects, non-uniform soiling, 3-Installation conditions, 4-Surrounding environment, dust particle characteristics. Photo: TÜV Rheinland Group

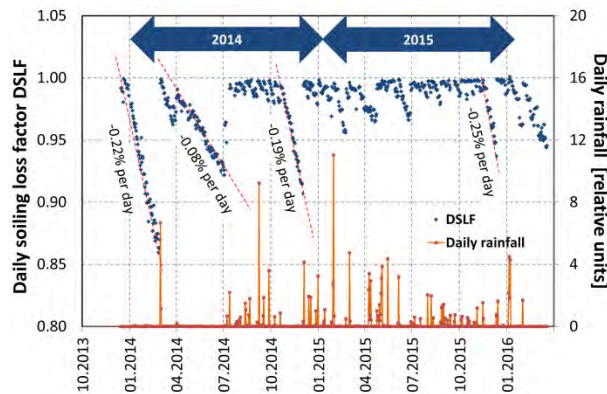
Fig. 33: Time evolution of Daily Soiling Loss Factor (DSLFL) at a location in Arizona desert.

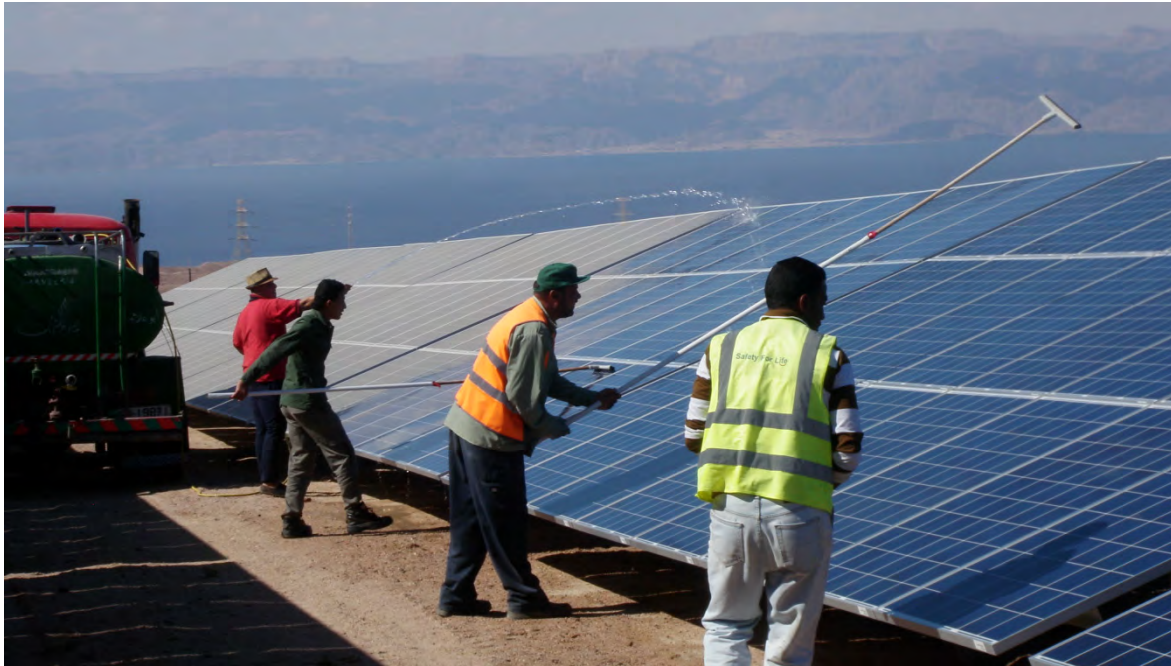
Fig. 35: Manual cleaning of a PV array. Photo: TÜV Rheinland Group

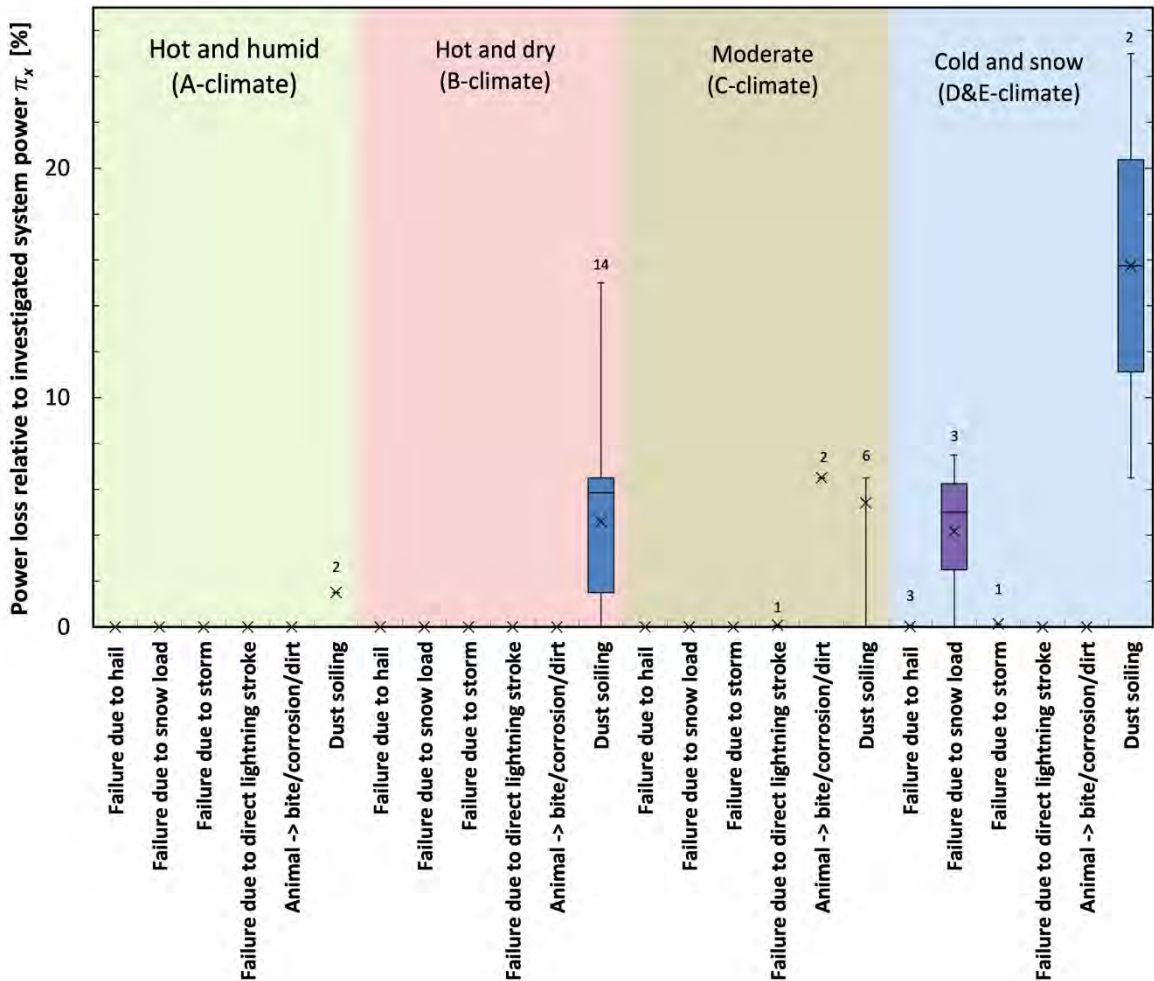
Fig. 53: Box plot of percentage of system power lost from the investigated system part after a sudden event. The numbers show the quantity of data per failure in the database.

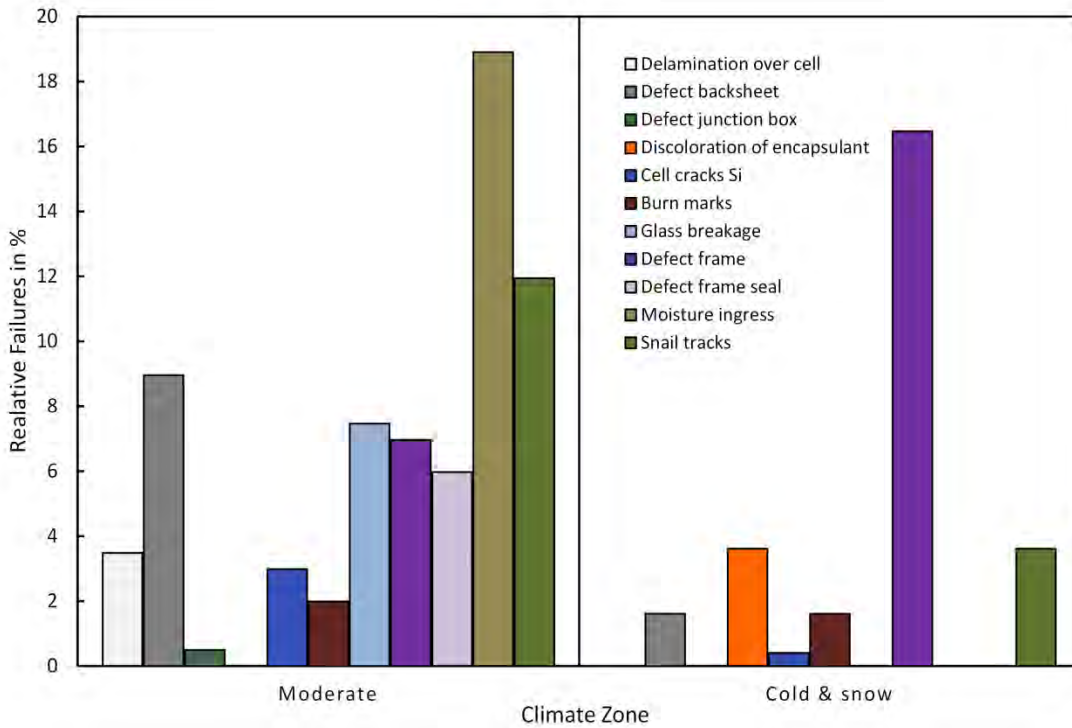
Fig. 60: Distribution of silicon PV module failures in the field classified in different climate zones according to Köppen-Geiger climate classification system [207].

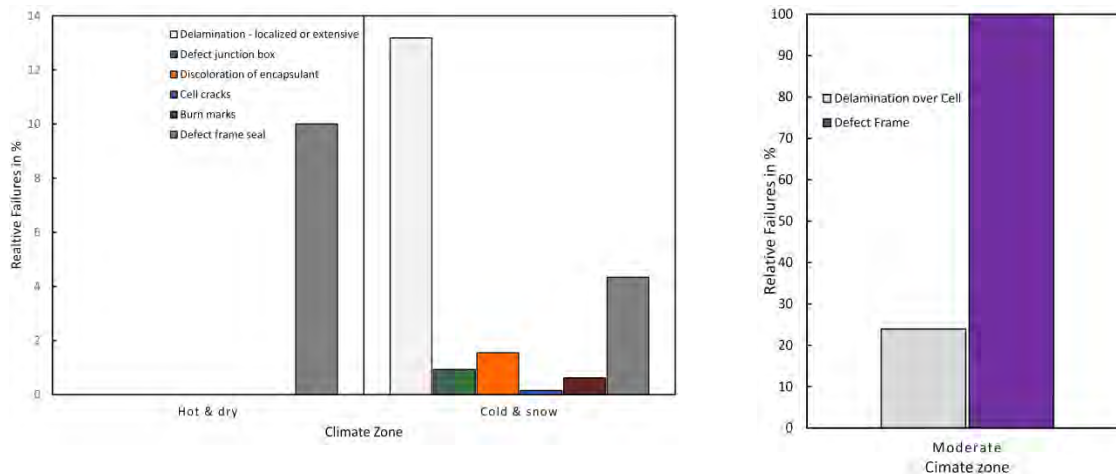
Fig. 61: Distribution of CdTe and CIGS module failures in the field classified in different climate zones according to Köppen-Geiger climate classification system [207].

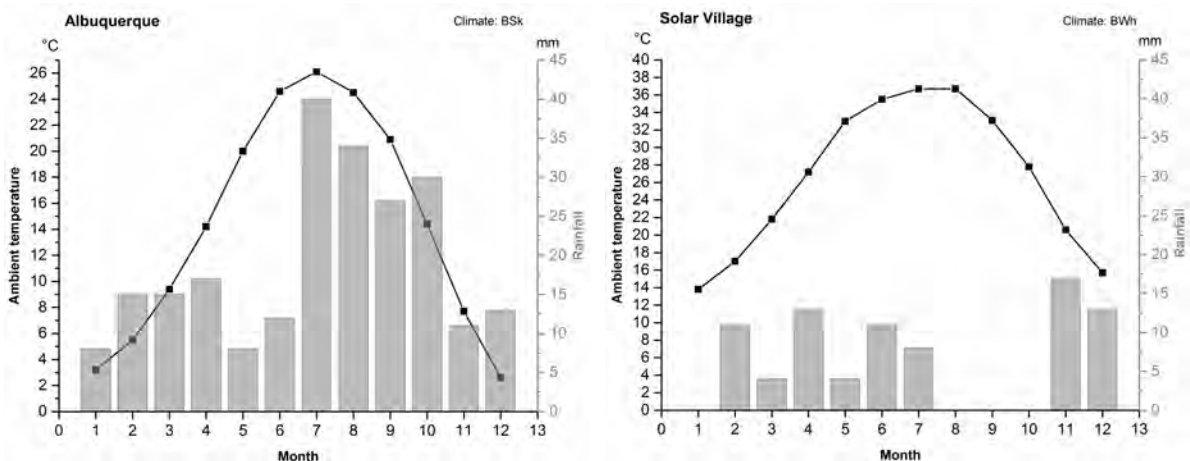
Fig. 66: Climate diagrams based on Meteornorm datasets [216] for two locations showing the variance between the climate conditions within one climatic group according to the Köppen-Geiger climate characteristic.

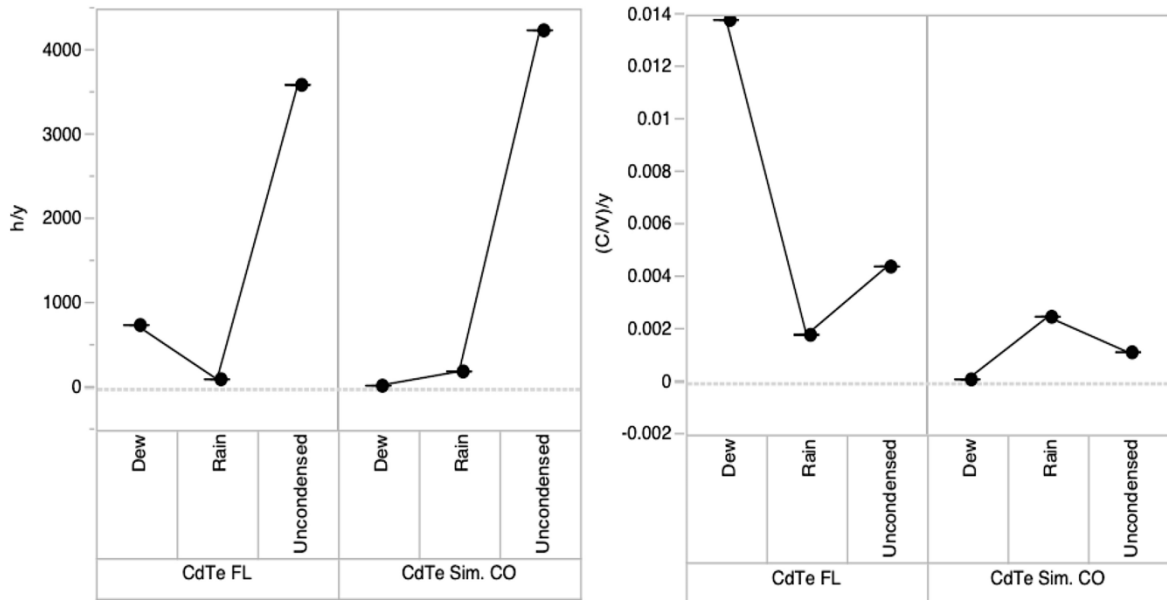
Fig. 70: (a) Time at each surface state, and (b), charge transferred for a CdTe module measured in Florida (FL) and simulated in Colorado (CO).
