## Review on Infrared and Electroluminescence Imaging for PV Field Applications

Report IEA-PVPS T13-10:2018

IEA PVPS Task 13, Subtask 3.3  
Report IEA-PVPS T13-10:2018  
March 2018

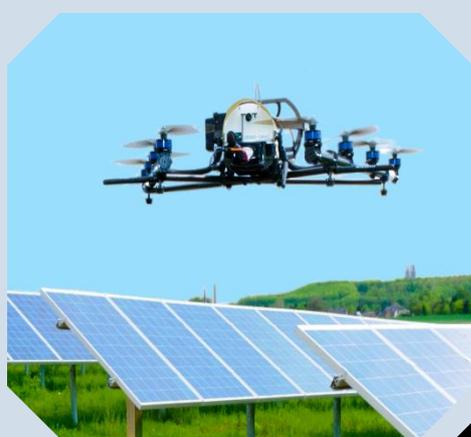
*Left: Outdoor infrared inspection using a drone for IR failure detection of PV power plants. Photo courtesy of TÜV Rheinland Energy, 2017.*

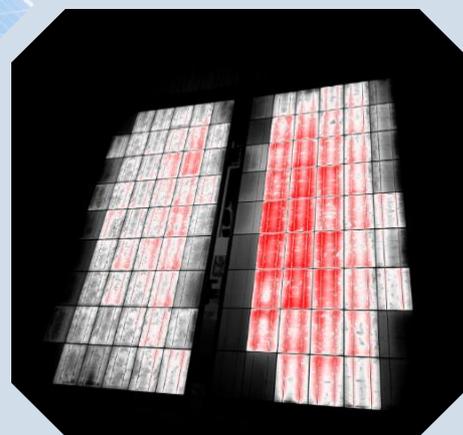
*Right: Night-time electroluminescence image using a consumer digital single-lens reflex camera of PID affected PV modules, in a black-white-red colour scheme. Photo courtesy of B. Kubicek, AIT, 2017.*

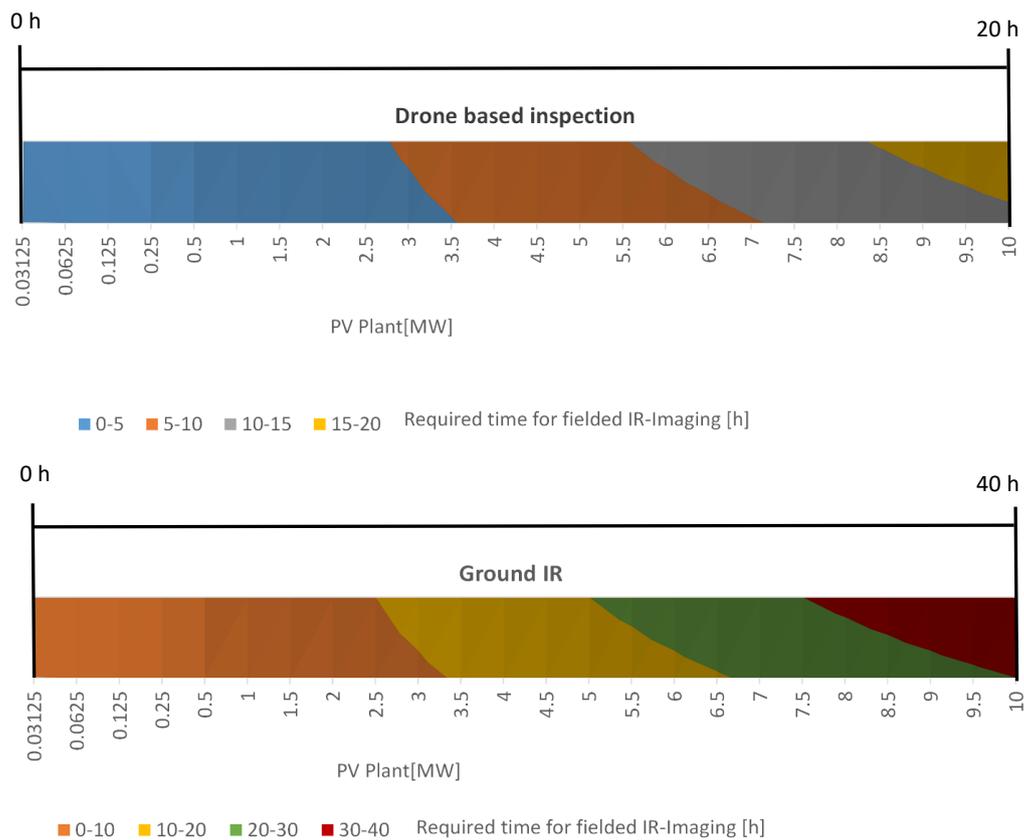
Figure 1-1 The required time for the inspection of PV modules using IR cameras, attached to a drone (top), and hand-held camera at the ground (bottom) with respect to the nominal power of the PV plant. The colours are used to identify the different time ranges for IR inspections.

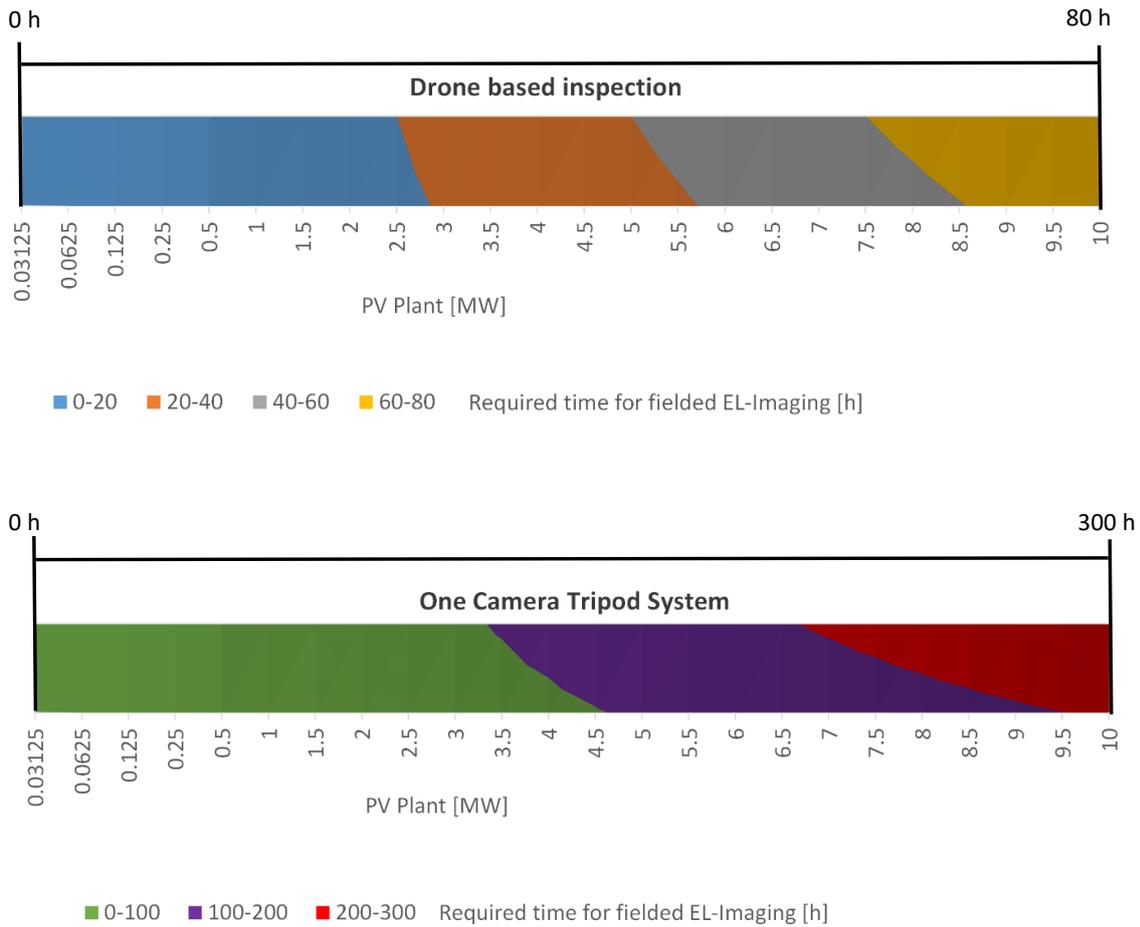
Figure 1-2 The required time for the inspection of PV modules with EL Imaging, attached to a drone (top), and hand-held camera at the ground (bottom) with respect to the nominal power of the PV plant. The colours are used to identify the different time ranges for EL inspections.

In Figure 1-2 (bottom) the required time for the inspection of a PV plant, with one EL camera, according to its nominal power is shown. For instance, a PV plant of 4 MWp nominal power requires approximately 100 - 150 hours inspection taking into consideration that all the other factors that might influence the inspection are ideal.

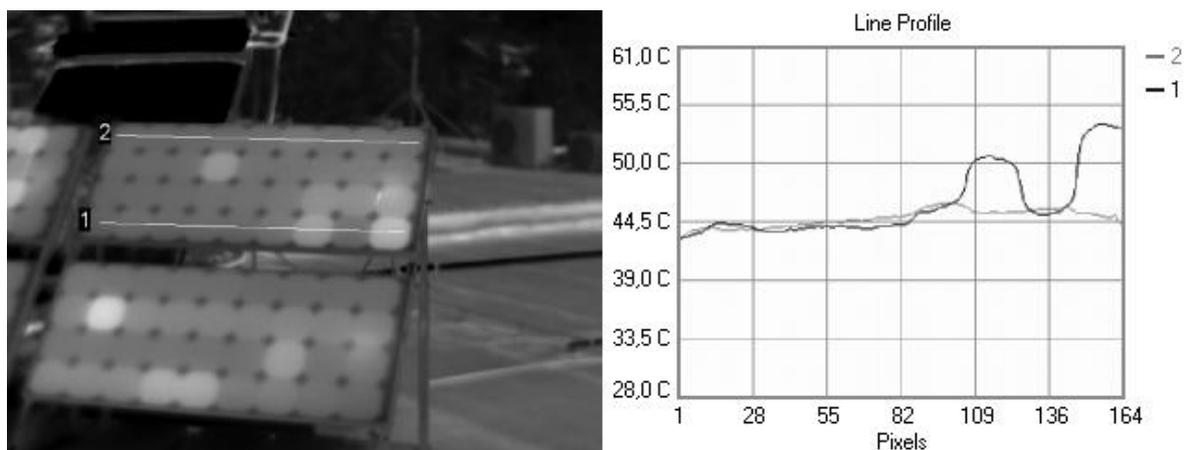
Figure 2-1: Example of a simple analysis based on temperature line profiles of ROIs corresponding to hot spots in a PV module under short circuit conditions.

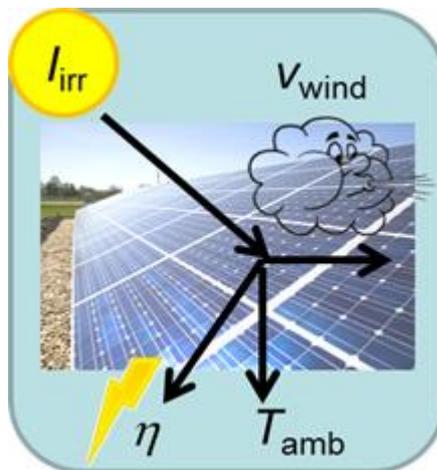
Figure 2-2: Heat flux scheme of a PV module outdoors.

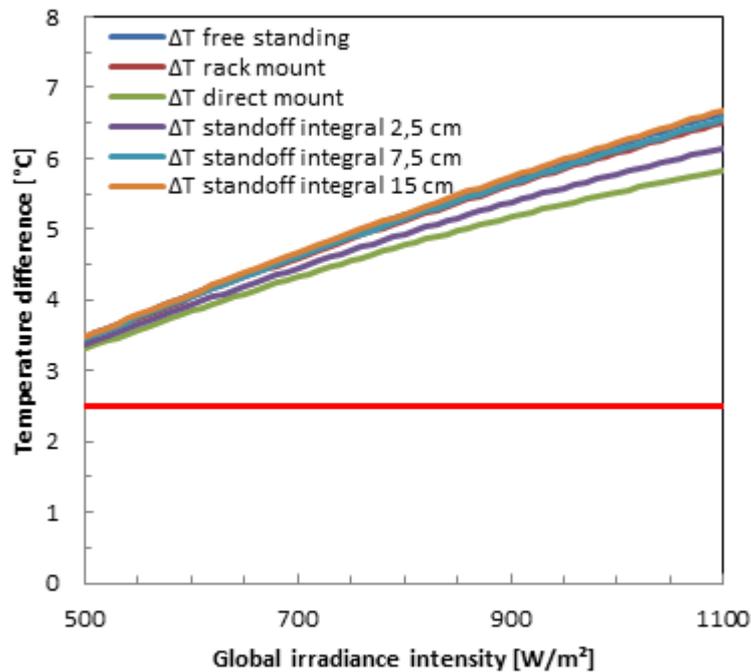
Figure 2-3: Example of temperature difference  $\Delta T$  calculated with Eq. (TDIFF) for a 15 % efficient PV module with  $T_{NOCT}=60$  °C, an ambient temperature  $T_a$  of 20 °C, for various installation situations and no wind having an active and an inactive part of the module. The red line represents a minimum temperature difference needed to assure that it is not an artificial effect.

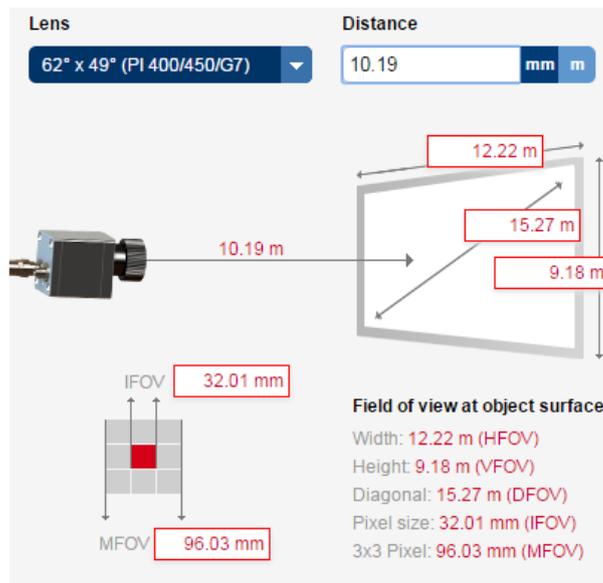
Figure 2-5: Example of lens calculation [51] and identification of  $d_{max}$  for an example case where  $IFOV \leq 32$  mm.

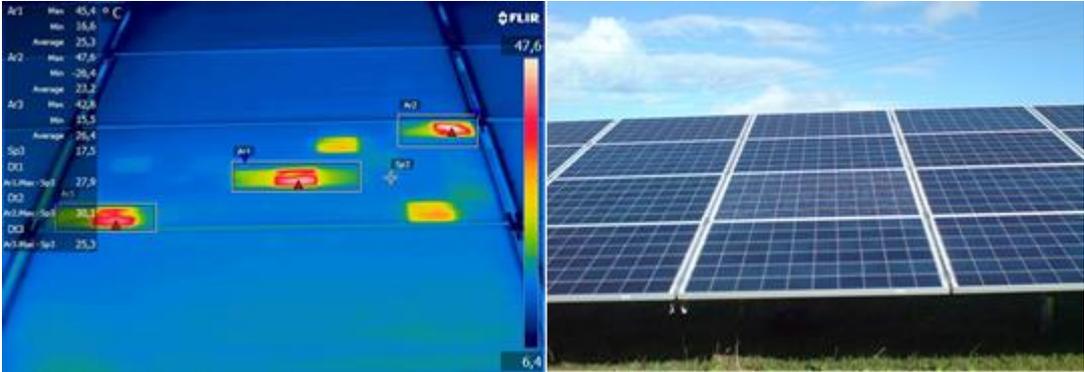
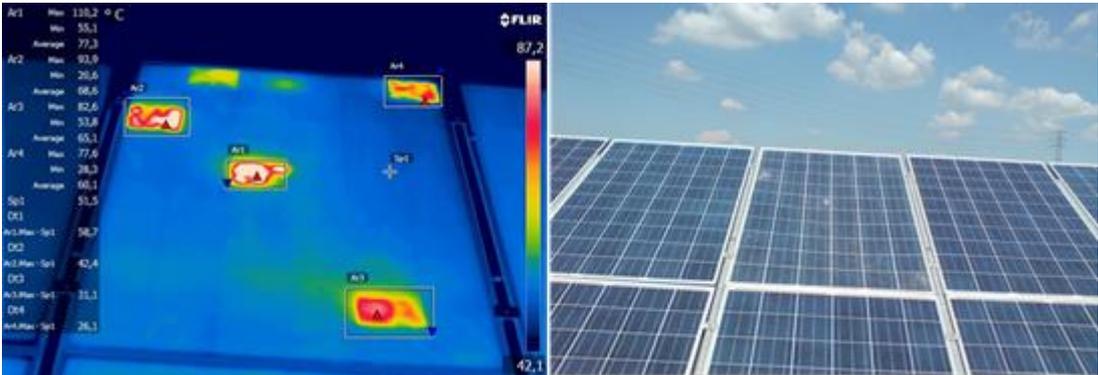
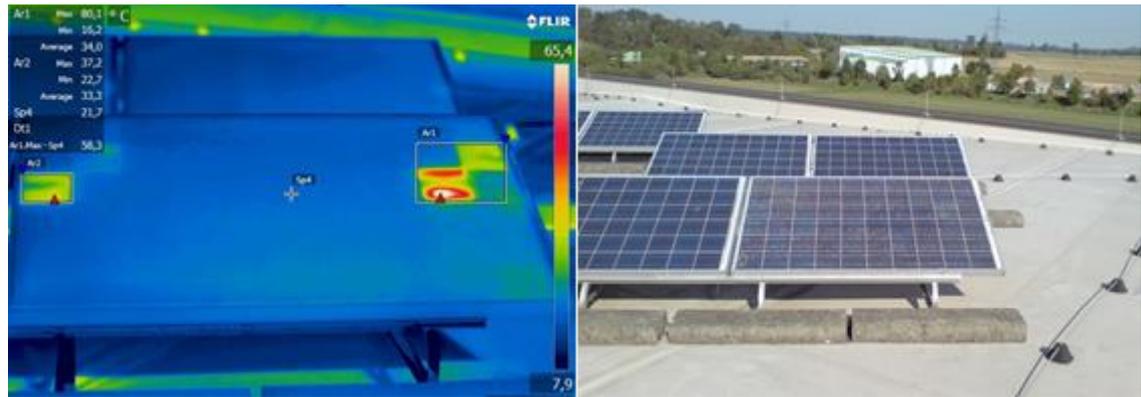
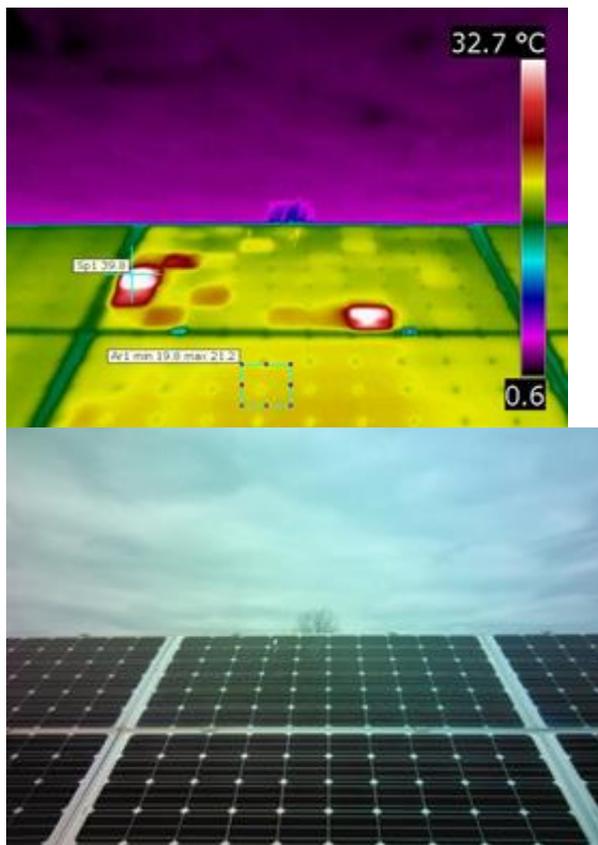
Figure 2-6: Breakage of front glass.

Figure 2-7: Breakage of front glass.

Figure 2-8: Breakage of front glass.

Figure 2-9: Breakage of front glass.

Figure 2-6 through Figure 2-9 show breakages of the front glass, caused by heavy impacts such as hail or other extreme mechanical stress onto the module frame, causing the front glass of the PV module to be damaged. The damage of the front glass often creates broken hot cells in the damaged PV module.

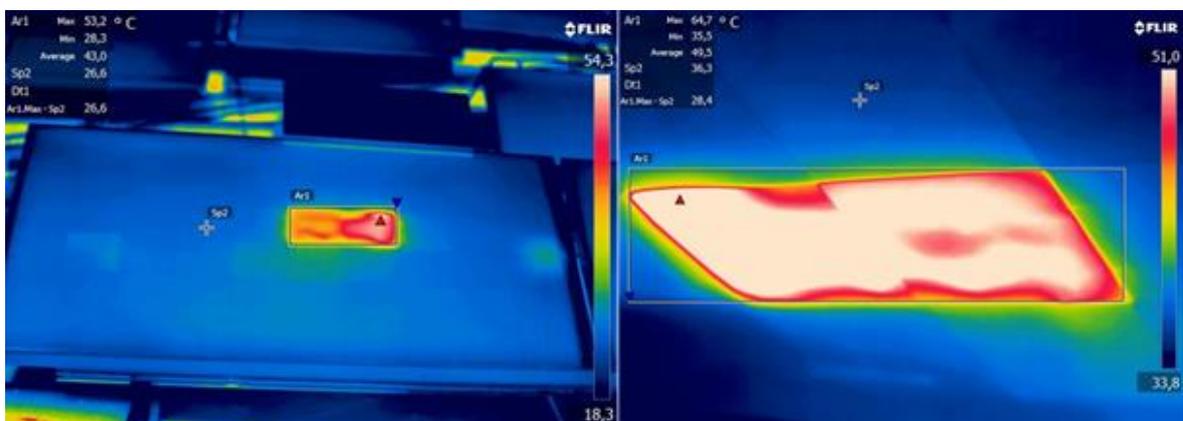
Figure 2-10: On the left side front view and on the right hand side rear side view of a PV module with overheated cell caused by internal cell problems.

The sample pictures presented in this category depict PV modules with overheated cells. These cells are overheated due to failures in the cell and module manufacturing process. Some examples for failures during these production processes are inaccurate cell sorting, local short circuits within the solar cell or an insufficient electrical contact. Most of the overheated cells derive from internal cell problems.

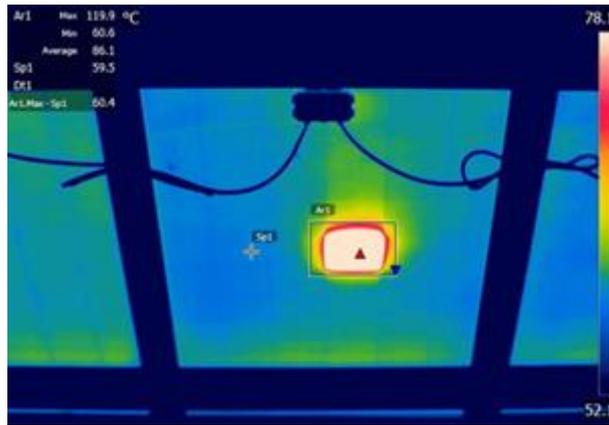
Figure 2-11: Rear side view of PV module with overheated cell caused by internal cell problems.

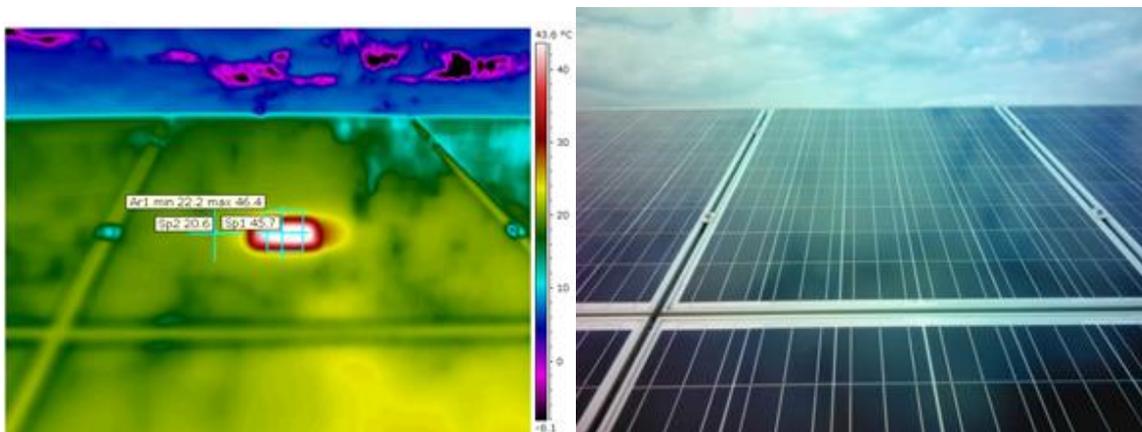
Figure 2-12: Hot Spot > 20 K.

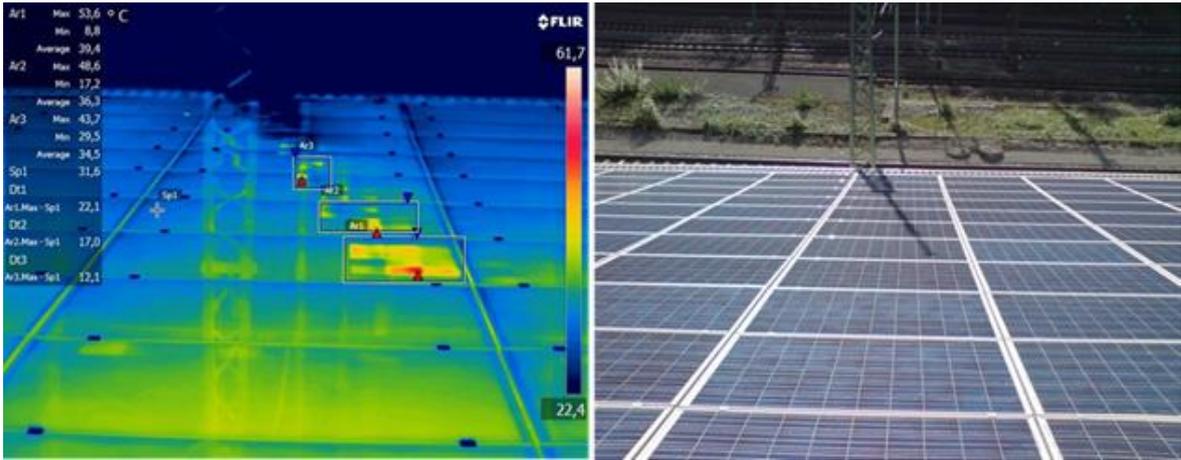
Figure 2-13: PV Module shows overheated cells due to shading by metal rod.

When the operating current of the overall series string of cells approaches the short circuit current of the shaded cell, the overall current of the string becomes limited by the shaded cell. The extra current produced by the good cells then forward biases the good solar cells. If the series string is short-circuited, then the forward bias across all of these cells reverse biases the shaded cell. Hot spot occurs when a number of series connected cells cause a reverse bias across the shaded cell, causing the dissipation of power in the shaded cell. Essentially the entire generating capacity of all the unshaded cells in the string cells is dissipated in the shaded cell.

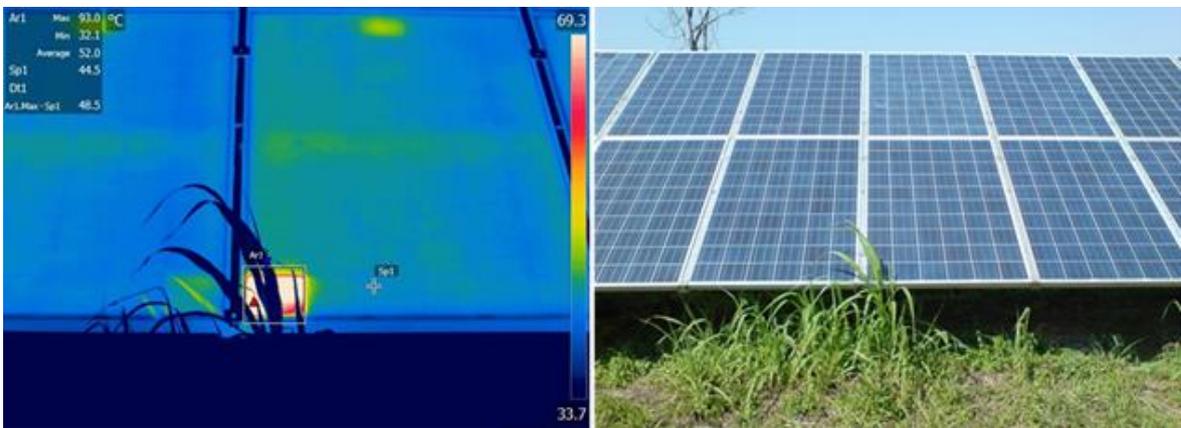
Figure 2-14: PV module shows overheated cells due to shading by plants.

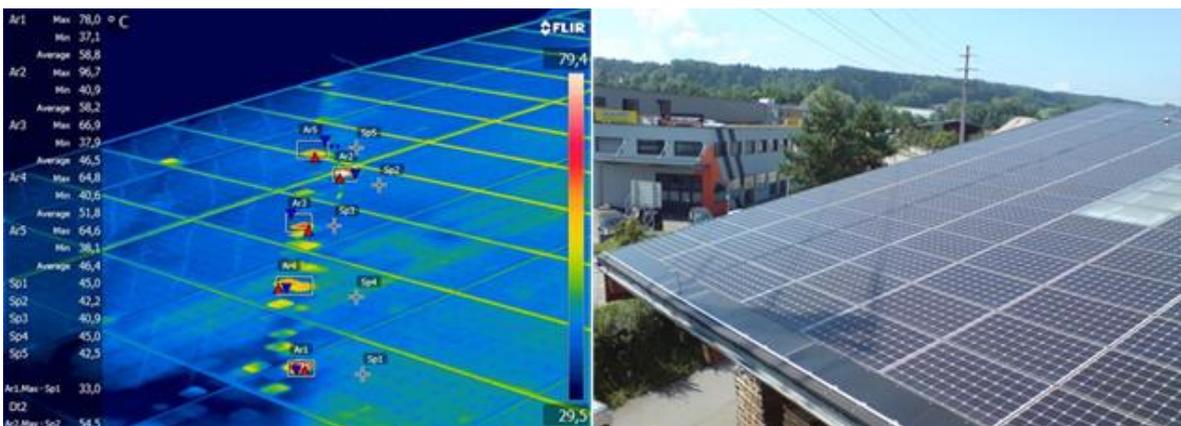
Figure 2-15: PV module shows overheated cells due to shading by the medium voltage overhead lines and its pylon.

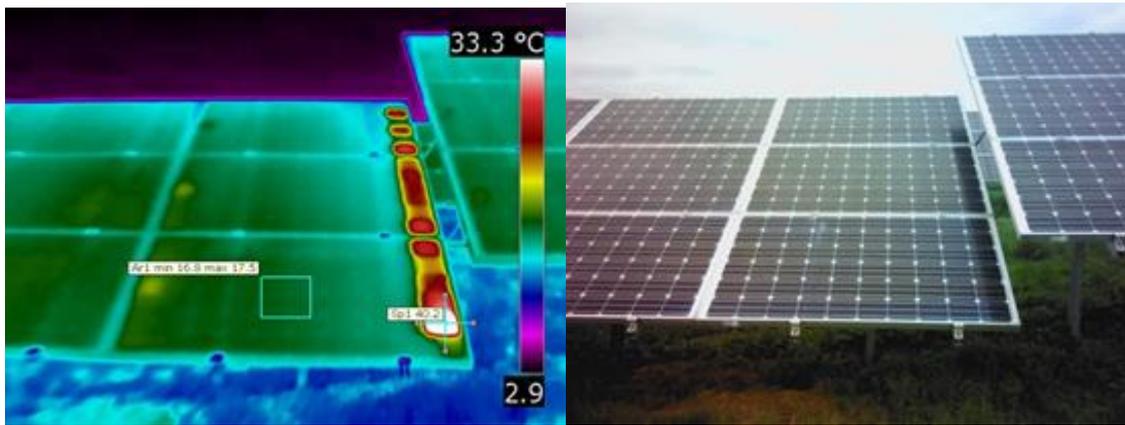
Figure 2-16: PV module shows overheated cells due to shading by neighbouring PV module row.

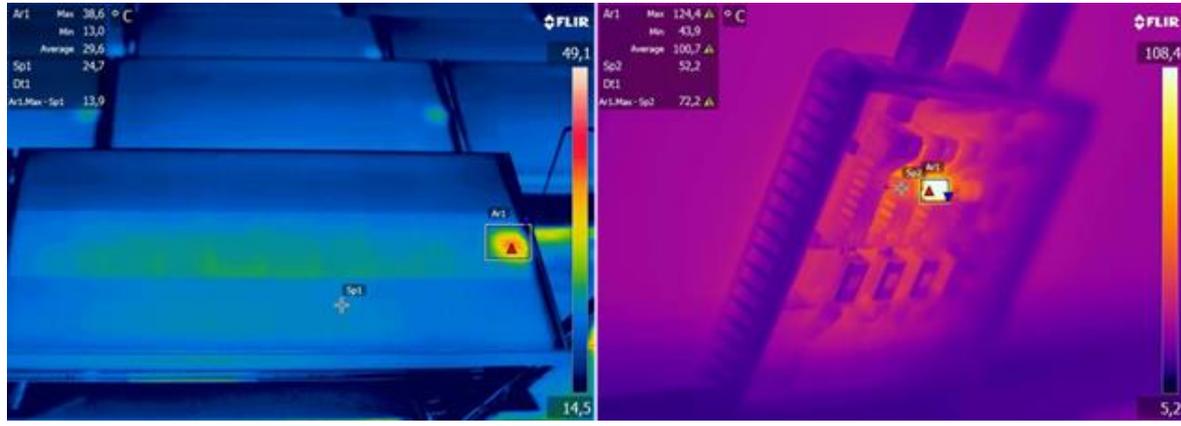
Figure 2-17: On the left side, front view PV module with overheated junction box and on the right hand side, rear side view with open junction box and overheated diode.

To reduce the effects of hot spots, a bypass diode is connected in parallel and with opposite polarity to a string of solar cells. Under normal operational conditions of the cells, the bypass diode will be reverse biased thus inactive. Due to mismatches of the cells or partial shading of the string of cells, the bypass diode is forward biased, active-, allowing the current to flow through it and not the cell that is shaded for example. Thus, the temperature of the diode when is active is higher than the inactive diodes.

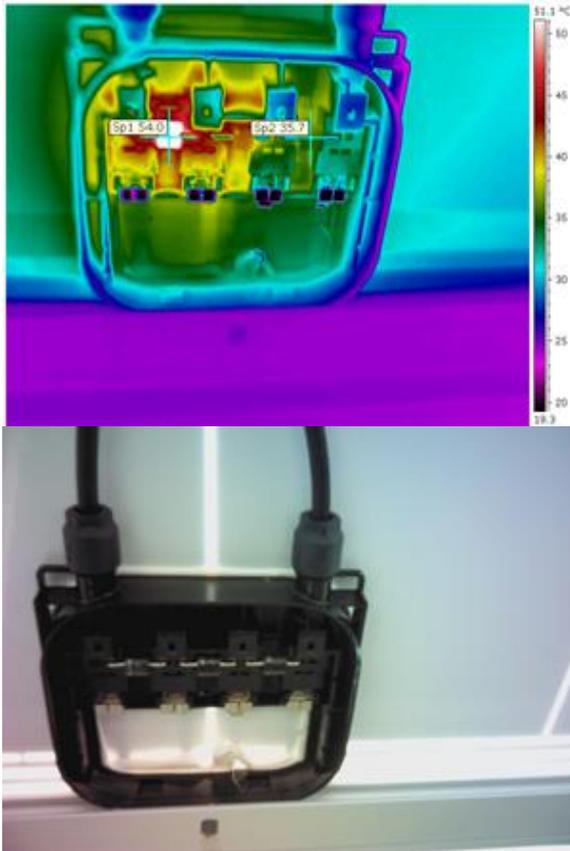
*Figure 2-18: Overheated bypass diode because it is forward biased and active.*

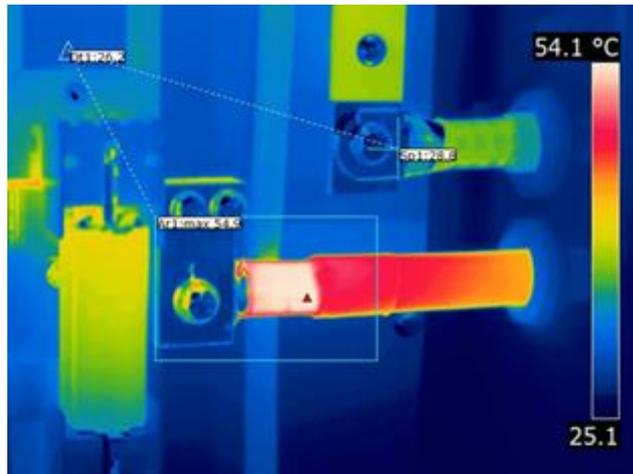
Figure 2-19: DC combiner box includes overheated interconnection with cross bar between cable and lug.

Large-scale PV power plants are often equipped with large central inverters, with DC combiner boxes used to collect individual DC strings and connect them to one larger, single cable. These combiner boxes sometimes evolve thermal problems too, most often caused by improper cable connections, either a loose cable connection within the internal cross bar or an improper compressed connection between the DC cable and the cable lug.

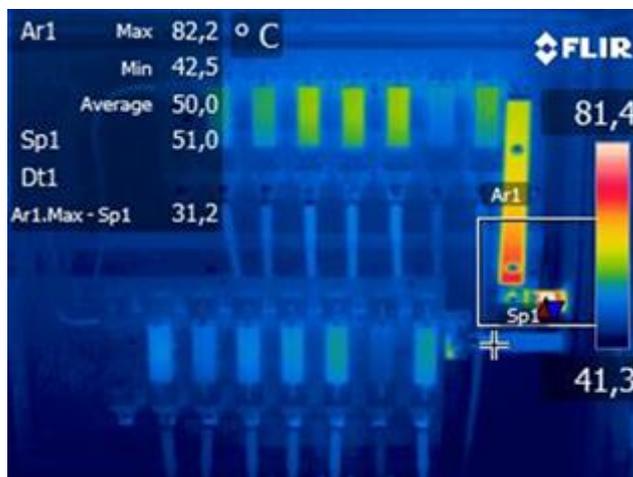
Figure 2-20: DC combiner box includes overheated interconnection with cross bar between cable and lug.

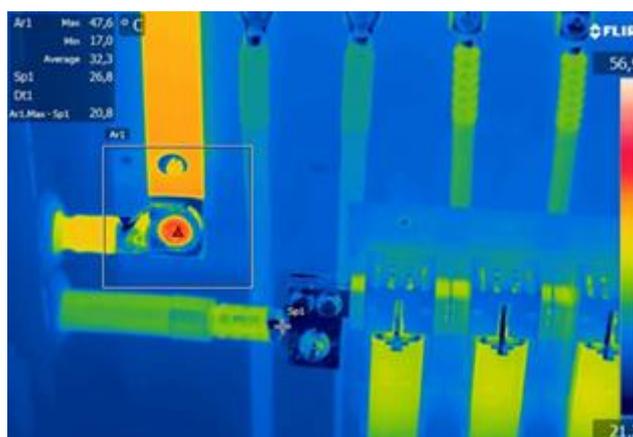
Figure 2-21: DC combiner box includes overheated cable interconnection with cross bar due to a loose screw.

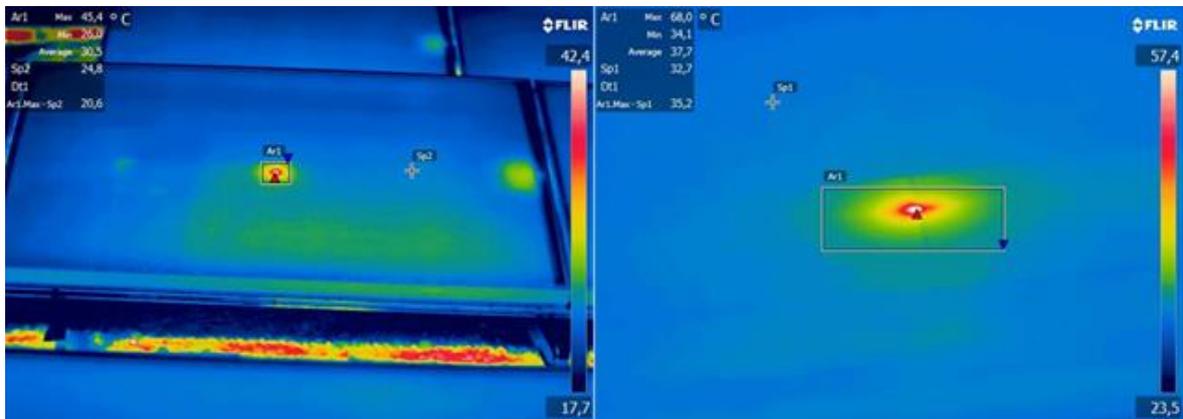
Figure 2-22: The left side IR image is derived from the front view of a PV module with heated cell interconnection. On the right hand side the rear side view of this heated cell interconnection is depicted.

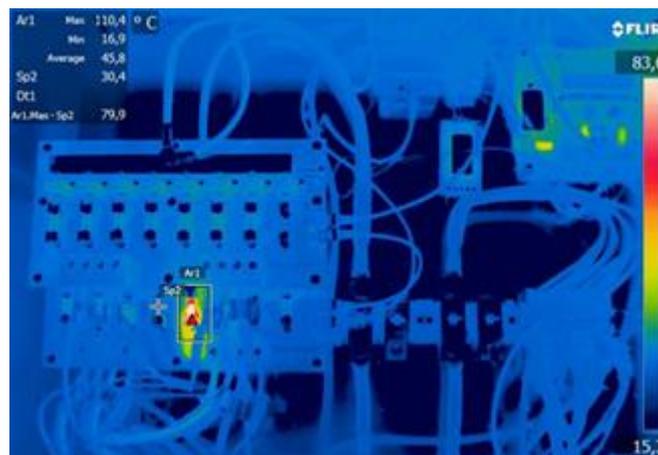
Figure 2-23: DC combiner box with overheated string fuse/spring clamp connection.

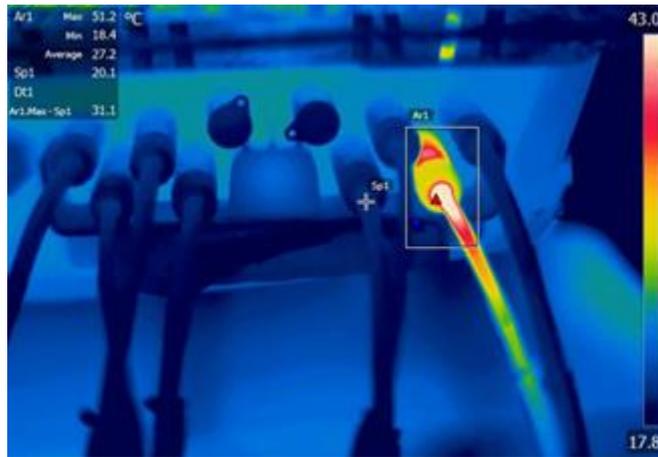
Figure 2-24: String inverter with overheated DC connector.

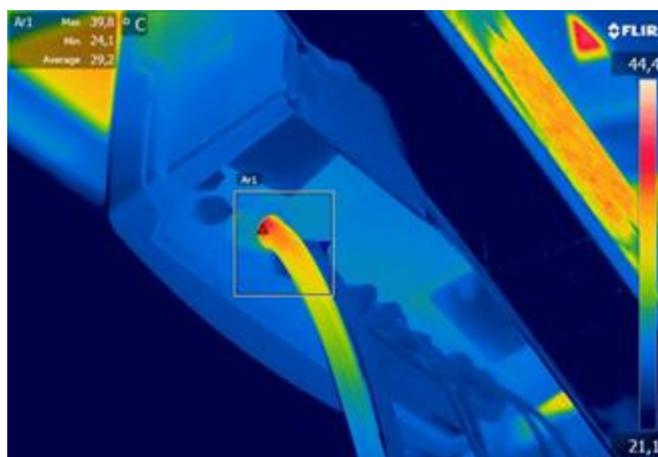
Figure 2-25: AC cable of string inverter shows overheating due to loose connection.

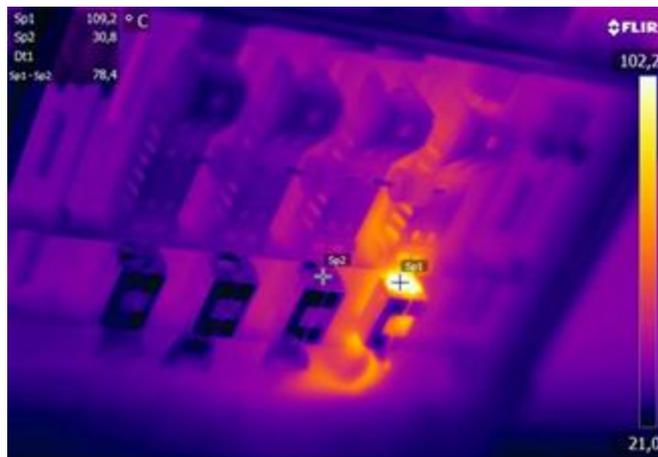
Figure 2-26: Open PV module junction box with overheated terminal.

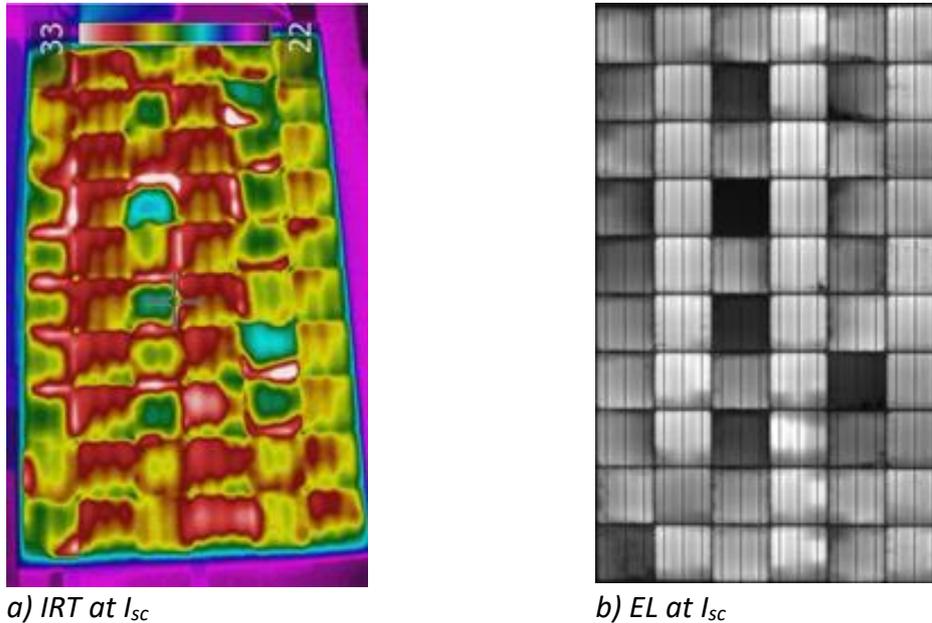
*Figure 2-27: IR thermography and EL image of a PID-s affected module at the same applied test current ( $I_{test} = I_{sc}$ ) in the dark. a) The IRT image shows that the strongly affected cells are cooler than the rest. b) The EL image shows that the affected cells are darker [53].*

For infrared thermography (IRT) and electroluminescence (EL) imaging of the PID-s affected module in the laboratory, a test current of  $I_{sc}$  was applied (see *Figure 2-27*) in a dark room. Both images were in good agreement. The strongly PID-s affected cells were cooler in IRT image and darker in EL image.

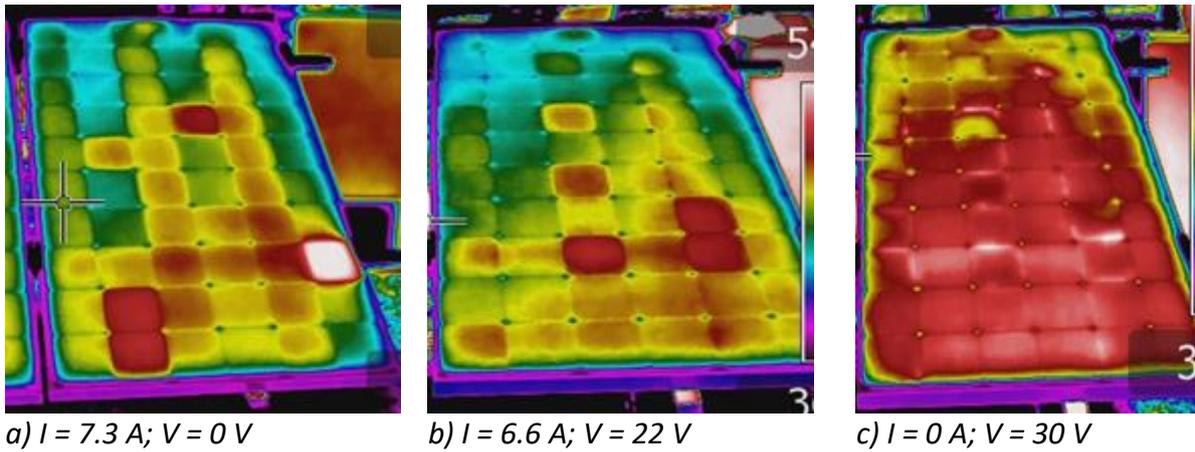
Figure 2-28: IR thermography of a PID affected module (same as in Figure 2-27) under sunlight conditions (approx.  $900 \text{ W/m}^2$ ):

To simulate operating conditions, the PID-s affected module was mounted at 30° tilt angle in natural sunlight. A variable resistive load was used to set module current and voltage. IR imaging (see *Figure 2-28b*) with the module operating close to maximum power (MPP) condition is in good accordance with EL imaging *Figure 2-29b*, but with the PID-s affected cells warmer instead of darker in the EL image. At open circuit conditions (*Figure 2-28c*) no pattern appears and at short circuit (*Figure 2-28a*) reverse bias operation of cells dominates the pattern. IRT patterns may differ if - instead of a resistive load - an active power source is applied, as it is also the case in string connected modules under string MPP operation (*Figure 2-29*), because the modules are never affected homogeneously by PID-s, and therefore have different IV-curves and operating points.

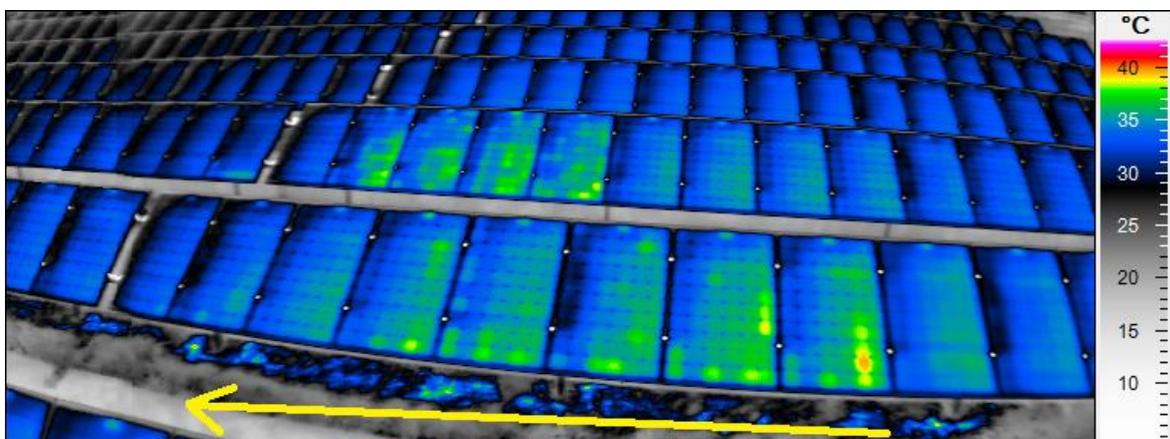
Figure 2-29: IRT image of a PID affected system under sunlight conditions. The modules in the foreground show PID patterns with warmer cells close to the bottom frame. The power

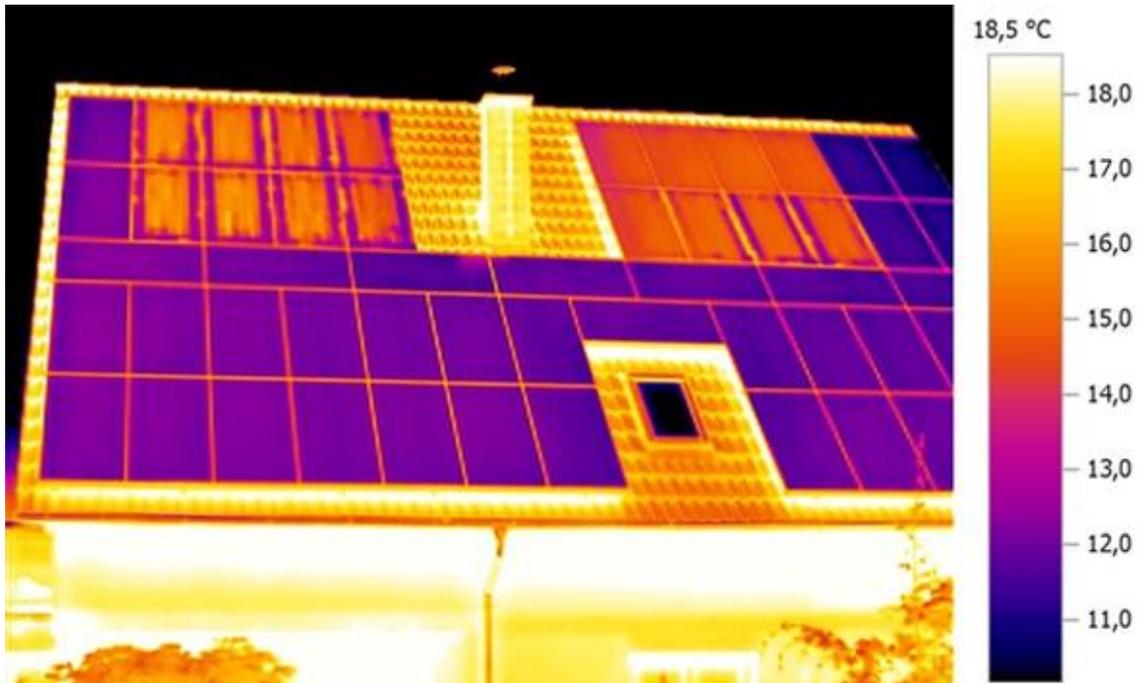
Figure 2-30: IRT image of a PID-s affected rooftop system with applied current during the night. In this case, the cooler cells are the PID-s affected cells [58].

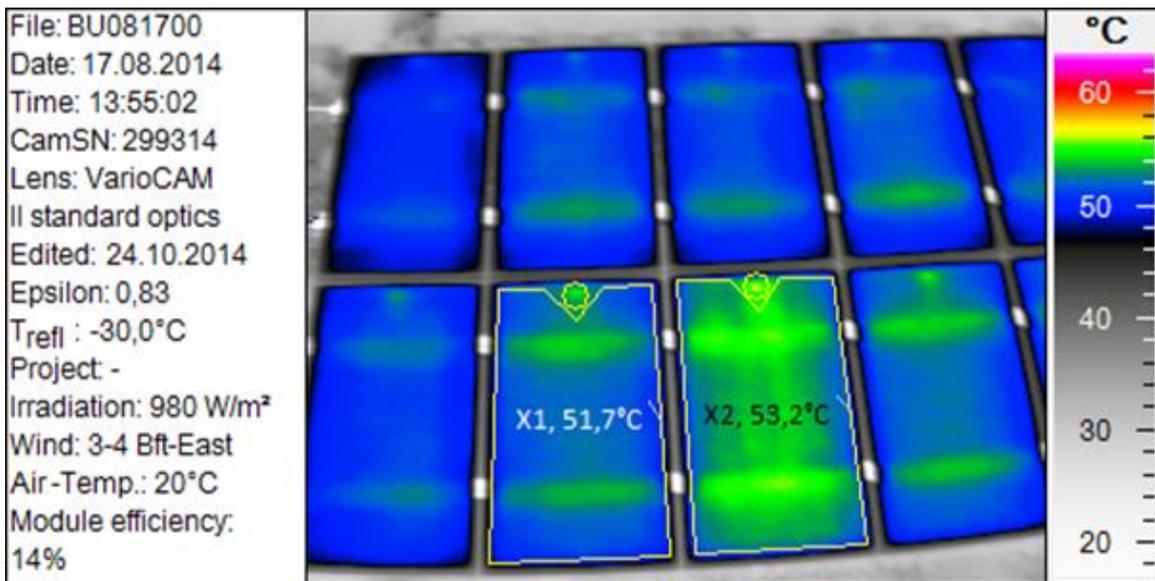
Figure 2-31: Example of plausibility check by determining the mean value of the temperature over the entire module excluding the junction box. In this example, the small temperature rise of 1.5 K was due to a different emissivity of the back sheet used for the two modules.

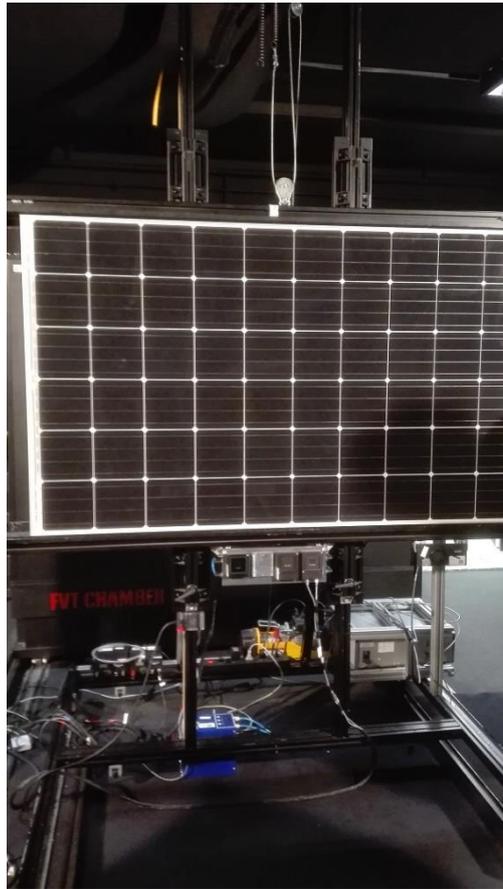
*Figure 3-1: Photo of a typical experimental setup for EL tests in the laboratory, taken in the PV lab at SUPSI, Lugano, Switzerland.*

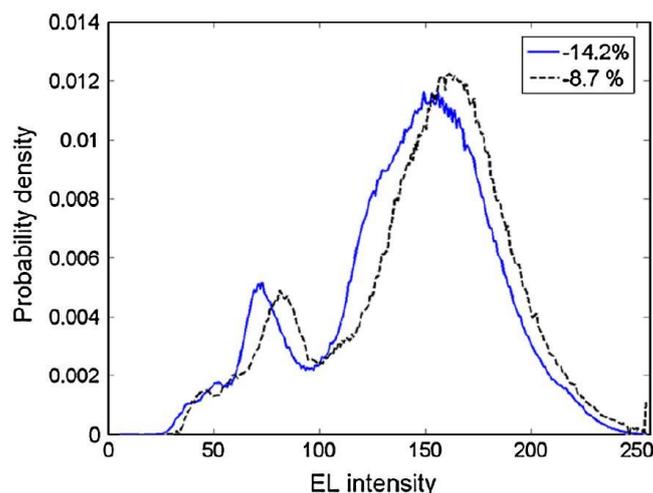
Figure 3-2: probability density functions of the EL intensity derived from EL images of two PV modules with 8.7 % and 14.2 % of power losses, respectively (from [60]). As a general trend, the probability density function of EL intensities shifts to the right in the case of higher power losses.

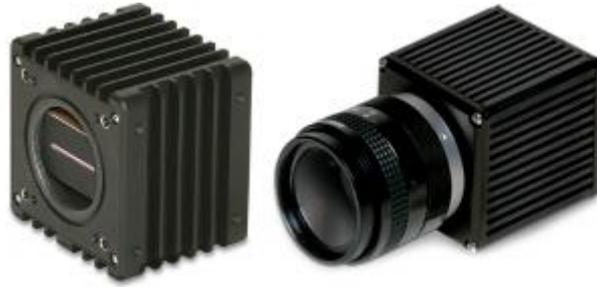
*Figure 3-3: Linescan (left) and area (right) cameras produced by UTC Aerospace Systems [67].*

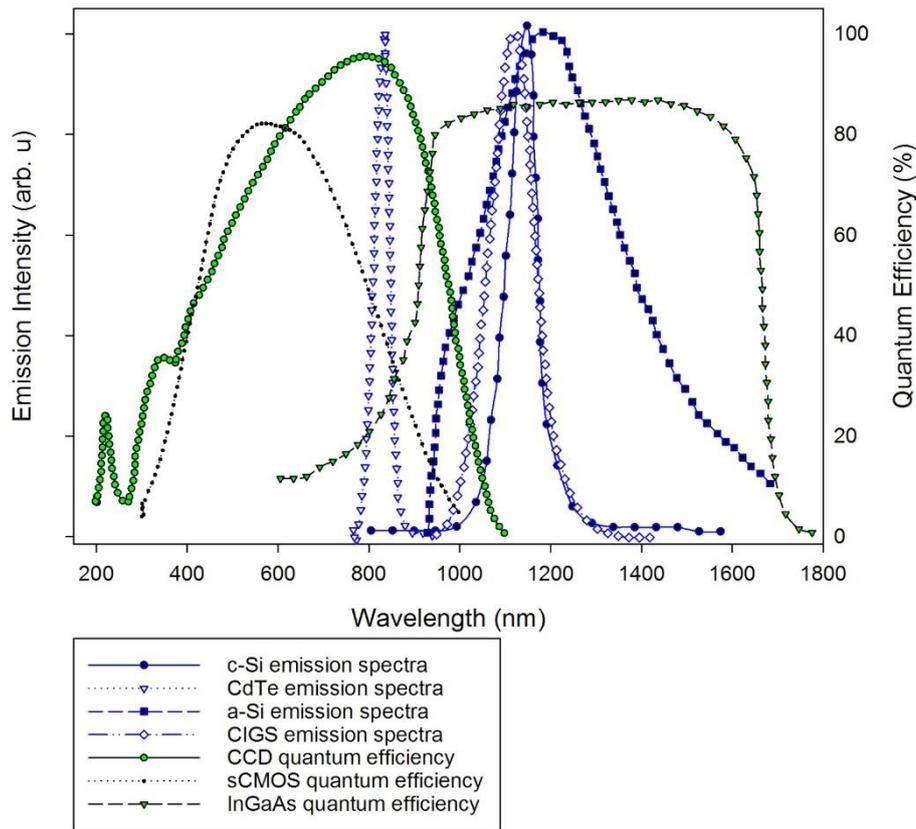
Figure 3-4: Emission spectra from a range of solar cell technologies and the quantum efficiency of silicon CCD, CMOS and InGaAs CMOS cameras.

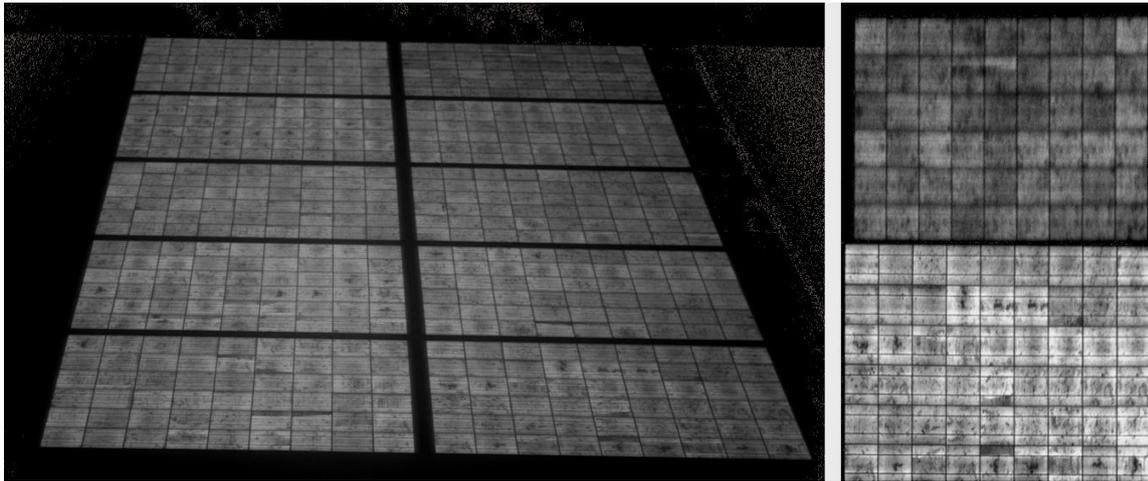
*Figure 3-5: An outdoor EL performed with a consumer DSLR. The focus was performed on the front modules. Hence, as depicted to the right, only the front row can be imaged correctly, while one of the upper modules (right, top) is very blurry.*

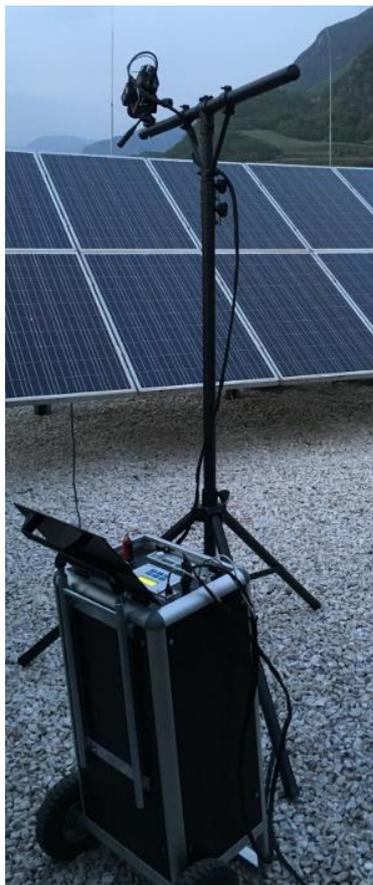
*Figure 3-6: GreatEyes LumiSolar outdoor measurement system for field tests of PV modules.*

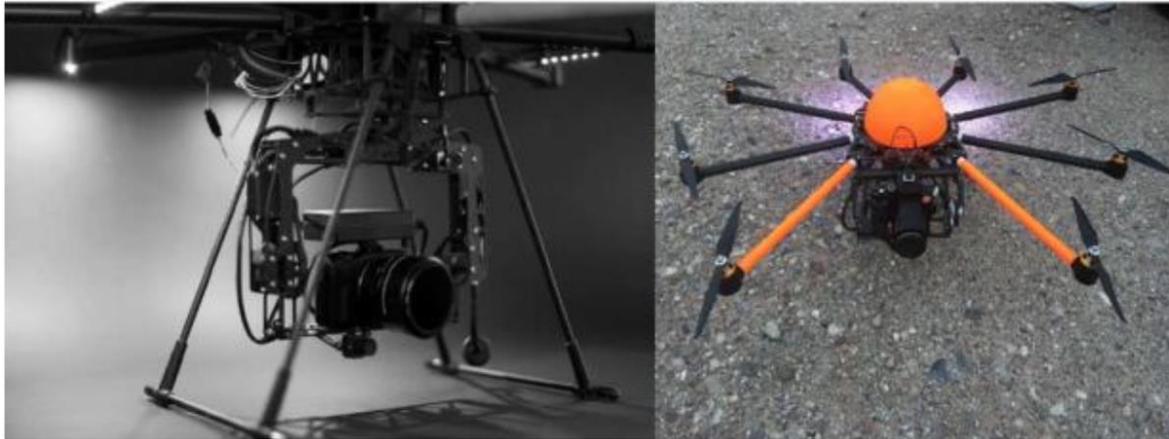
Figure 3-7: EL camera mounted on octocopter [79].

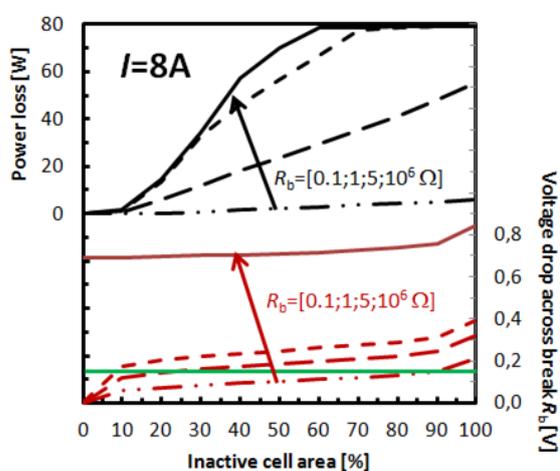
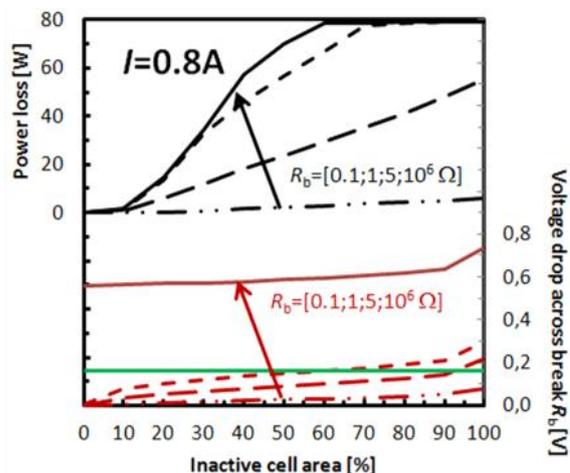
Figure 3-8: Simulated voltage drop across the break resistance of a separated cell part for a 230 W<sub>p</sub> PV module at a forward current of 8 A (nominal current of the module). The green line marks 150 mV being able to detect with a low noise 12 bit CCD camera.

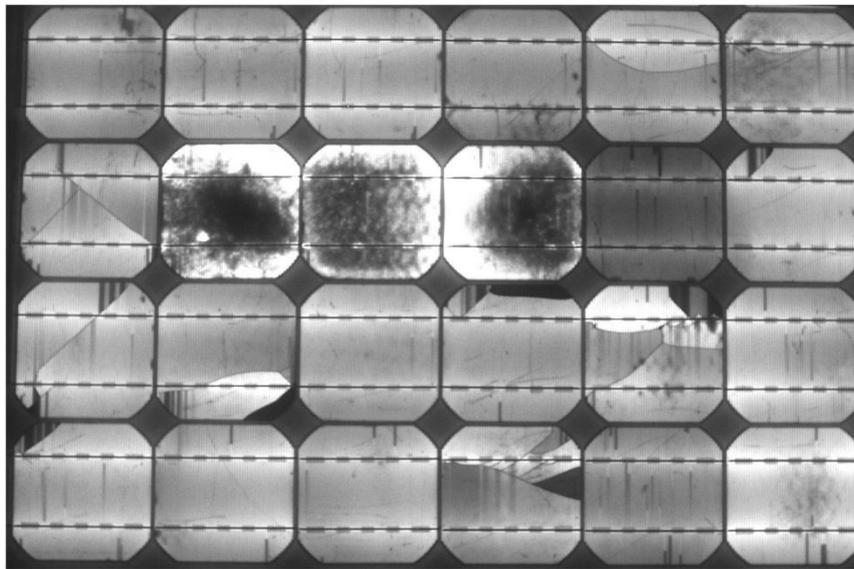
*Figure 3-10: EL image of a monocrystalline PV module with various defects (from [60]).*

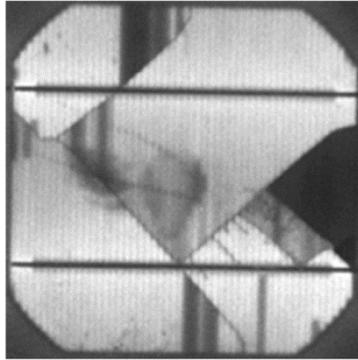
*Figure 3-11: EL image of a solar cell with a typical crack pattern due to impacts (from [60]).*

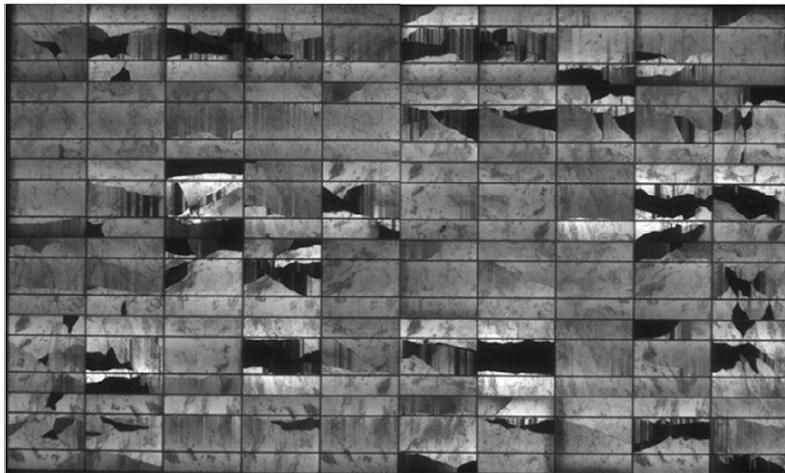
*Figure 3-12: EL image of a polycrystalline PV module with cracked cells (from [60]).*
