## Review on Infrared and Electroluminescence Imaging for PV Field Applications

Report IEA-PVPS T13-10:2018

IEA PVPS Task 13, Subtask 3.3  
Report IEA-PVPS T13-10:2018  
March 2018

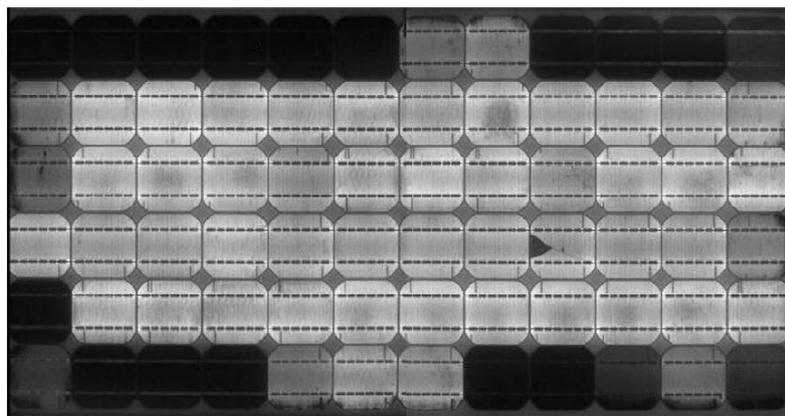
*Figure 3-13: EL image of a monocrystalline PV module with potential induced degradation (from [60]).*

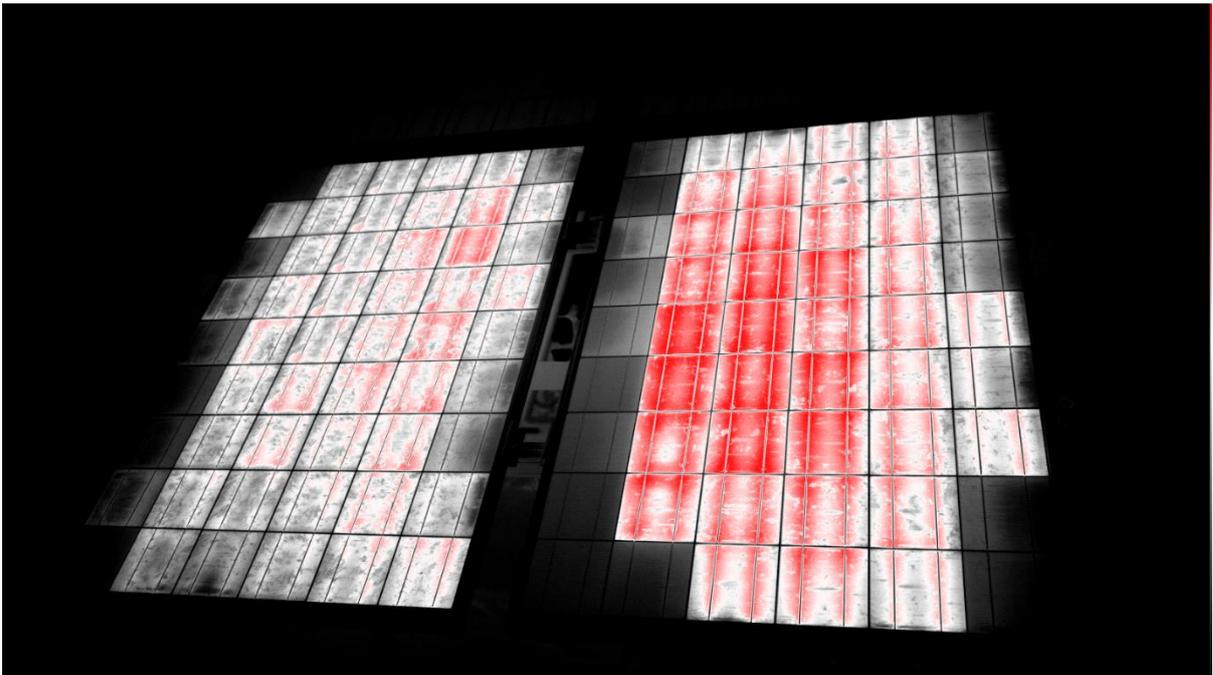
*Figure 3-14: Night-time EL using a Consumer DSLR of PID affected modules, in a black-white-red colour scheme. The accumulated exposure time was around four minutes. The darkening of cell edge regions close to the frame can be observed, which is commonly attributed to current passing through the decreased parallel resistance instead of the PN-junction [82].*

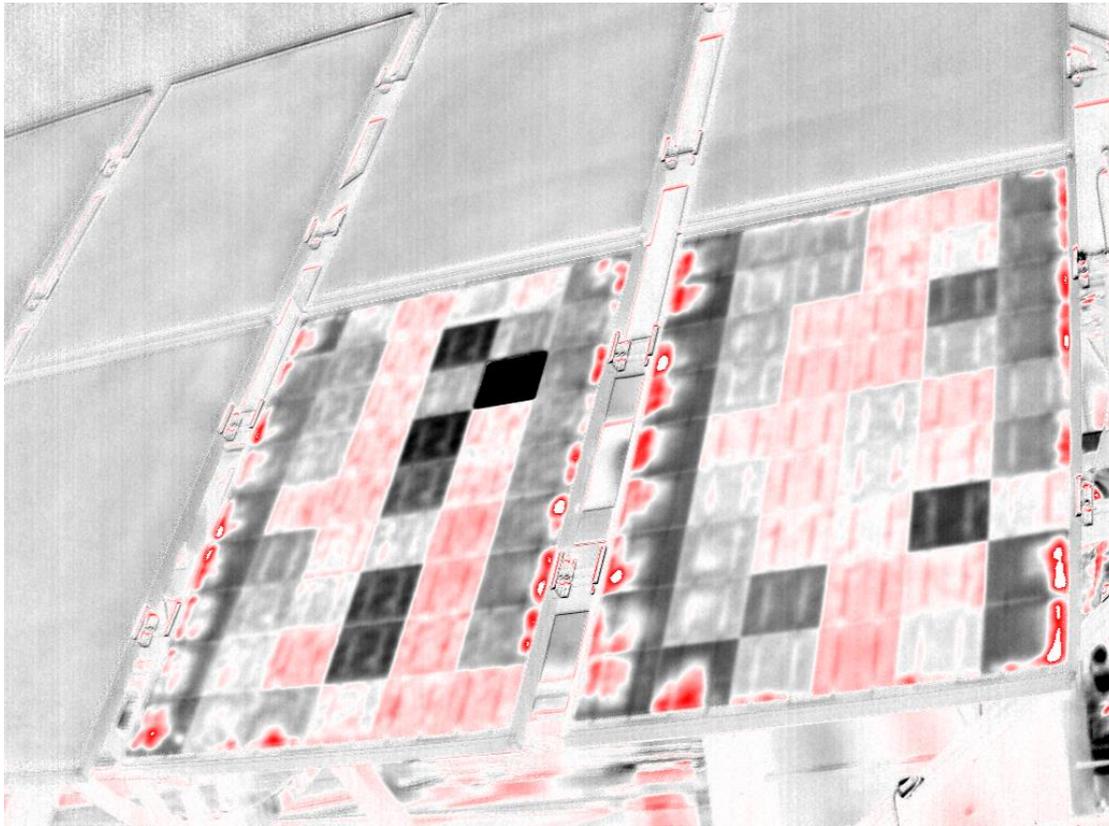
*Figure 3-15: Daylight Outdoor Lock-In Thermography of the same modules as in Figure 3-14. The modules are repeatedly toggled between short and open circuit with a period time of 50 seconds, while a thermography camera observes transient temperature waves at the glass surface. The amplitude of the waves is plotted, white being no thermal change in time, black indicating heat-up of 0.1 K at short circuit, while red indicates heat-up of 0.1 K at open circuit [82].*

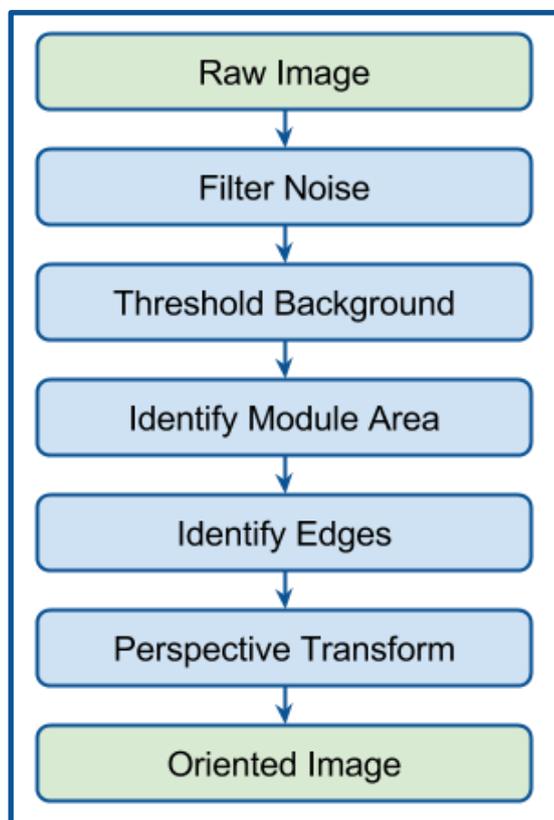
*Figure 3-16: A flow diagram for the typical process used to transform raw images to uniformly oriented images.*

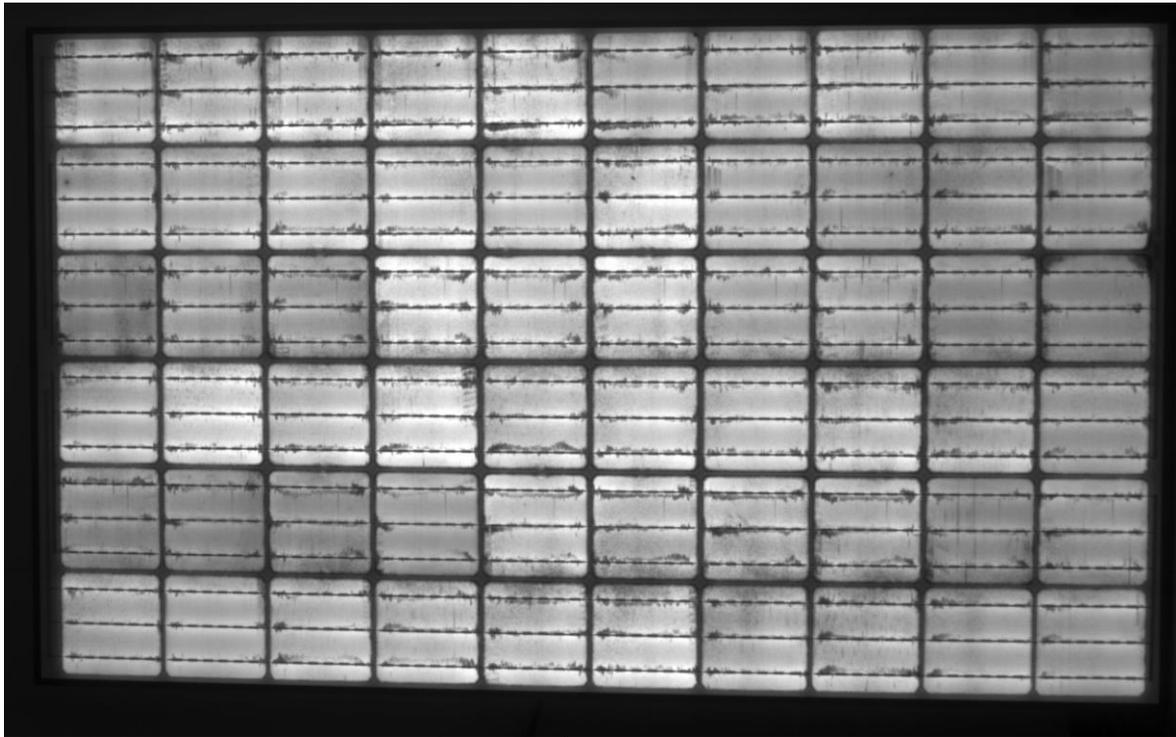
Figure 3-17: A raw grayscale EL image. This particular module has undergone 2500 hours of lab-based accelerated damp-heat exposure [90].

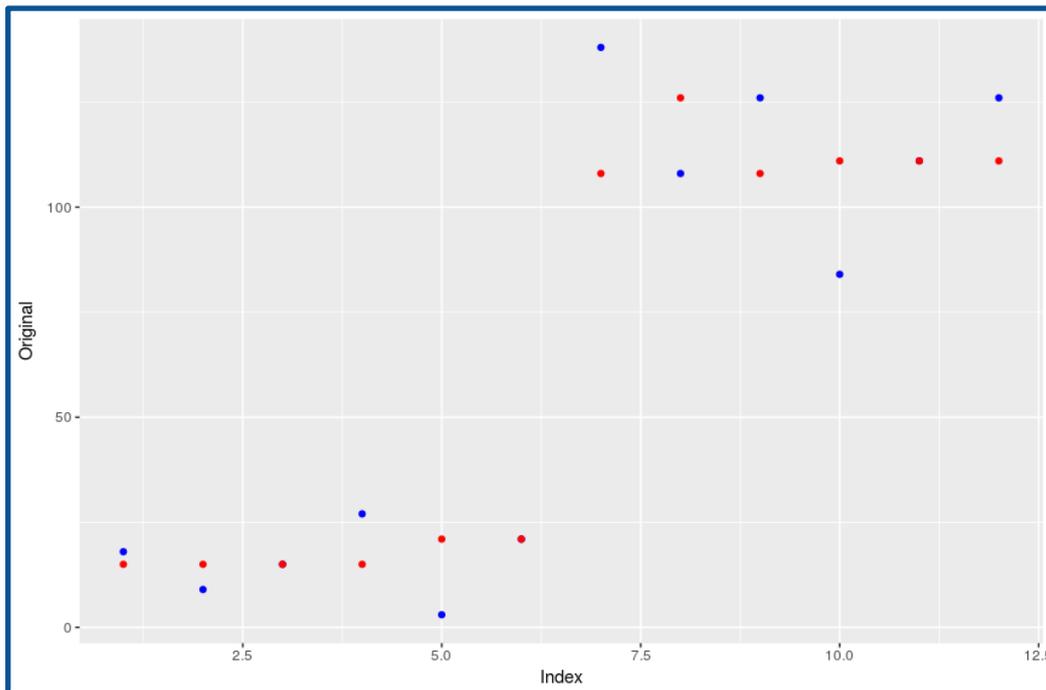
Figure 3-18: A simulated image edge represented as a 1-D vector (blue) and median filter of that vector (red).

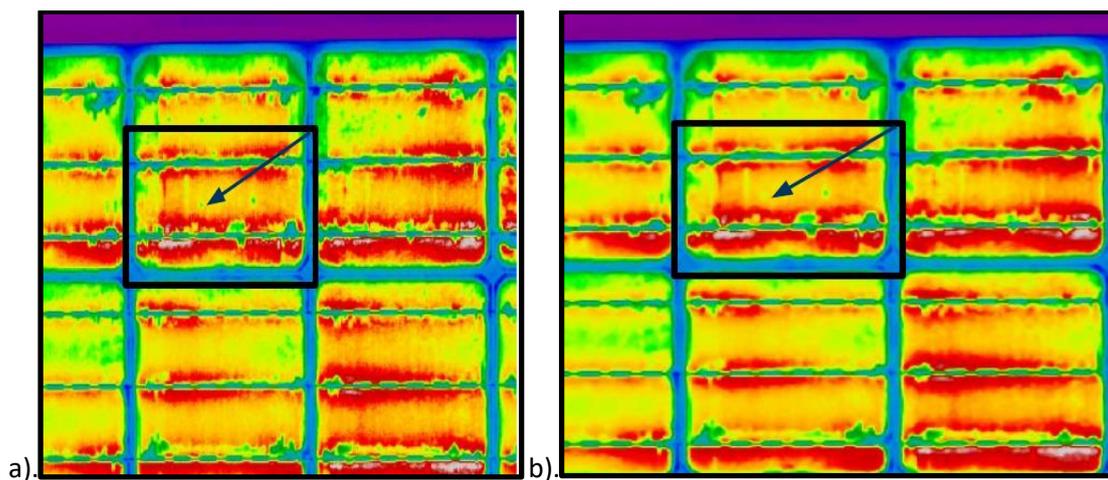
*Figure 3-19: An EL image section displayed using a coloured spectral mapping for ease of visualization. The arrow points to a bright pixel value that was reduced by filtering.*

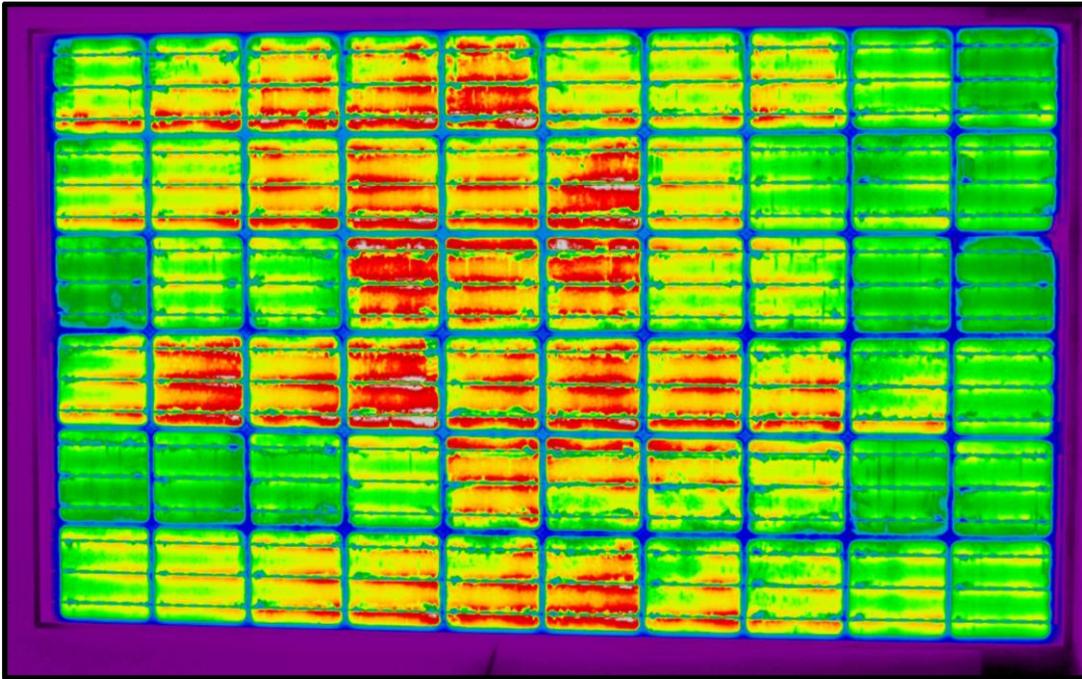
Figure 3-20: A median filtered grayscale EL image. Displayed using a spectral colour mapping.

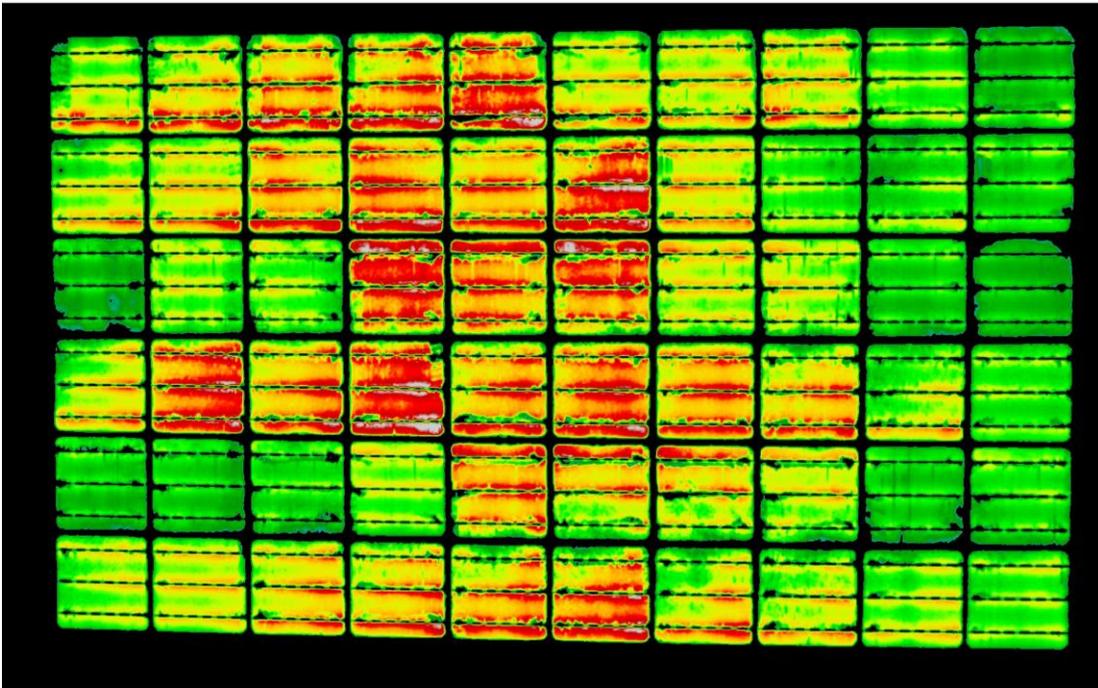
Figure 3-21: A filtered grayscale EL image with the background thresholded to 0 (black). Displayed using a spectral colour mapping.

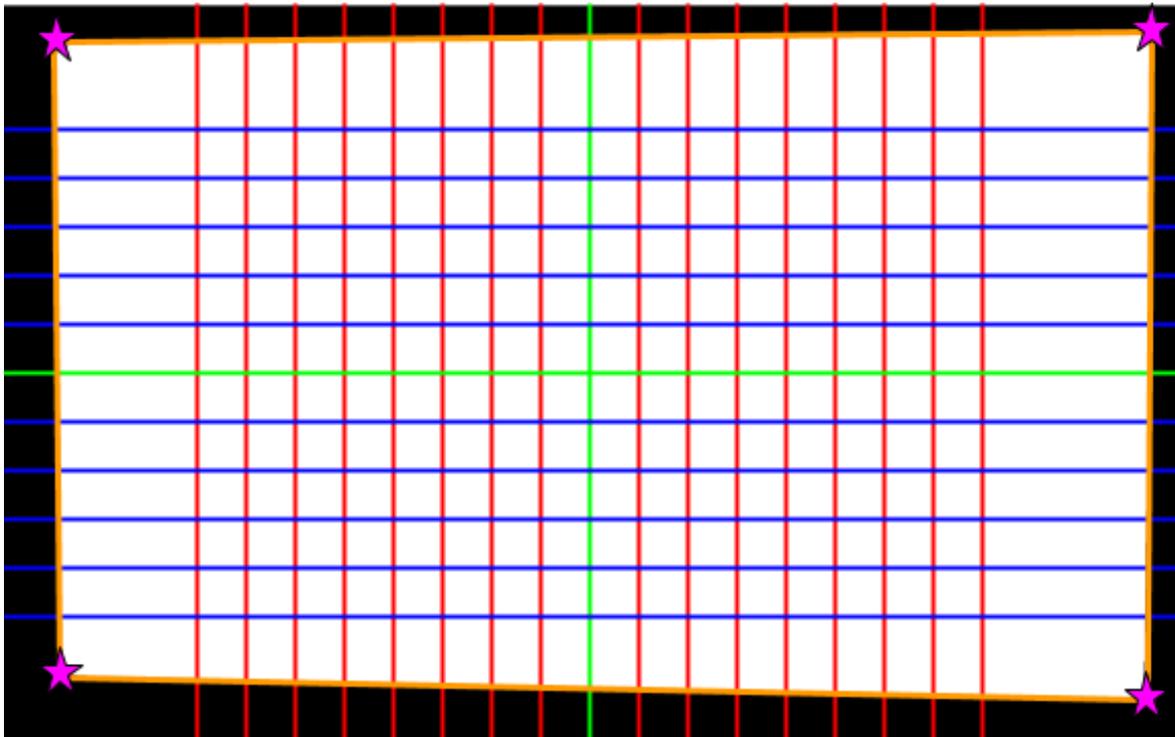
Figure 3-23: Visualization of the steps used to identify the four corners of the active cell region. The green lines are references lines for the mid-points in the x and y dimensions. Blue lines indicate horizontal vector slices. Red lines indicate vertical vector slices. Orange lines represent linear regression fits of the active area edges. Magenta stars represent the four corners of the active cell regions where the linear regression fits intersect.

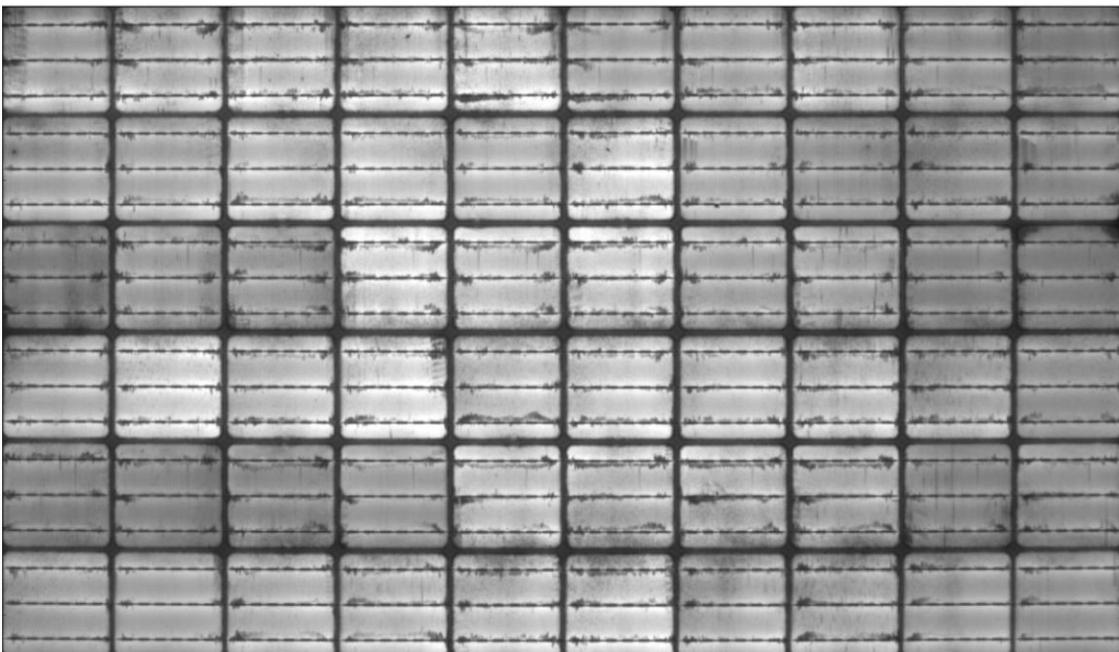
Figure 3-24: A perspective transformed EL image into a uniform orientation using the four corner points represented by the magenta stars in Figure 3-23.

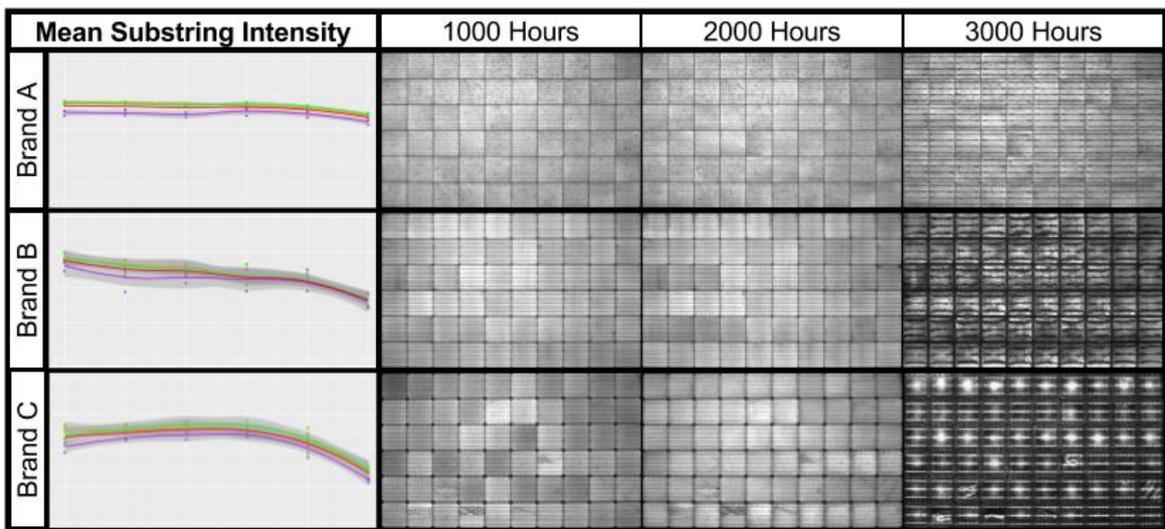
Figure 3-25: Mean substring intensity for three brands of modules over 3000 hours of damp-heat exposure [90]. The plots show 500, 1000, 1500, 2000, 2500, and 3000 hour steps of exposure along the x-axis, however, for only the corresponding 1000, 2000, and 3000 hour steps are shown as EL images. At each time-step, data points for 3 samples are plotted. The standard error is shown as a gray bounding shadow behind the data points.

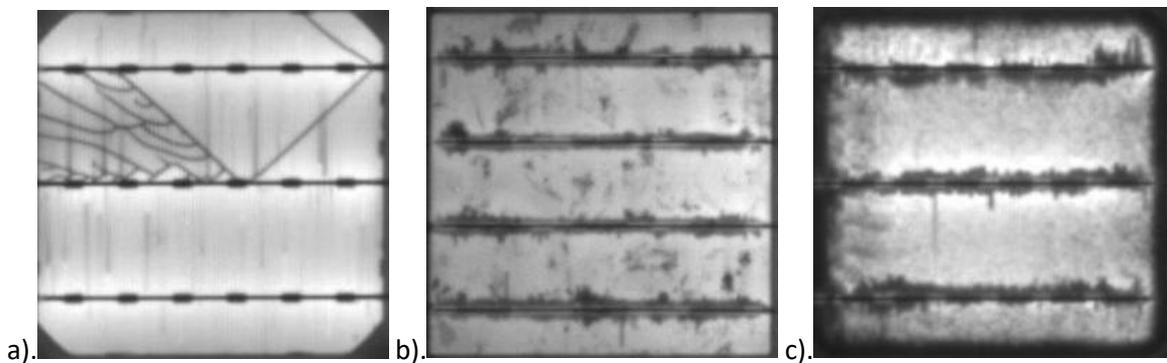
*Figure 3-26: An assortment of extracted cells using simple slicing of uniformly oriented module images.*

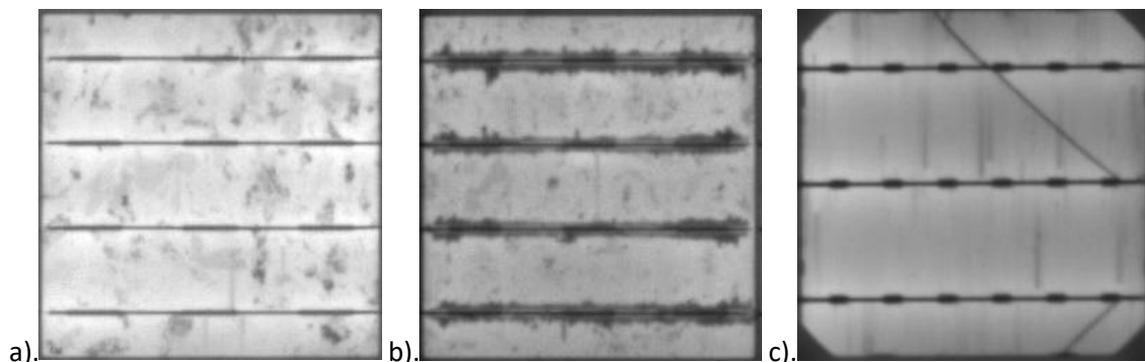
*Figure 3-27: Characteristic cells for each of the 3 cell types classified a). Good/clean, b). Busbar corroded and c). Cracked.*

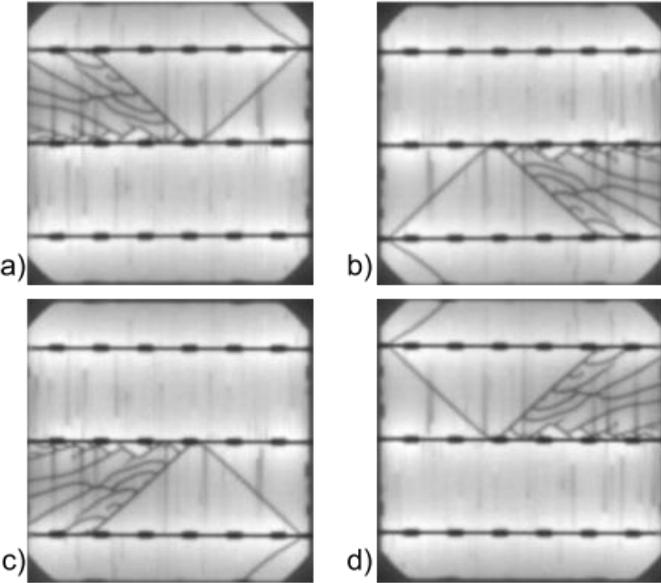
Figure 3-28: a) Original, b) Rotate 180°, c) Flip about x-axis, d) Flip about y-axis.
